Technical Service Bulletin

**KNOCKING NOISE FROM REAR SUSPENSION WHEN DRIVING OVER
ROAD BUMP**

Bulletin No.: 02-006/19

2014-~~2018~~ Mazda3 vehicles (Mexico built)

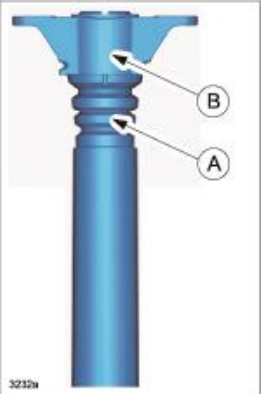
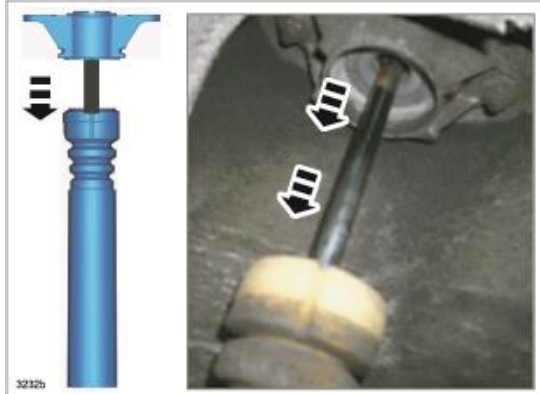
Some vehicles may exhibit a knocking noise from the rear of the vehicle when driving over a road bump. Upon inspection of the rear suspension, the bump stop (bound stopper) of the rear shock absorber is coming out of the mounting rubber.

Normal Condition: Bump stop (bound stopper) (A) is press fit and bonded to the mounting rubber (B).		Problem condition: Bump stop (bound stopper) is coming out of the mounting rubber.

This is caused by the adhesive surface of the mounting rubber bracket having inadequate roughness opposite to the bound stopper and the bracket shape being inappropriate to have sufficient holding force. The bound stopper may come out under any of the following conditions:

- When the bound stopper shrinks during cold weather
- When the bound stopper expands during cold weather after absorbing water
- When the shock absorber moves down after freezing over in between the shock absorber and the dust cover.

1. Verify customer concern.
2. Disassemble and assemble the affected rear shock absorber using a new bump stop (bound stopper) mounting rubber and nut according to the instructions on MGSS online (REAR SHOCK ABSORBER DISASSEMBLY/ASSEMBLY).
