<b>Subject:</b>  <b>DTC U2050:55 STORED AFTER BCM SOFTWARE UPDATE</b>	<b>Service Alert No.:</b> SA-055/19
	<b>Last Issued:</b> 12/10/2019

2019 Mazda3

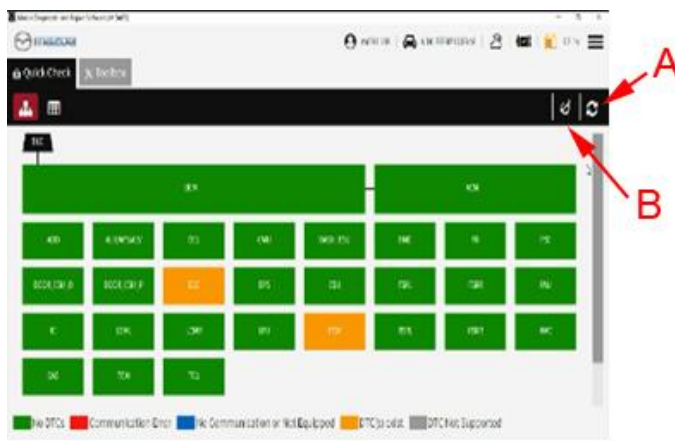
- If the engine is not started, DTC P2610 is stored and cannot be erased.
- If DTC U2050:55 is stored, ignore it. A TSB is pending.

6. Select Quick Check (A), then start the engine and select the DTC Clear icon (B).
