# Service Alert

<b>Subject:</b> <b>SERVICE CAUTION FOR REAR GLASS REPLACEMENT</b>	<b>Service Alert No.:</b> SA-057/19
	<b>Last Issued:</b> 12/17/2019

2006-2010 Mazda5

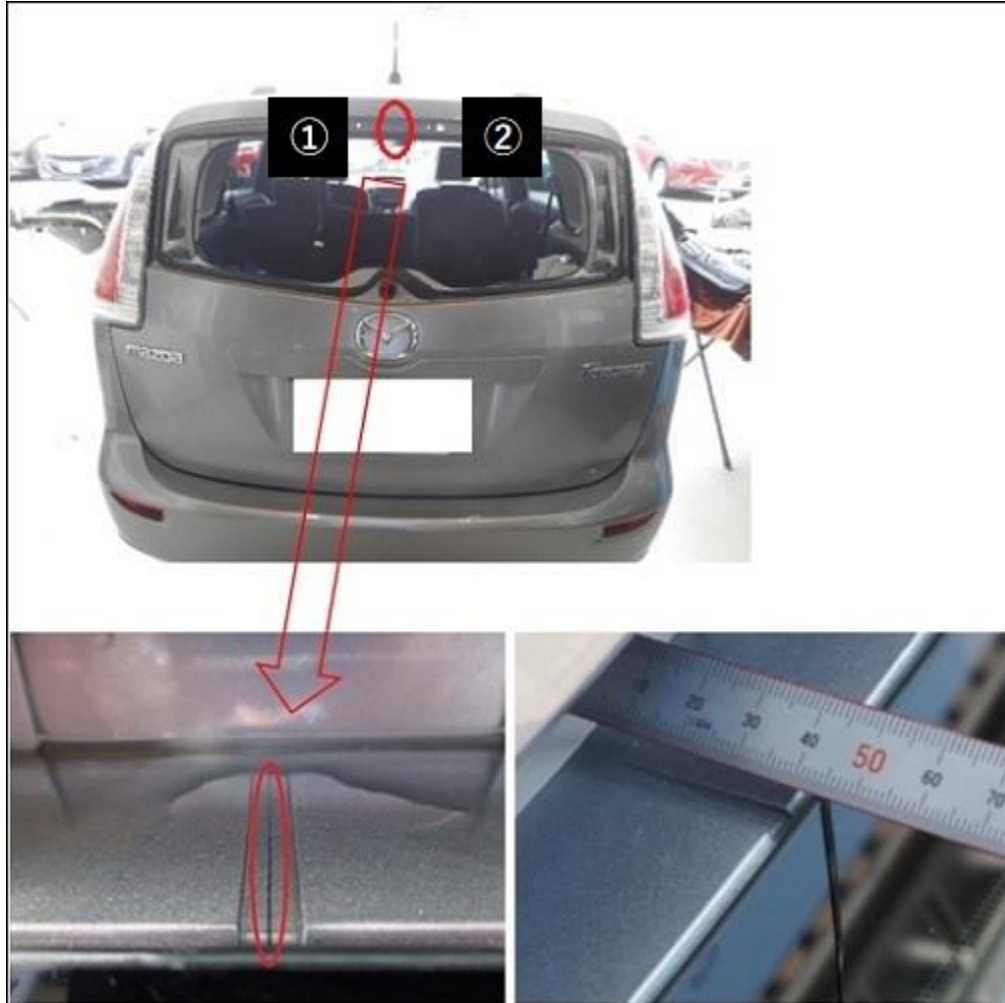
The crack occurs beneath the high mount stop light, with cracking towards the front direction. This might be caused by insufficient adhesive application when the rear glass was removed.

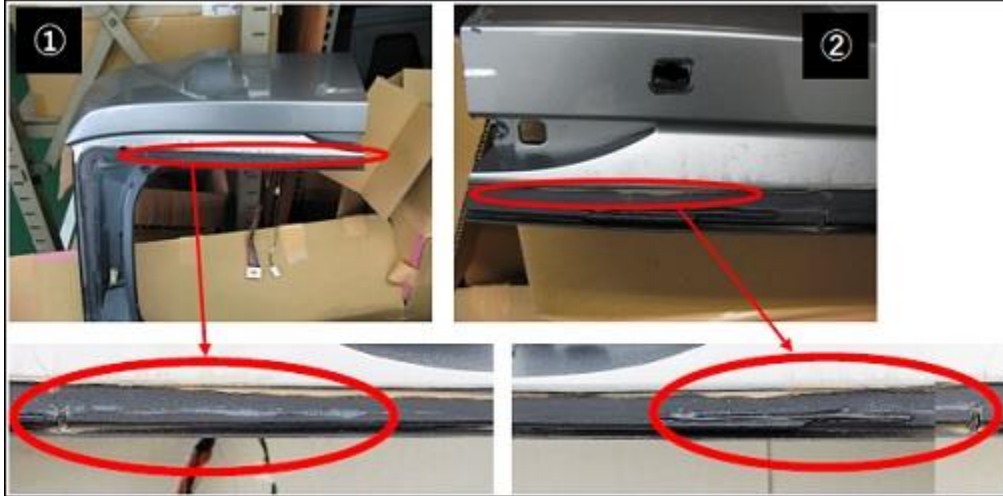
Cross sectional view

Good (glass is pressed perpendicular to frame)

No good (glass is NOT pressed perpendicular to frame)

**NOTE:** The glass needs to be pressed perpendicular to the frame during installation. Appropriate glass installation and adhesive application in between glass and outer layer of lift gate panel are essential to prevent the lift gate crack after rear glass replacement.

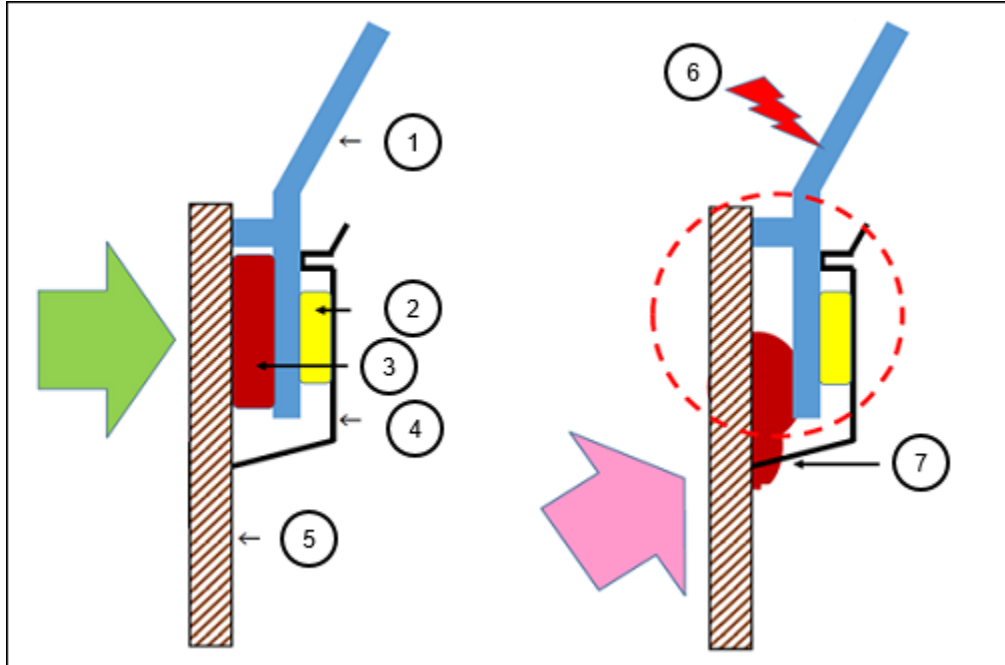
1	Outer Layer
2	Adhesive Inner - Outer
3	Adhesive Glass - Outer
4	Inner Layer
5	Glass
6	Cracking
7	If rear glass is installed diagonally and the adhesive is not applied properly in between glass and outer layer of lift gate panel, it causes unusual load on the circled area when opening and closing the lift gate. Then the outer layer and the adhesive itself can be cracked, which may result in water leaking into the cabin.
