# New Cascadia Pana-Pacific 540 Radio Controls Not Operating Normally

# 54-323

**Freightliner  
Service Bulletin**

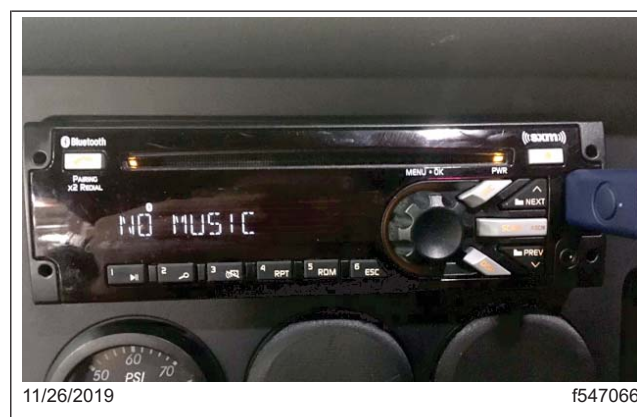
**Fig. 1, Radio Displaying "No Music"**

4. Plug in the USB stick to the radio. The radio will display "No Music." See [Fig. 1](#).

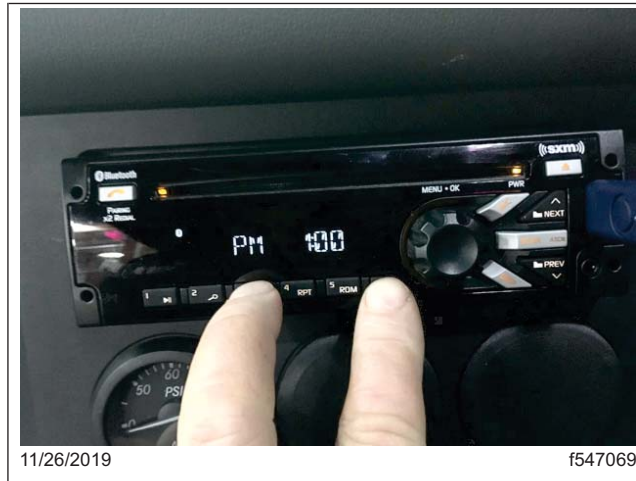
**Fig. 2, Holding Buttons 3 and 6**

5. Press and hold buttons 3 and 6 until the radio resets. See [Fig. 2](#). The radio will display "BOOTLOADER" and "REFLASHING" during the programming process. See [Fig. 3](#) and see [Fig. 4](#).

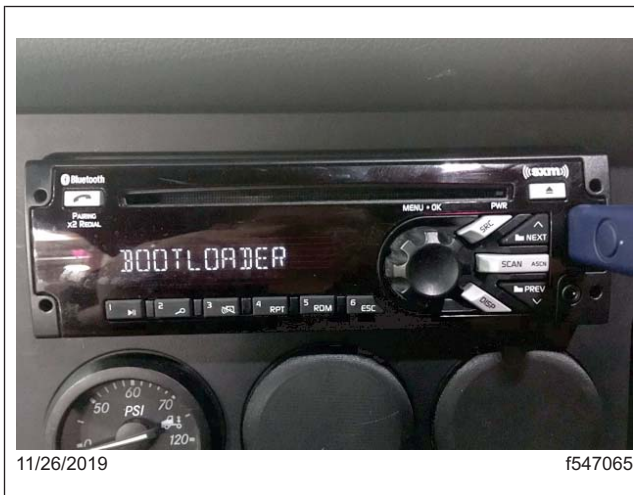
**Fig. 3, Radio Displaying "Bootloader"**

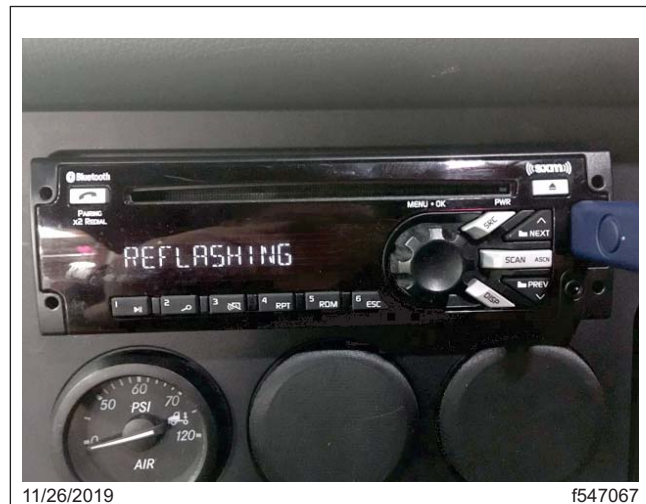
**Fig. 4, Radio Displaying "Flashing"**

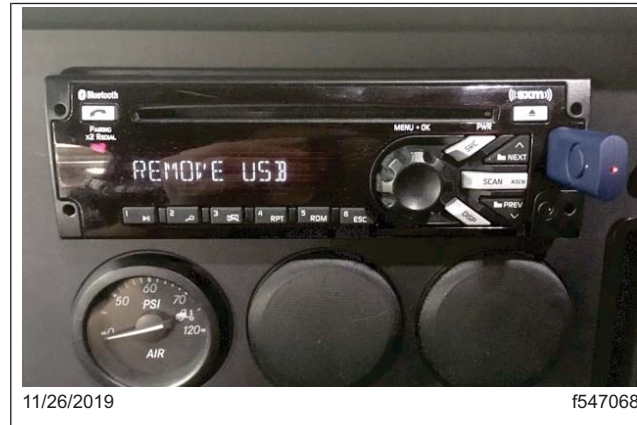
**Fig. 5, Radio Displaying "Remove USB"**

6. Wait for "Remove USB" to display. Remove the USB. See [Fig. 5](#)
