# Water Leak at the Top of a Cab Door, Cascadia Day Cab with FE13 Roof Fairing

# 60-155

**Freightliner  
Service Bulletin**

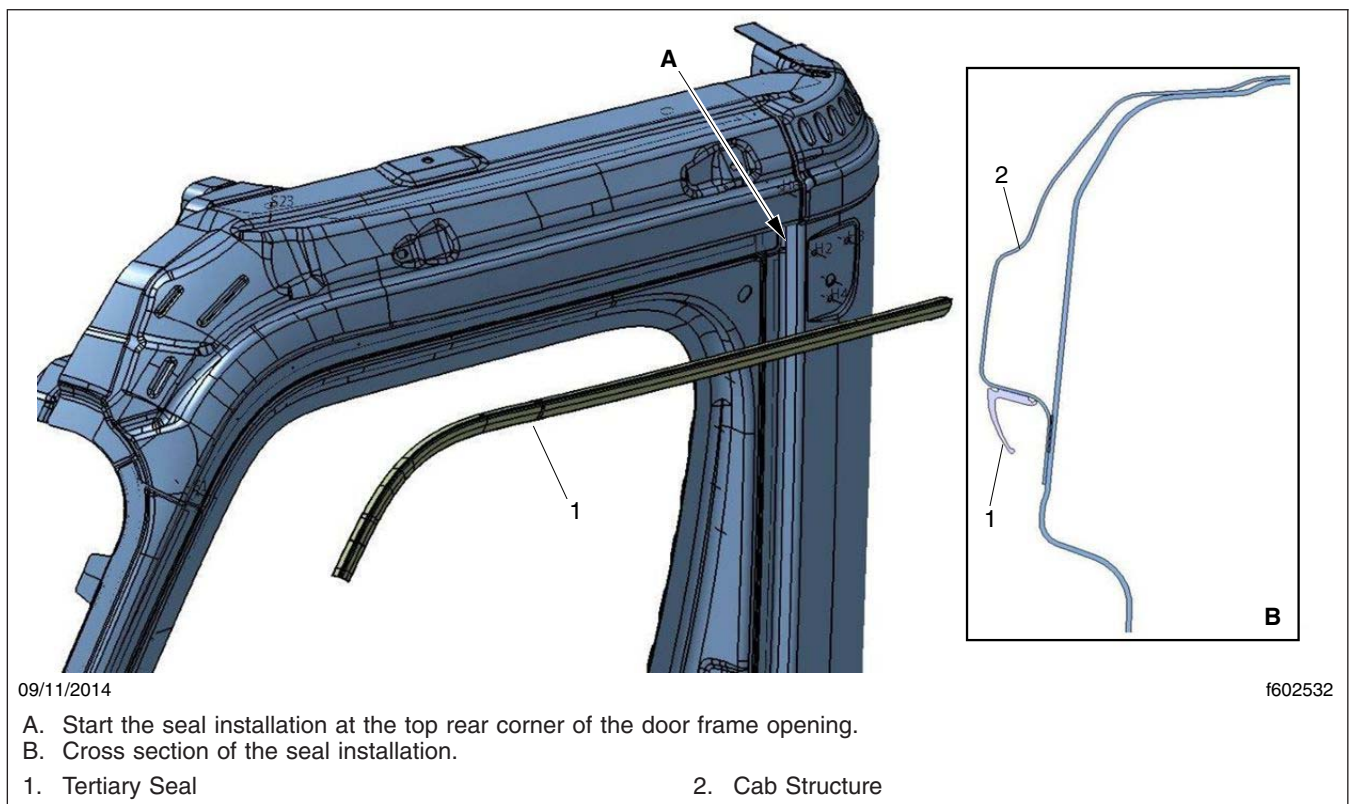
**Fig. 1, Tertiary Seal Installation**

Some Cascadia day cabs with FE13 roof fairings (data code 784-084) may be more susceptible to water intrusion into the cab at the top of the cab door. Due to the way the air flows around the FE13 fairing, water is pushed past the door seals while the vehicle is in motion, possibly resulting in water intrusion. A tertiary (rain deflector) seal has been designed to keep water away from the top of the door opening.

1. Park the vehicle on a level surface, shut down the engine, and set the parking brake. Chock the tires.
2. Open the door.
3. Wipe the mounting surface clean with alcohol. Refer to [Fig. 1](#) for the seal mounting location on the underside of the door opening overhang. Allow it to dry.
4. Peel back the adhesive backing at the rear end of the tertiary seal.
5. Install the seal on the underside of the door opening overhang, starting at the top rear corner of the opening. See [Fig. 1](#). Press the seal firmly to the cab, following the door opening contour. Peel back the adhesive backing as you proceed. See [Fig. 2](#).
