Technical Service Bulletin

Subject: "AUTO LIGHT SYSTEM MALFUNCTION. TURN ON/OFF LIGHTS MANUALLY" WARNING MESSAGE AND DTC B10AD:09 STORED WHEN PARKED DURING HOT WEATHER CONDITIONS	Bulletin No.: 09-036/19
	Last Issued: 12/17/2019

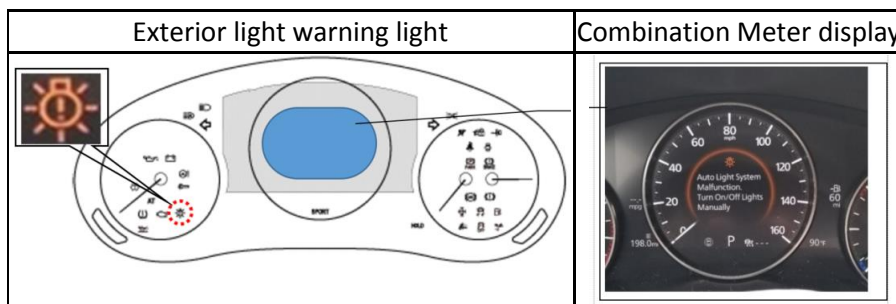
Some customers may complain about an instrument cluster warning message "Auto Light System Malfunction. Turn On/Off Lights Manually". DTC B10AD:09 (Humidity sensor/solar radiation sensor/auto light sensor/rain sensor malfunction) may also be stored with the exterior light warning indicator light ON.

This is caused by the rain sensor detecting a temperature higher than the operation range and temporarily stopping the auto light system. As a fail-safe, the low beam headlights are turned on. The auto light system will start to operate normally when the A/C is turned on and the interior temperature drops. To correct this concern, the heat resistance performance of the rain sensor has been enhanced.

1. Verify customer concern.
2. Replace the rain sensor with a modified one according to the instructions on MGSS (RAIN SENSOR REMOVAL/INSTALLATION).
3. Verify repair.
