Technical Service Bulletin

CHECK ENGINE LIGHT ON WITH P0012:00

Bulletin No.: 01-021/19

2019-2020 Mazda3 (Japan built) vehicles with VINs lower than JM1BP*****147795 (produced before Jul.1, 2019)

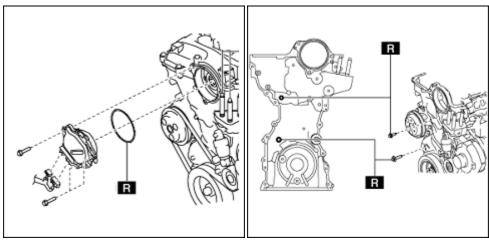
Location of the replacement parts [R]

Ring,'O' Bolt

Gasket, Head Cover

Parts Number	Description	Qty.	Notes
PE02-12-4X0	Actuator, Variable Valve Timing	1	
PE01-12-257	Ring,'O'	1	[R] For electric variable valve timing motor/driver
9YA0-20-678	Bolt	1	[R] Upper blind plug at timing chain cover
9YA0-20-863	Bolt	1	[R] Lower blind plug at timing chain cover, 2.0L
9YA0-20-865	Bolt	1	[R] Lower blind plug at timing chain cover, 2.5L
PE01-10-235	Gasket, Head Cover	1	[R] [US/Mexico - Japan built] For 2.0L w/o cylinder deactivation
PE7W-10- 235	Gasket, Head Cover	1	[R] [US/Mexico - Mexico built] For 2.0L w/o cylinder deactivation
PY01-10-235	Gasket, Head Cover	1	[R] For 2.5L w/o cylinder deactivation
PYFA-10-235	Gasket, Head Cover	1	[R] For 2.5L with cylinder deactivation
