# Technical Service Bulletin

<b>Subject:</b>  WATER PUMP COOLANT LEAK	<b>Bulletin No.:</b> 01-022/19
	<b>Last Issued:</b> 12/13/2019

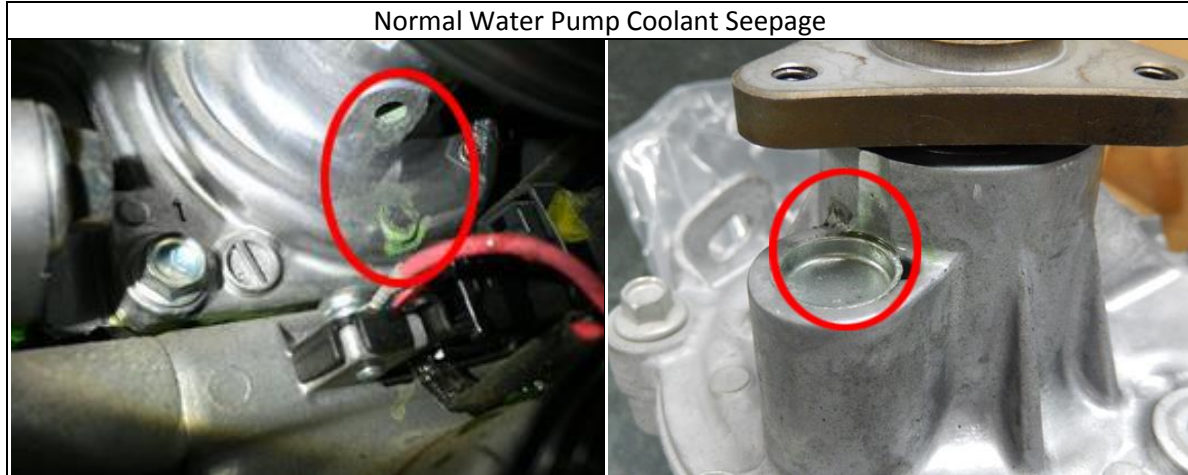
A mechanical seal (A) is used for the water pump. This mechanical seal can seal coolant (B) by sliding a mating ring (C) against a seal ring (D). When the sliding surface temperature of the mechanical seal is more than 248 °F (120 °C) while driving, a small amount of steam (E) is leaked and bleeds through the bleeding hole (F). After drying, the steam leaves a green coolant deposit near the water pump bleed hole (F). This is a normal condition and does not require water pump replacement. The water pump should only be replaced if there is an accumulation of crystallized coolant near the bleed hole.

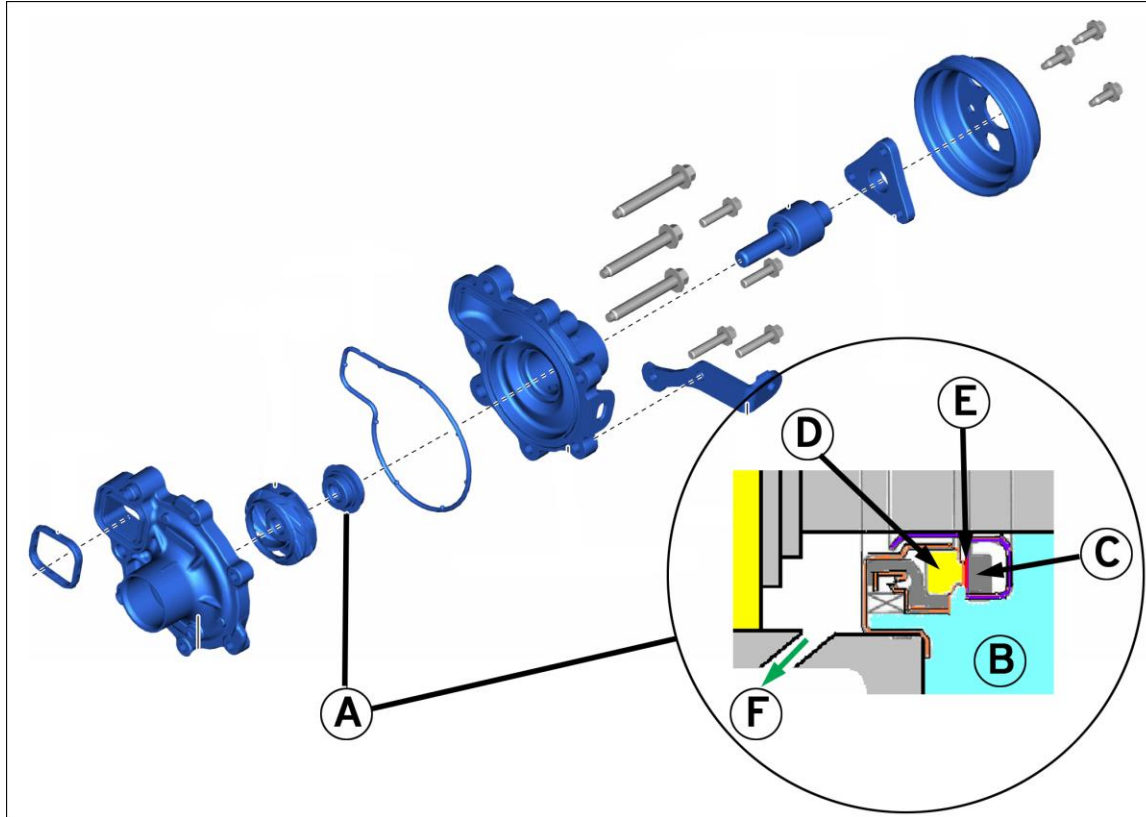
Bleed hole (F) is located under water pump

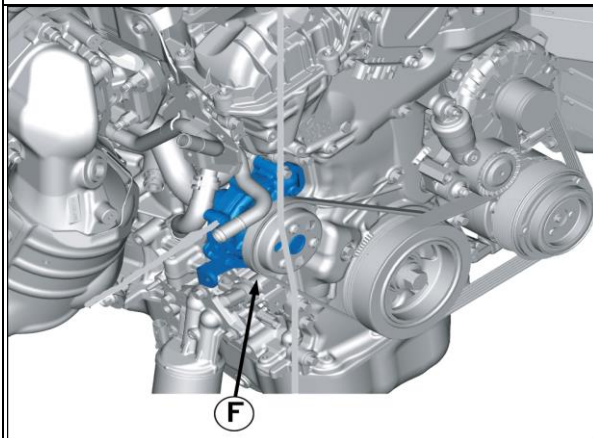
Dried coolant steam shows as green-color deposit at bleed hole

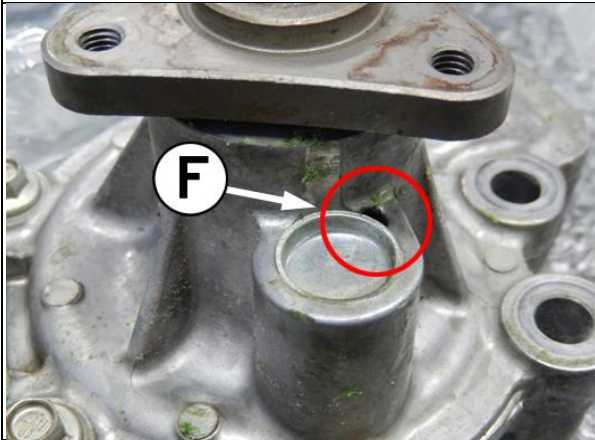
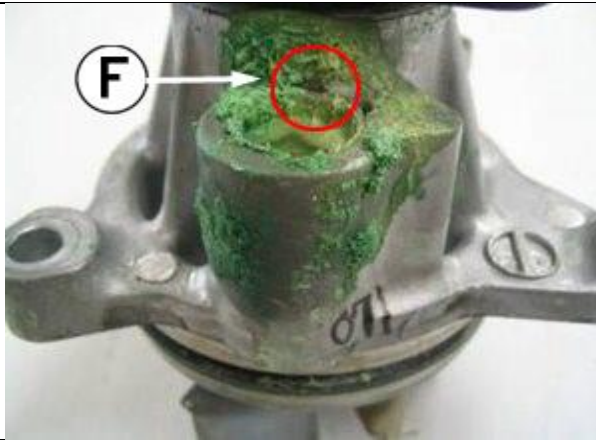
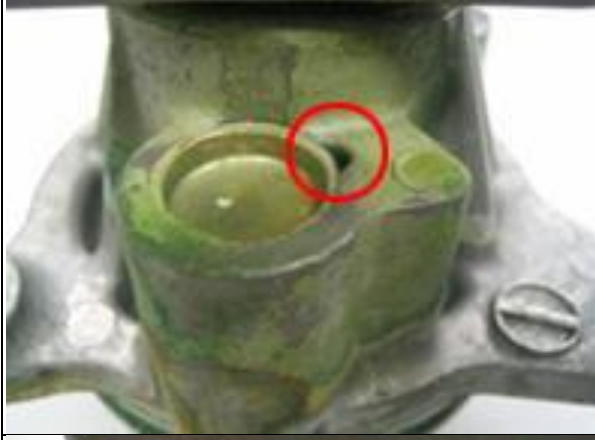
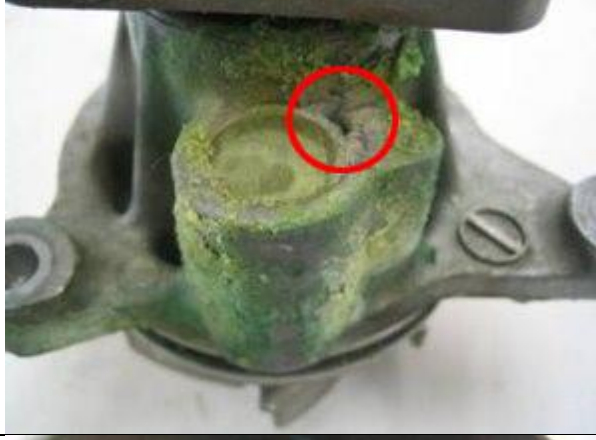
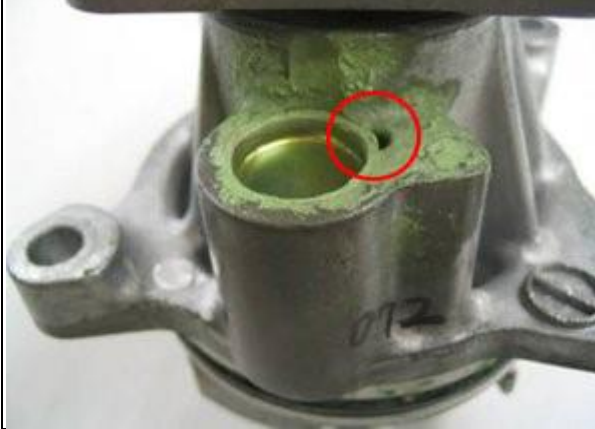
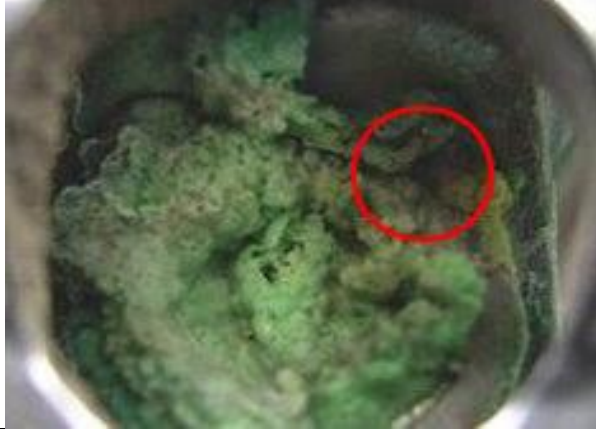
Water Pump Samples:	
GOOD	NO GOOD
No accumulation of crystallized coolant. <b>DO NOT</b> replace the water pump.	Accumulation of crystallized coolant near the bleed hole (F). Replace the water pump.
