First Release

## UPPER REACTION RODS TORQUE INSPECTION

B13R (9700 us/can)

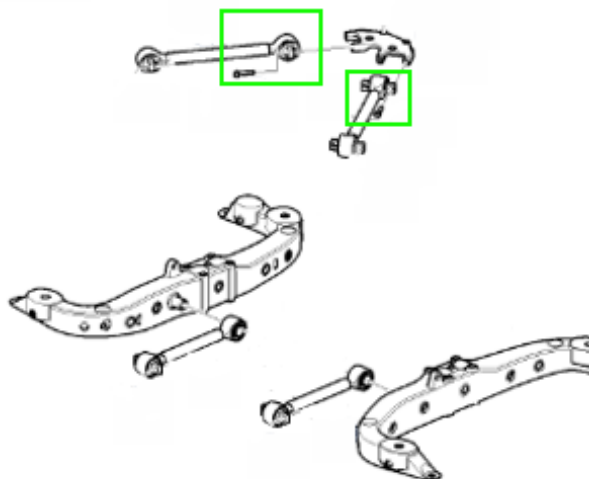
On the vehicles affected by this bulletin, the flange bolts securing the upper reaction rods to the drive axle may not have been sufficiently torqued and may come loose.

Four measurements (total) are required (the two reaction rods are held by two bolts each at the axle side).

5. Once measurements are recorded, re-torque all 4 bolts to **275Nm +/- 45** (200 lb-ft +/- 30).

- All loose fasteners (showing less **100Nm** (75 lb-ft) during the initial inspection) must be replaced.
- Replace bolts one by one to avoid disturbing the rod adjustment (shims could be present).
- Order bolt(s) # **984837**.
- Torque all new bolts to **275Nm +/- 45** (200 lb-ft +/- 30).
