Service Alert

2020 CX-30 SERVICE CAUTIONS FOR NEW AND REVISED FEATURES

Service Alert No.: SA-051/19

2020 CX-30

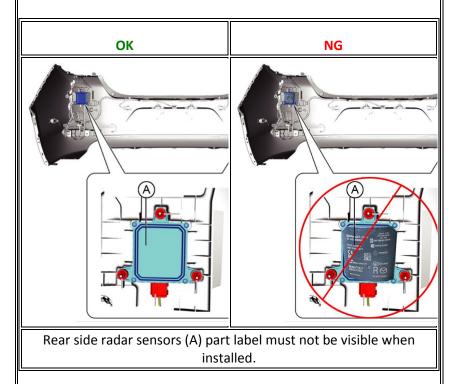
- 1. BSM system indicates vehicle on the opposite side.
- 2. i-ACTIVSENSE indicator ring will not turn green
- 3. Rear Cross Traffic Alert (RCTA) does not work
- 4. Rear side radar sensor aiming may fail
- 5. TPMS DTC(s) stored

This may be caused by BSM rear side radar sensor(s) installed facing the wrong direction.

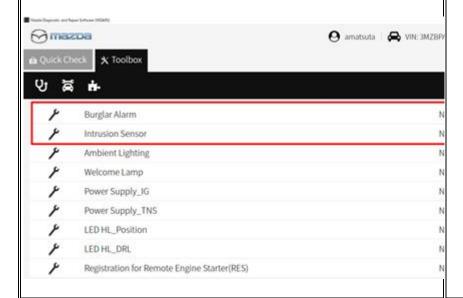
The CX-30 does not have the necessary Theft-Deterrent System hardware to function if enabled using MDARS, and MDARS cannot disable the Theft-Deterrent System after it has been enabled. The following DTC's may be stored if the burglar alarm or intrusion sensor are enabled:

- 1. B109F:87 Intrusion Sensor Module
- 2. B2002:87 On Board Charger DC/DC Low Voltage Side Contact Hotline if the Theft-Deterrent System has been accidently enabled.

Contact Hotline for latest repair information.
