TT8532EN  
November 20, 2019  
Page 1 of 3

**SUBJECT:** Incorrect ETC2 Range Parameter Format Setting in Navistar Vehicles

**MODELS AFFECTED:** Navistar Vehicles with 1000, 2000, and 3000 Series Transmissions with 5th Generation Controls

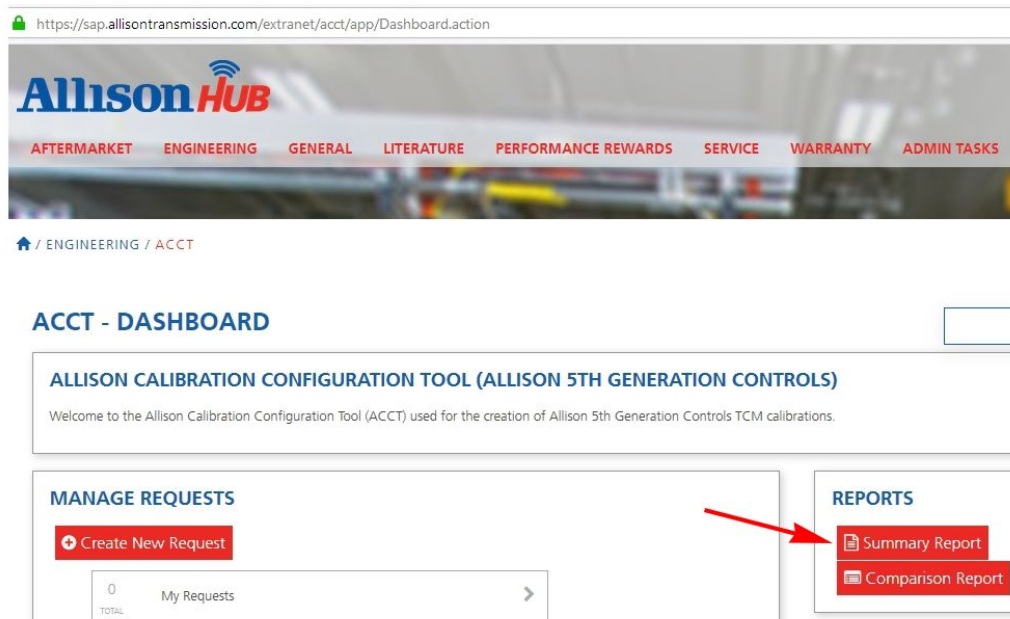
Figure 1. ACCT Main Page

- a. Choose Summary Report from the ACCT main page on the HUB. Refer to [Figure 1](#).

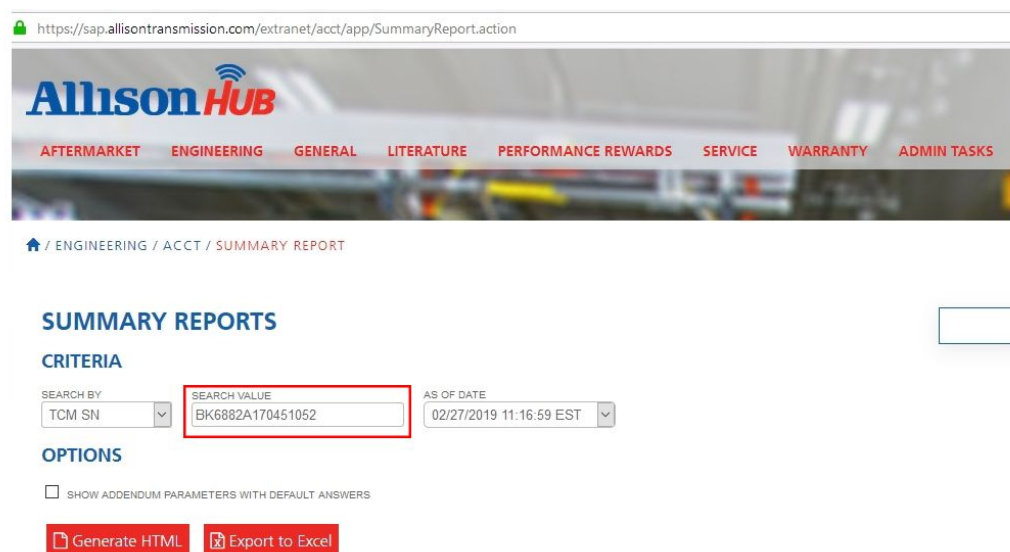
Figure 2. Summary Report Generation

- b. Enter the TCM serial number in the Search Value field, wait for As of Date field to populate, and click Generate HTML. Refer to [Figure 2](#).
- c. Verify that parameter 30210: J1939 Broadcast: ETC2 Range Parameter Format is set to 5th Gen Format [1] in the Basic section of the calibration summary report. Refer to [Figure 3](#).
- d. If parameter 30210: J1939 Broadcast: ETC2 Range Parameter Format is set to 5th Gen Format [1], proceed to step 7.
