TO: Mercedes-Benz Dealer Principals, General Managers, Sales Managers, Service Managers, Parts Managers	FROM: Gregory Gunther, Department Manager, Vehicle Compliance and Analysis, Engineering Services
RE: <b>Service Campaign Launch Notification</b> <b>Bolt Replacement on the Steering Rack</b> <b>MY12-17 166, 204, 205, 207, 212, 213, 217,218, 222, 253, 292 (C-Class, CLS-Class, E-Class, GL-Class, GLC-Class, GLE-Class, GLK-Class, GLS-Class, M-Class S-Class)</b>	DATE: November 8, 2019

Campaign No. 2019080019, November 2019

SUBJECT: **Various Models**  
**Model Years 2012-2017**

**Replace Steering Gear Bolts**

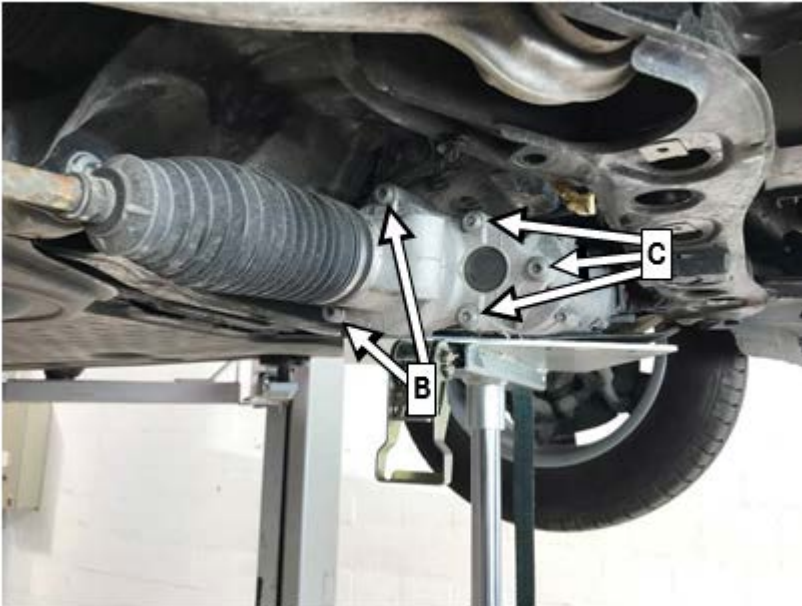
Figure 2

- i** If a **screw** should **break off** or have already broken off, **replace the electric power steering rack.**
  - i** For basic data, **see AR46.20-P-0600EL and AR46.20-P-0600EF.**

- Remove screws (B and C, Figure 2), making **absolutely sure** to do so **individually and one after the other**, replace with new steel screws and tighten with the specified torque incl. tightening angle.

- i** The procedure must be completed so that the power-pack does not twist away from its set position thus resulting in consequential damage.
  - Hm** Power-pack screw on steering gear: **5 Nm and 90°** tightening angle.

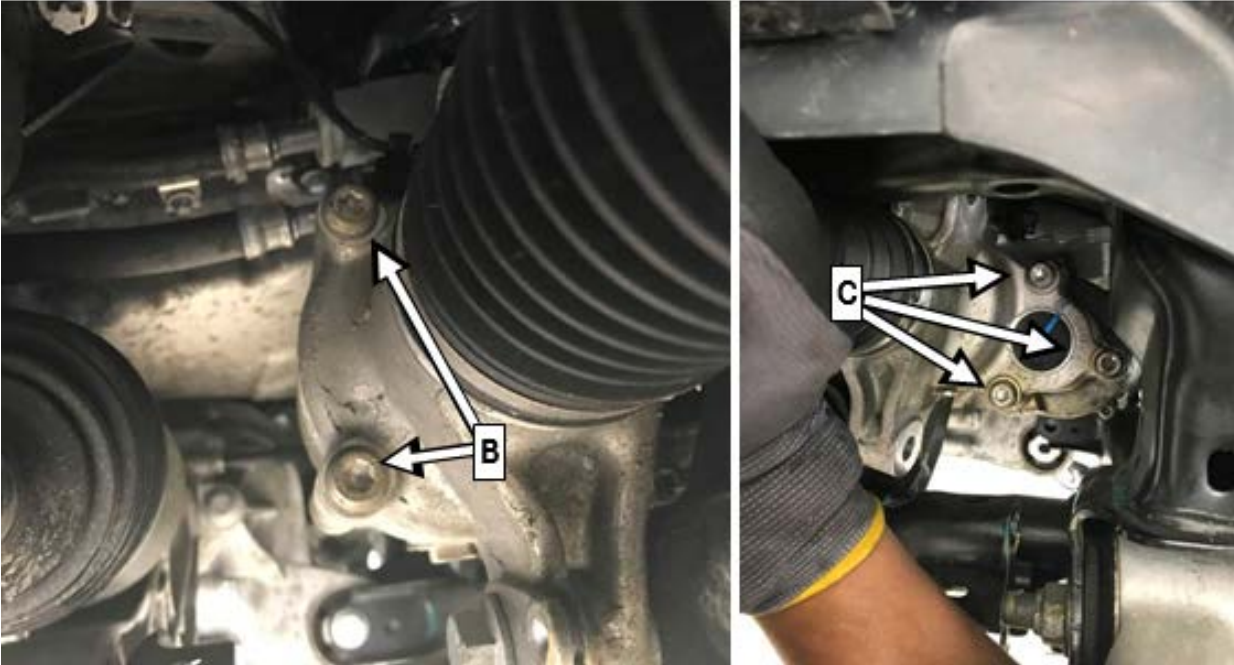
Figure 8

- Nm** Power-pack screw on steering gear: **5 Nm and 90°** tightening angle.
- i** If a **screw** should **break off** or have already broken off, **replace the electric steering rack**.

5. Slightly lift steering on left and right and move towards rear in front axle carrier so that the screws **(B and C, Figure 8)** are accessible.

6. Remove screws (**B and C, Figure 8**), making **absolutely sure** to do so **individually and one after the other**, replace with new steel screws and tighten with the specified torque incl. tightening angle.

- i** The procedure must be complied with so that the power-pack does not twist away from its set position thus resulting in consequential damage.
- i** **Important:** Take into account the different screw lengths of screws B and C in models 166 and 292!
