Service Update

N192273400 Positive Crankcase Ventilation Tube Loose

Release Date: November 2019

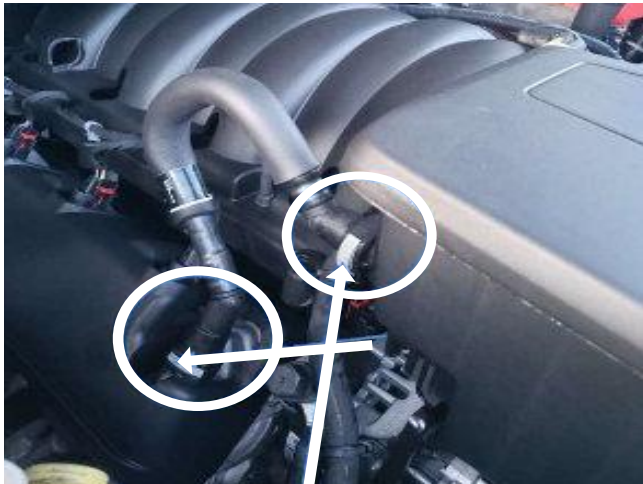
2. Locate the PCV connectors (2) as shown above on the PCV Tube.

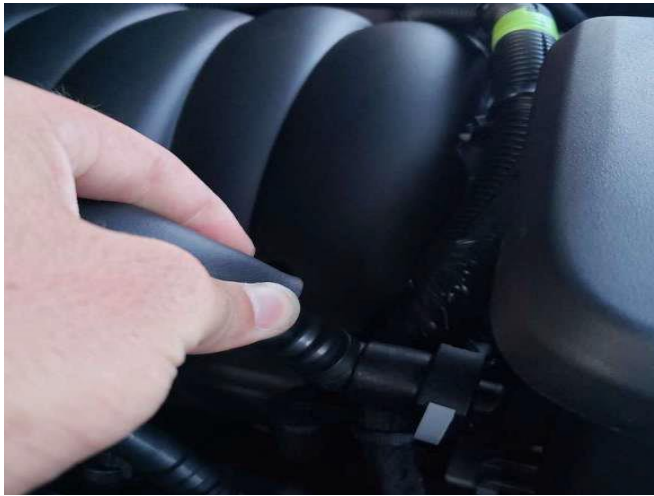
5431224

3. Gently pull the PCV Tube and ensure the connector is fully seated at the location as shown.

5. If either connector is not fully seated, push the connector until the clip is in the correct position and fully seated.
6. Remove fender covers and close hood.

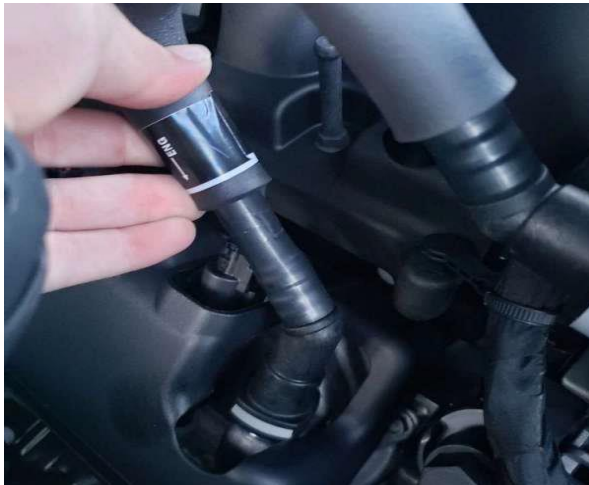
5431225

4. Gently pull the PCV Tube and ensure the connector is fully seated at the location as shown.
