# Service Update

## N192279900 Steering Wheel Dither

**Release Date:** November 2019

Models: 2020 Chevrolet Silverado HD  
2020 GMC Sierra HD  
Equipped with Active Hydraulic Assist Gear (RPO NV8)

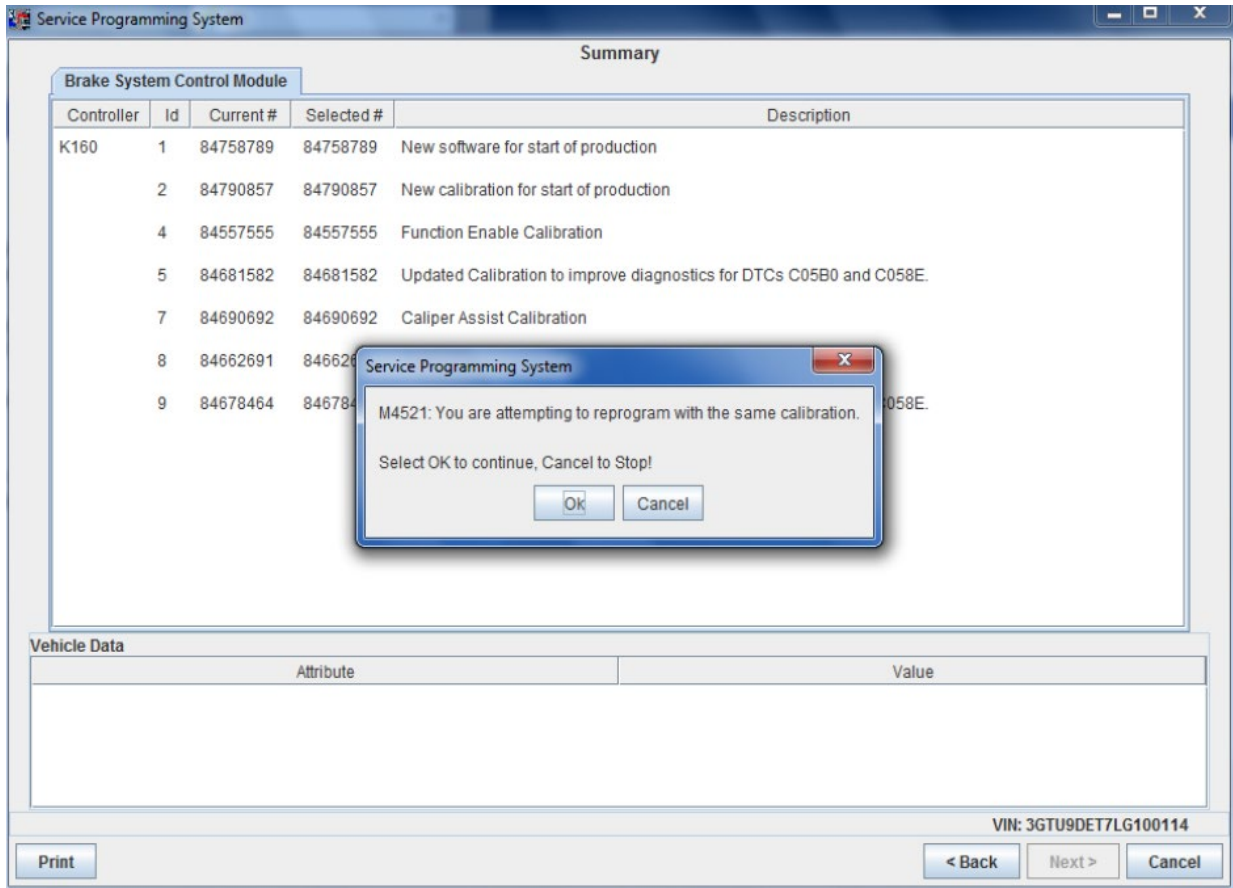
5431207

**Note:** If the Same Calibration/Software Warning is noted on the SPS screen, select OK and follow screen instructions. After a successful programming event, the WCC is located in the Service Programming System dialogue box of the SPS Summary screen. No further action is required. Refer to the Warranty section of the bulletin.

1. Reprogram the Power Steering Control Module. Refer to *K43 Power Steering Control Module: Programming and Setup* in SI.

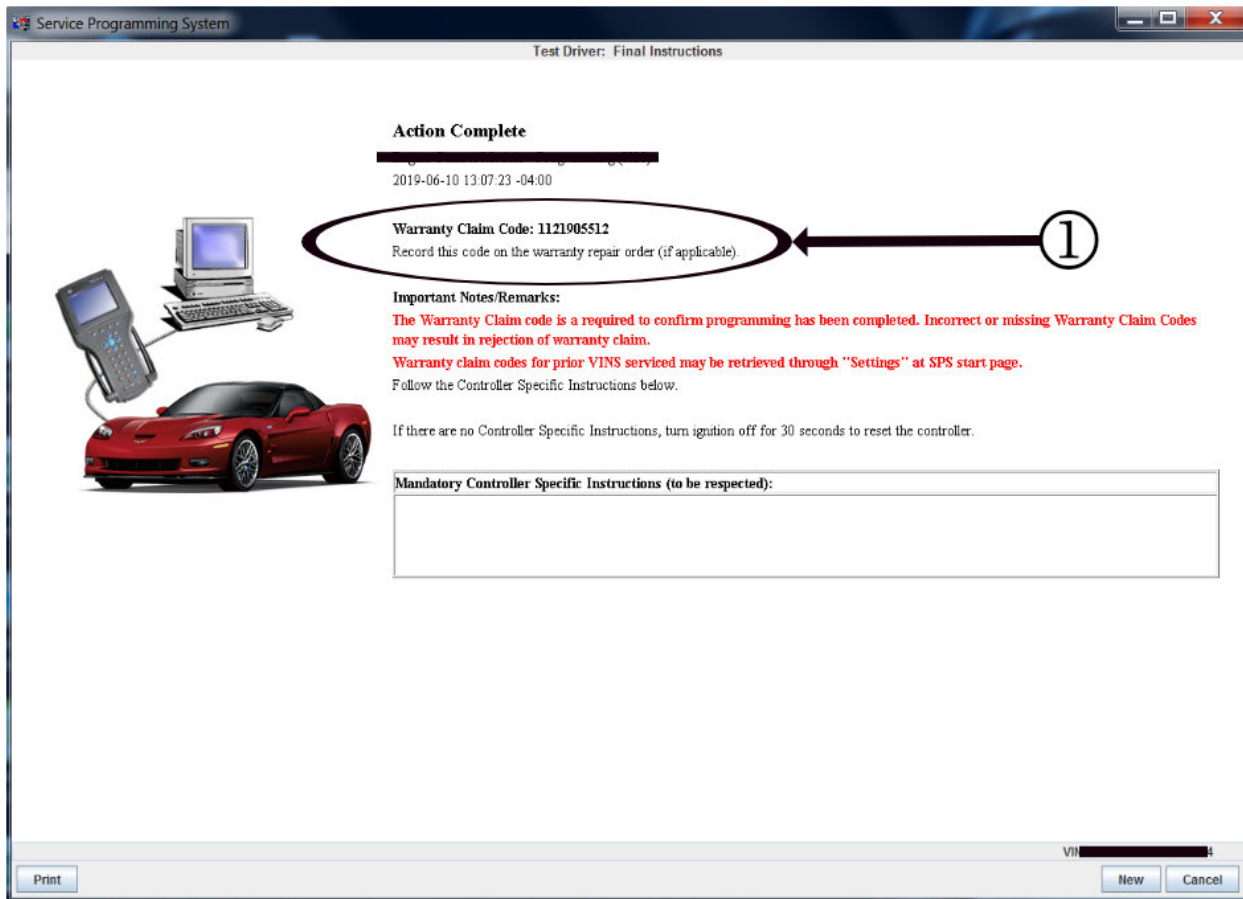
5431209

**Note:** To avoid warranty transaction rejections, you **MUST** record the warranty claim code provided on the SPS Warranty Claim Code (WCC) screen on the job card. Refer to callout 1 above for the location of the WCC on the SPS screen.

2. Clear out K43 data: using GDS 2, perform a "Learned Values Reset".
3. Record SPS Warranty Claim Code on job card for warranty transaction submission.
