# Service Update

## N192273640 Engine Control Module Torque Reduction

**Release Date:** November 2019

**Revision:** 00

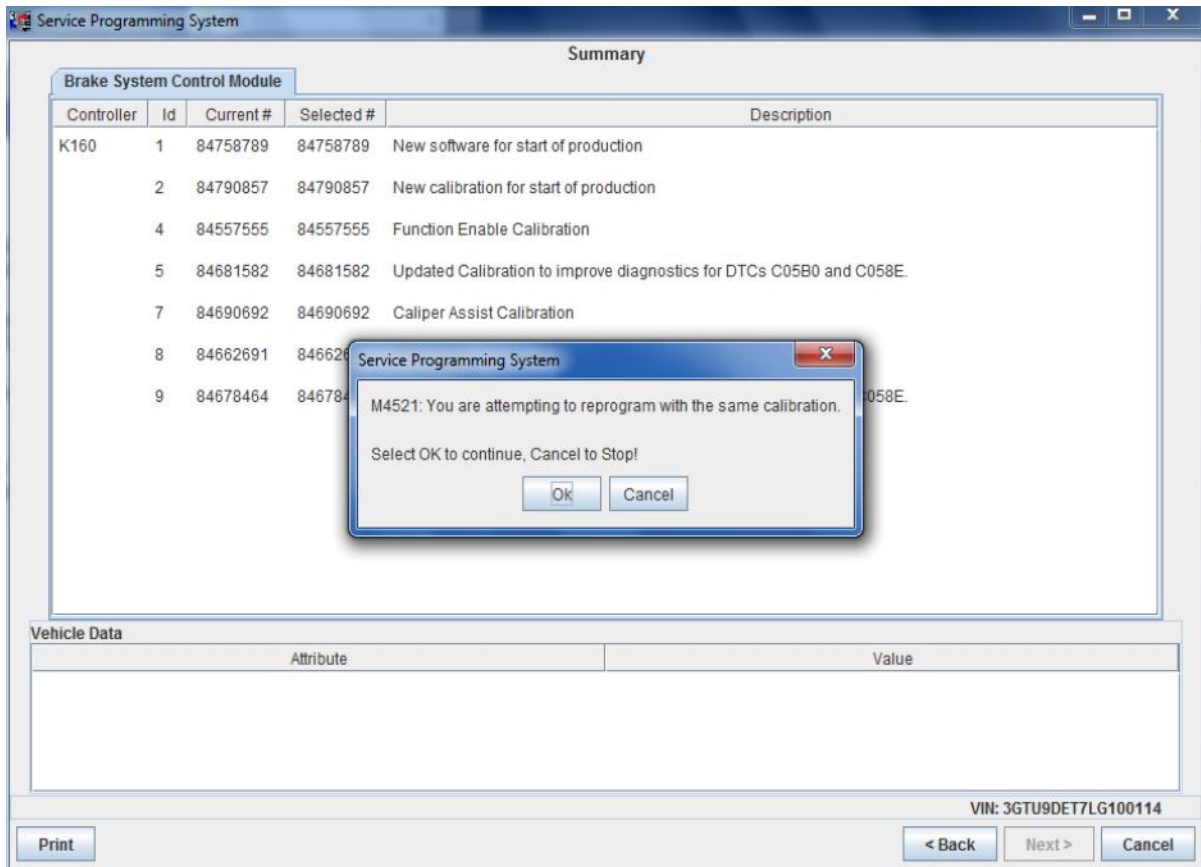
5431207

**Note:** If the Same Calibration/Software Warning is noted on the SPS screen, select OK and follow screen instructions. After a successful programming event, the WCC is located in the Service Programming System dialogue box of the SPS Summary screen. No further action is required. Refer to the Warranty section of the bulletin.

1. Reprogram the Engine Control Module. Refer to *K20 Engine Control Module: Programming and Setup* in SI. Modify as required (e.g., select x module from the controller screen). Then provide step-by-step instructions or refer to SI procedure.

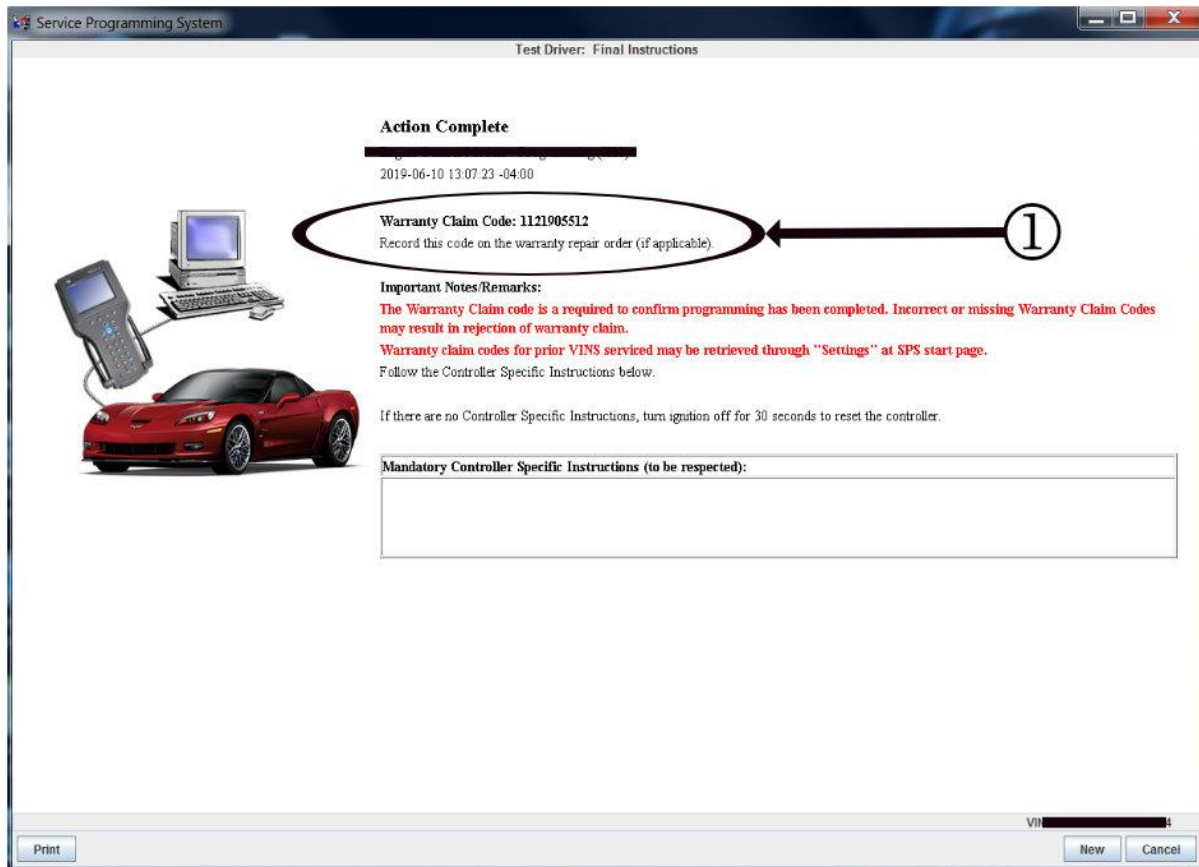
**Note:** To avoid warranty transaction rejections, you **MUST** record the warranty claim code provided on the SPS Warranty Claim Code (WCC) screen on the job card. Refer to callout 1 above for the location of the WCC on the SPS screen.

2. Record the SPS Warranty Claim Code on job card for warranty transaction submission.
