Service Update

N192216310 Customer May Be Able To Shift Out of Park With Expired Latent Fault Mode Counter

Release Date: November 2019

Subject: N192216310 - Service Update
Customer May Be Able To Shift Out of Park With Expired Latent Fault
Mode Counter

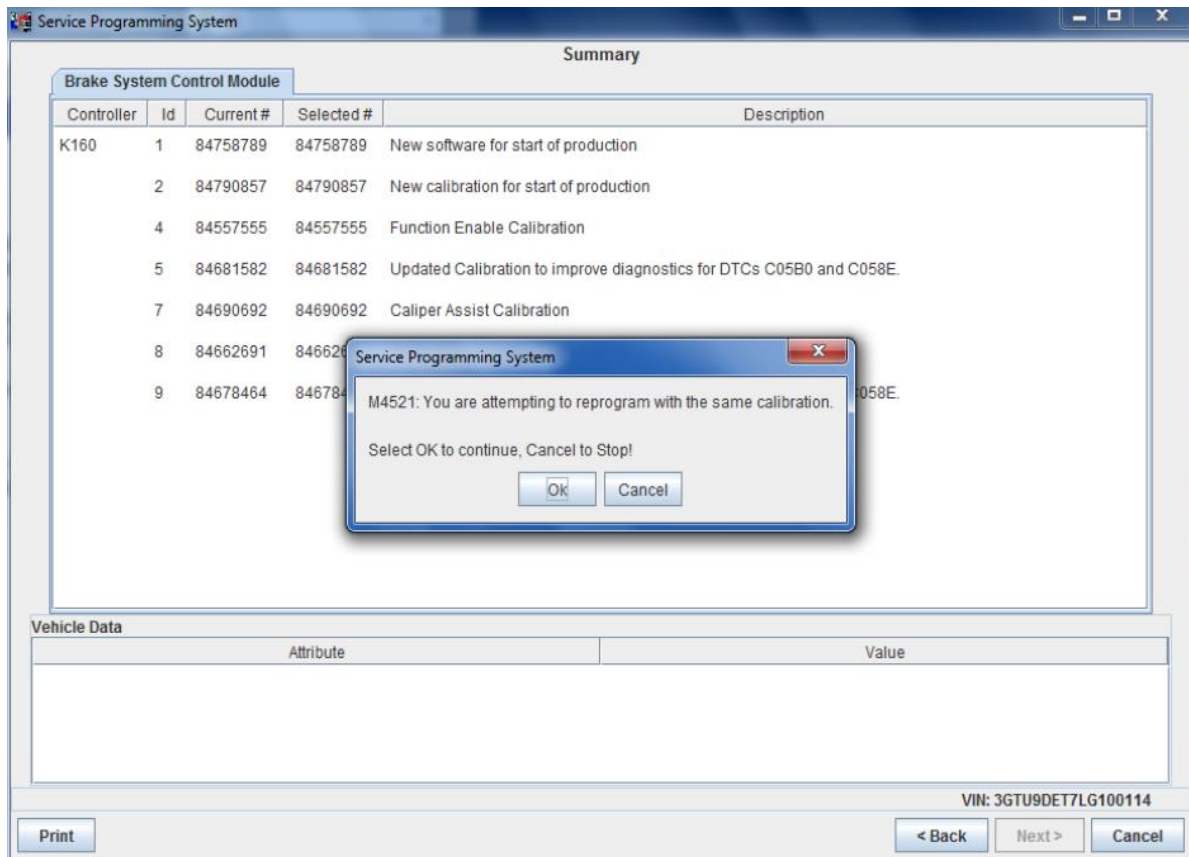
5431207

Note: If the Same Calibration/Software Warning is noted on the SPS Summary screen, select OK and follow screen instructions. After a successful programming event, the WCC is located in the Service Programming System dialogue box of the SPS Summary screen. No further action is required. Refer to the Warranty section of the bulletin.

1. Reprogram the Chassis Control Module. Refer to *K38 Chassis Control Module: Programming and Setup* in SI.

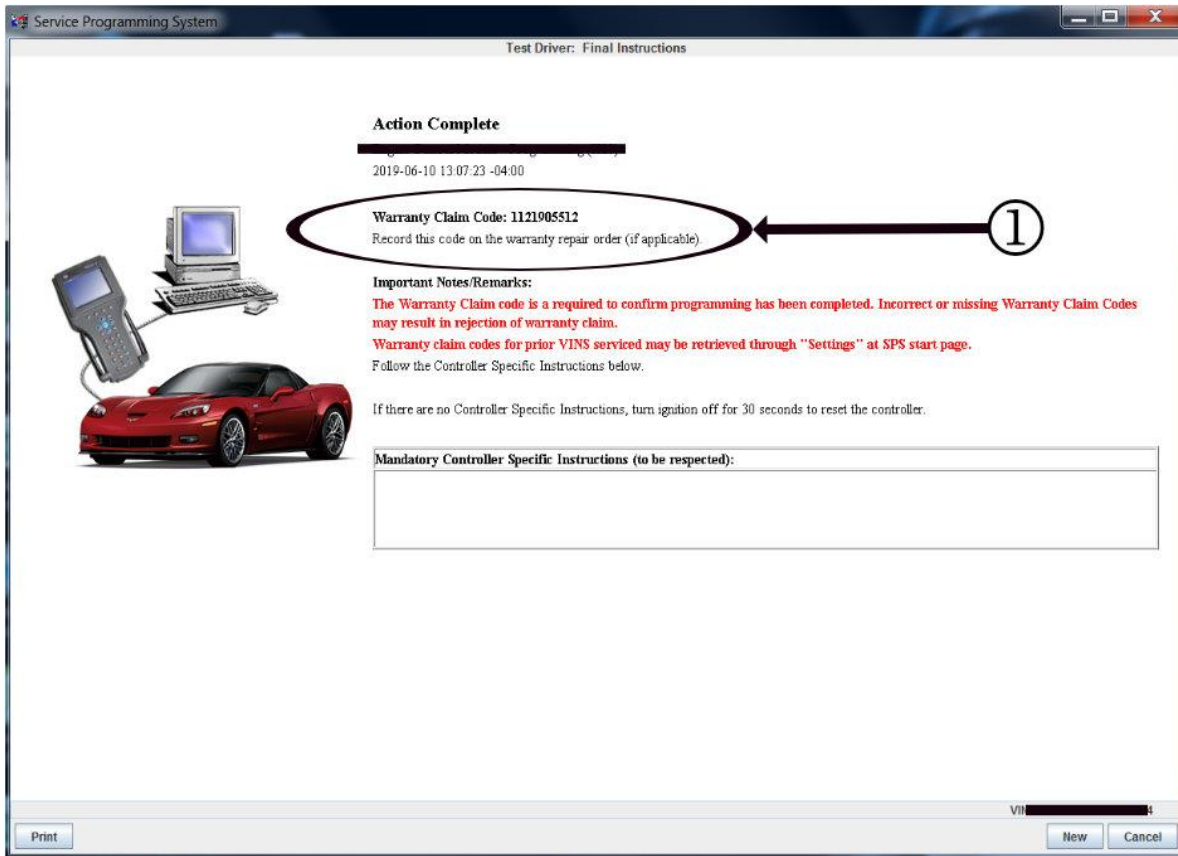
5431209

Note: To avoid warranty transaction rejections, you **MUST** record the warranty claim code provided on the SPS Warranty Claim Code (WCC) screen on the job card. Refer to callout 1 above for the location of the WCC on the SPS screen.

2. Record SPS Warranty Claim Code on job card for warranty transaction submission.
