# Customer Satisfaction Program

## N192219370 Engine Harness Chafing

Release Date: November 2019

Make	Model	Model Year		RPO	Description
		From	To		
Chevrolet	Silverado 1500 (New Model)	2019	2019	L3B	2.7L, 4cyl. Turbo engine
GMC	Sierra 1500 (New Model)	2019	2019	L3B	2.7L, 4cyl. Turbo engine

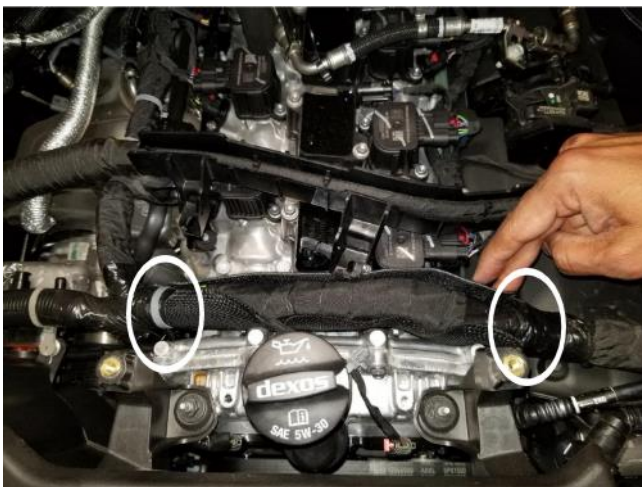
5392844

5. Inspect the engine harness (across the camshaft cover as shown) for any damage. Repair as required. Refer to *Wire to Wire Repair* in SI.

6. Carefully install the protective sleeve velcro side up around the engine harness. Be sure the edge of the harness is covered with the sleeve as shown above.

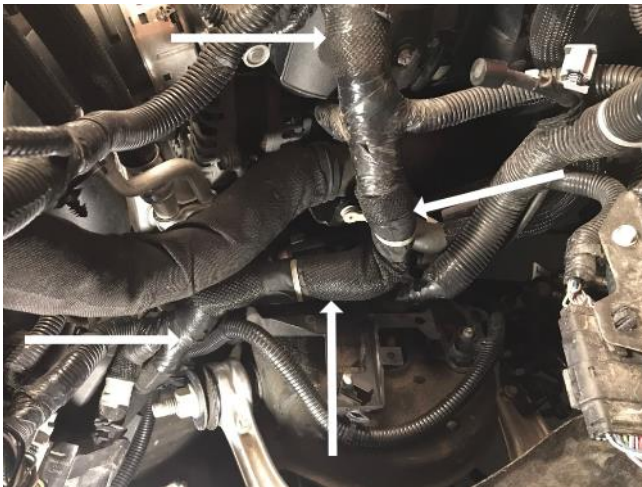
5386376

9. Locate the engine wiring harness where the protective sleeves need to be installed as shown above.
10. Remove and discard the engine harness retainers/clips (if equipped with heater cord, remove retaining clip from the cord).
11. Inspect the harness for any damage. Repair as required. Refer to *Wire to Wire Repair* in SI.

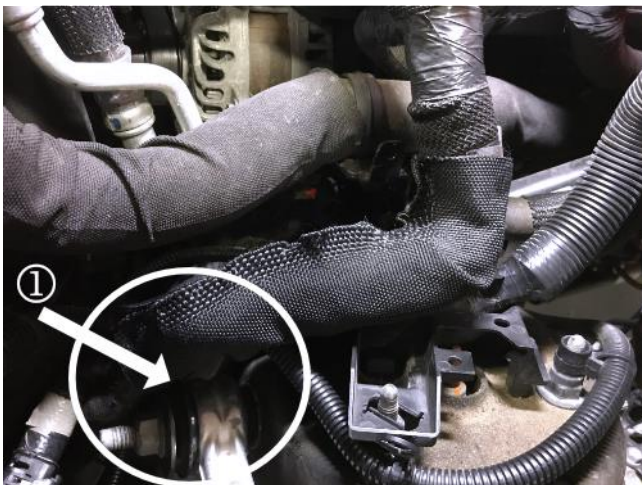
5386380

**Important:** Be sure the protective sleeve is installed past the lower control arm washers (1) to prevent any damage to the engine harness.

12. Install the protective sleeve around the lower engine harness as shown (near the shock tower and control arm).
