Customer Satisfaction Program

N192264450 Premature Brake Wear Notification

Release Date: November 2019

Make	Model	Model Year		RPO	Description
		From	To		
Cadillac	CT6	2019	2019	JBP	Brake Lining Wear System Life Span Prognostic Indicator

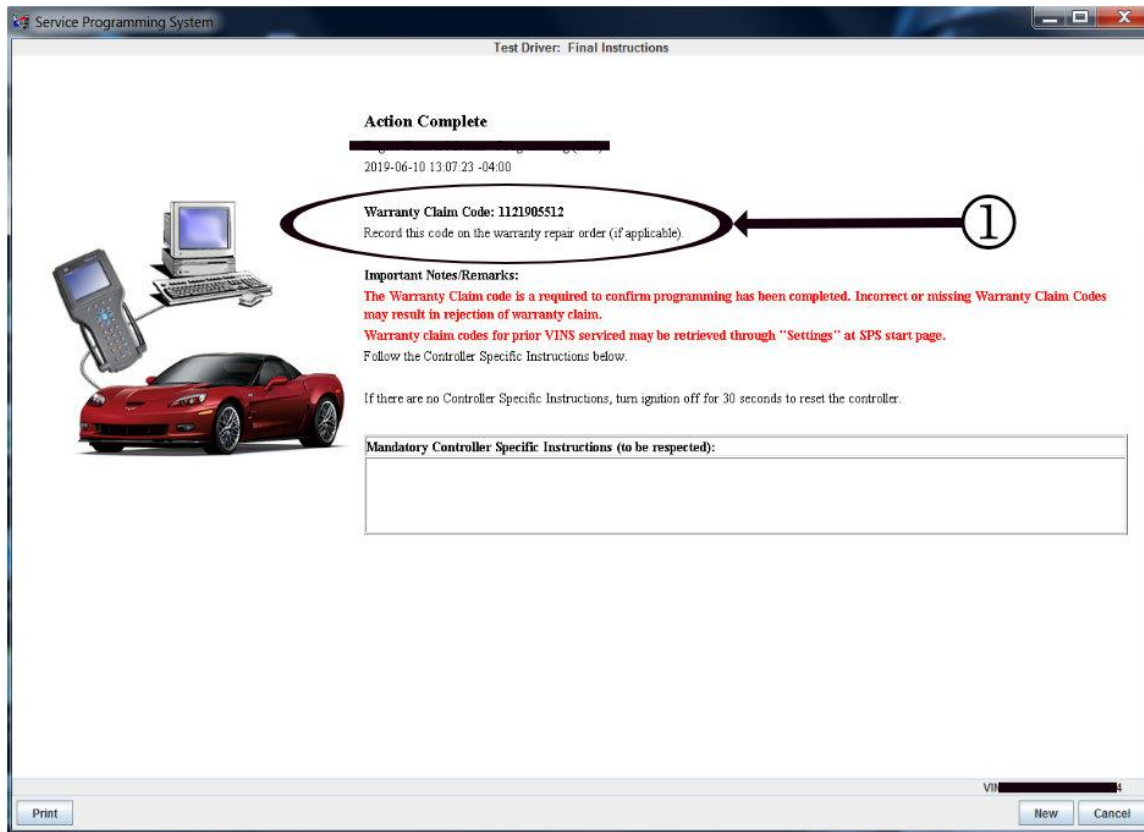
5431209

Note: To avoid warranty transaction rejections, you **MUST** record the warranty claim code provided on the SPS Warranty Claim Code (WCC) screen on the job card. Refer to callout 1 above for the location of the WCC on the SPS screen.

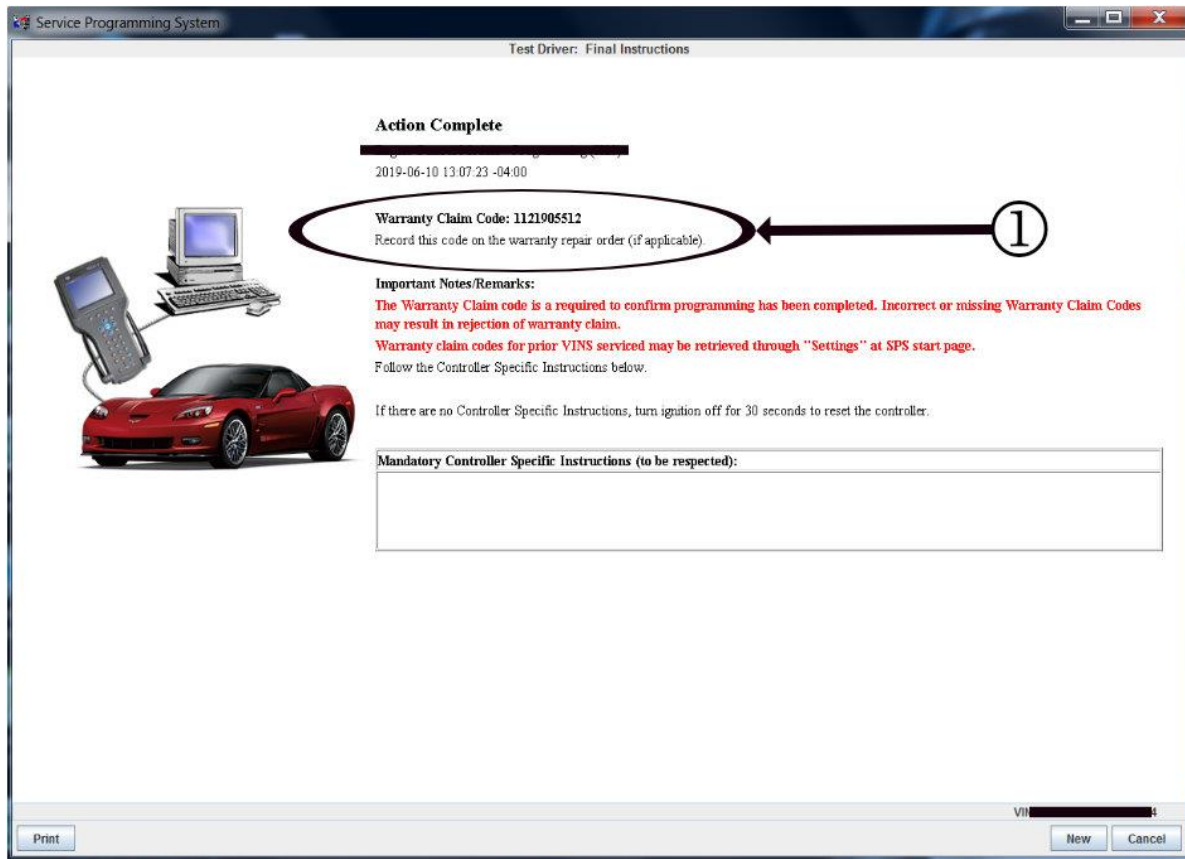
5431209

Note: To avoid warranty transaction rejections, you **MUST** record the warranty claim code provided on the SPS Warranty Claim Code (WCC) screen on the job card. Refer to callout 1 above for the location of the WCC on the SPS screen.

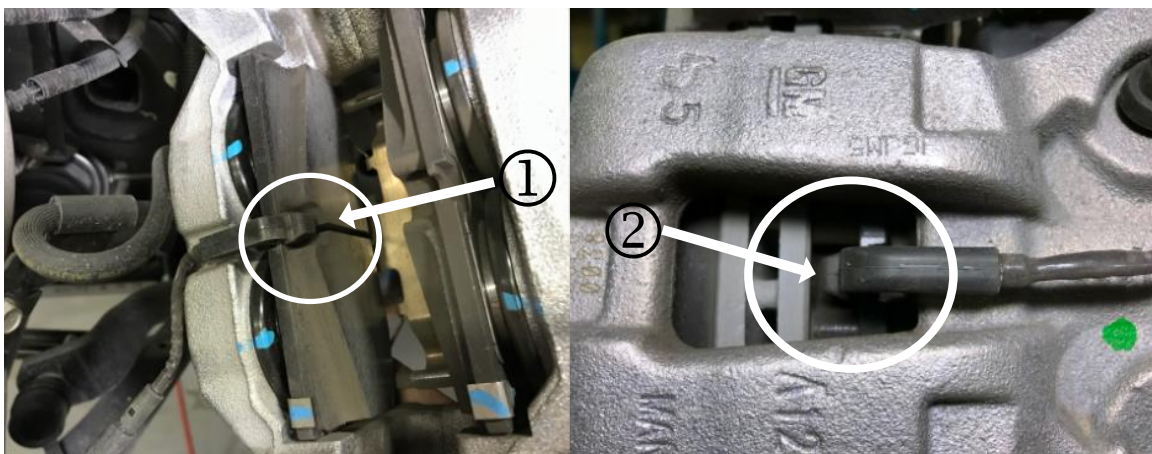
5. Inspect the brake pad wear sensors on both the front (1) and rear (2) brake pads.
