# Special Coverage Adjustment

## N182180270 Tail Lamps Inoperative

Release Date: November 2019

<b>Condition</b>	On some 2015-2016 model year GMC Yukon, Yukon XL, Yukon Denali, and Yukon Denali XL vehicles, stop and tail functions inside the tail lamps may become inoperative.
<b>Special Coverage Adjustment</b>	<p>This special coverage covers the condition described above for a period of 6 years or 72,000 miles (116,000 km), whichever occurs first, from the date the vehicle was originally placed in service, regardless of ownership.</p> <p>For vehicles covered by Vehicle Service Contracts, all eligible claims with repair orders on or after November 26, 2019, are covered by this special coverage and must be submitted using the labor operation codes provided with this bulletin. Claims with repair orders prior to November 26, 2019, must be submitted to the Service Contract provider.</p> <p>Vehicle owners or lessees who paid for repairs referenced in this Special Coverage ("Customers") are eligible for reimbursement of their reasonable and customary expenses in accordance with the procedures specified below. The conditional right to reimbursement is provided by GM solely in the interes

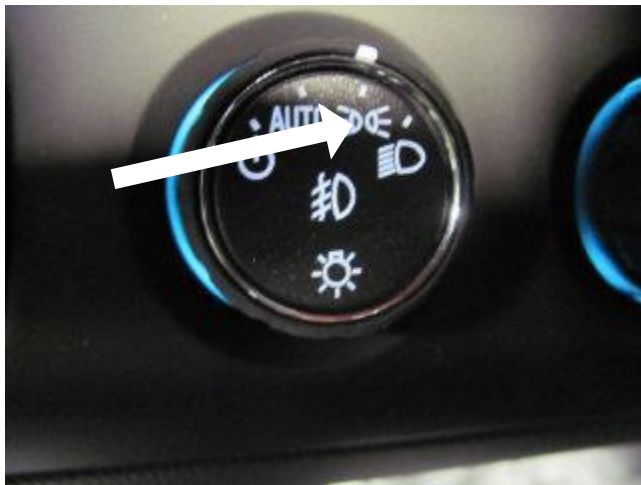
5440616

- Turn the exterior lamp control to the parking lamps “on” position. Go to the rear of the vehicle and verify the customer concern that one or both taillamps are displaying an inoperative condition.
  - If both taillamps are functioning, no further action is required.
  - If one or more taillamps are inoperative, proceed to step #2.
