Service Update

N192279350 Fog Lamps Inoperative

Release Date: November 2019

Models: 2020 Chevrolet Silverado 1500
2020 GMC Sierra 1500
Equipped with Accessory-Lamp Kit-Front Fog (RPO S3U)

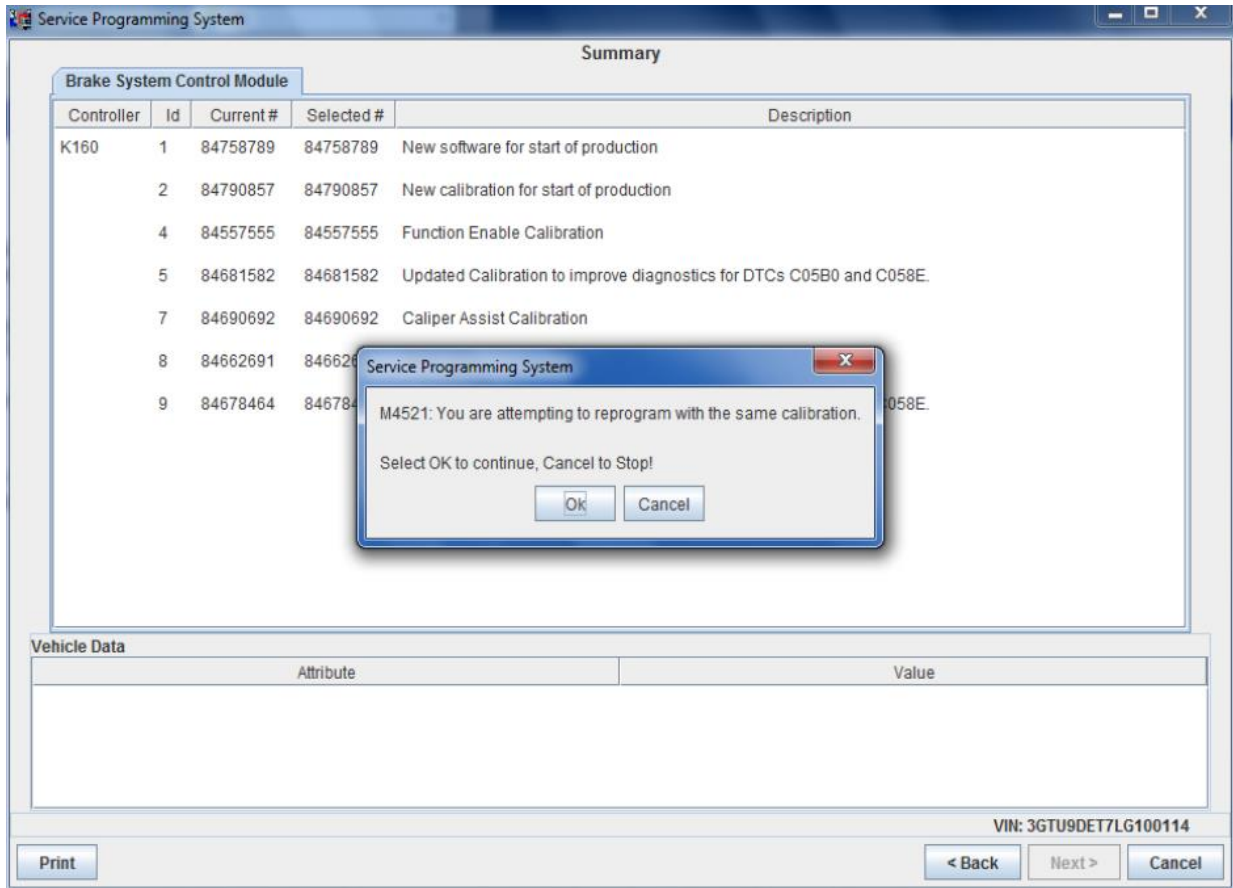
5431207

Note: If the Same Calibration/Software Warning is noted on the SPS screen, select OK and follow screen instructions. After a successful programming event, the WCC is located in the Service Programming System dialogue box of the SPS Summary screen. No further action is required. Refer to the Warranty section of the bulletin.

1. Reprogram the Body Control Module. Refer to *K9 Body Control Module: Programming and Setup* in SI.

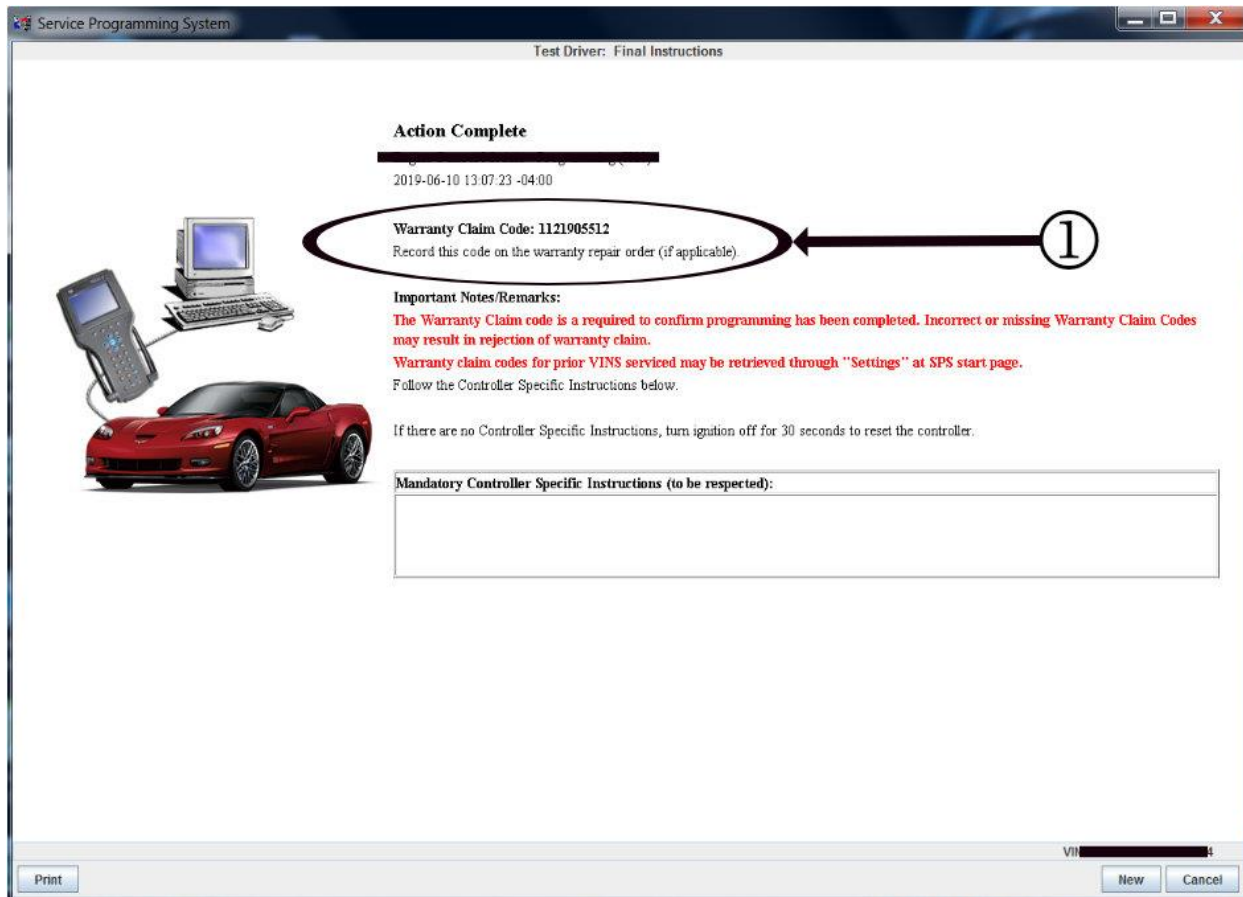
5431209

Note: To avoid warranty transaction rejections, you **MUST** record the warranty claim code provided on the SPS Warranty Claim Code (WCC) screen on the job card. Refer to callout 1 above for the location of the WCC on the SPS screen.

- Record SPS Warranty Claim Code on job card for warranty transaction submission.
