Customer Satisfaction Program

N192264450 Premature Brake Wear Notification

Release Date: November 2019

Revision: 02

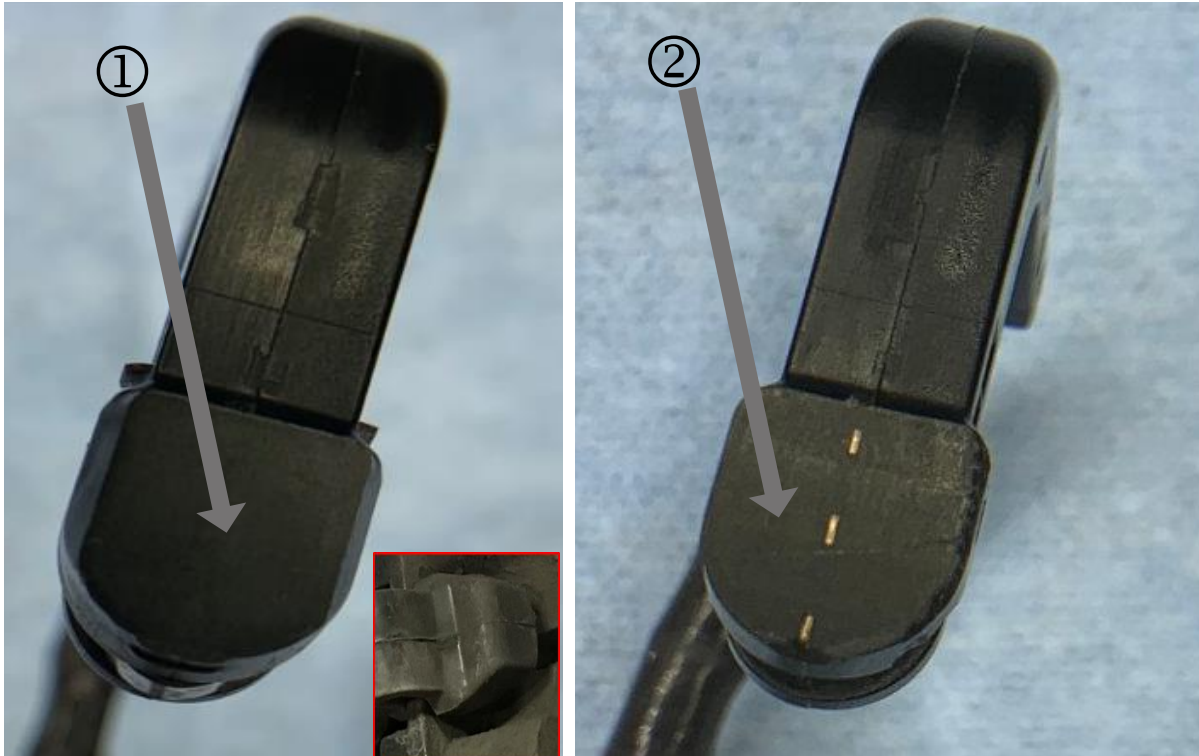
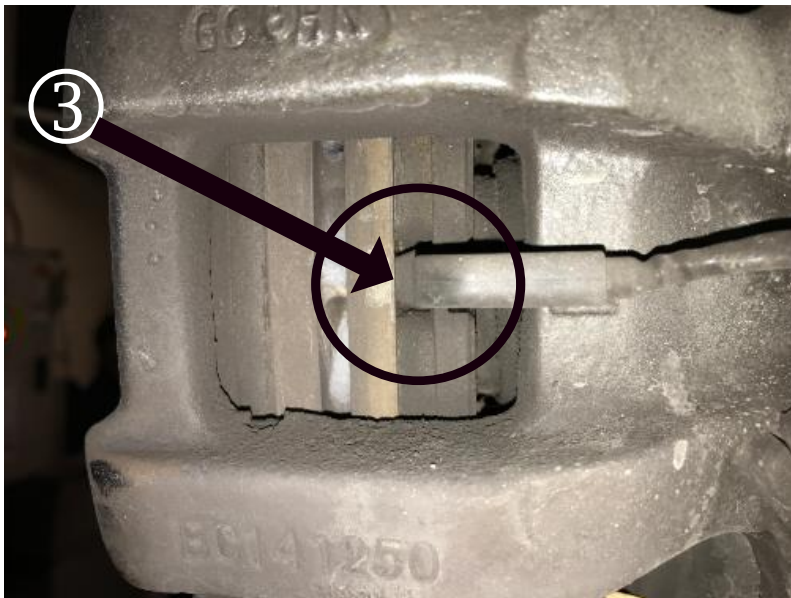
5. Inspect the brake pad wear sensors on both the front (1) and rear (2) brake pads.

- If there is ANY wear on the brake pad wear sensors or if the sensors are contacting the rotor (3), replace the brake pads associated with the affected axle (front, rear or both) and continue to step 6. Example of a good brake pad wear sensor (1) and a worn brake pad sensor (2) shown above.
 - If there is NO wear on the brake pad wear sensors, continue to step 7.
6. Replace the front, rear or both disc brake pads depending on the axle set that shows sensor wear. Refer to *Front Disc Brake Pads Replacement* and *Rear Disc Brake Pads Replacement* in SI.
7. Install the front caliper. Refer to *Front Brake Caliper Replacement* in SI for torque specification.
