Technical Service Bulletin

60 Rattle noise near the central roof area

60 19 38 2054270/5 December 20, 2019. Supersedes Technical Service Bulletin Group 60 number 19-35 dated August 19, 2019 for reasons listed below.

Model(s)	Year	VIN Range	Vehicle-Specific Equipment
A6	2019 - 2020	All	Not Applicable

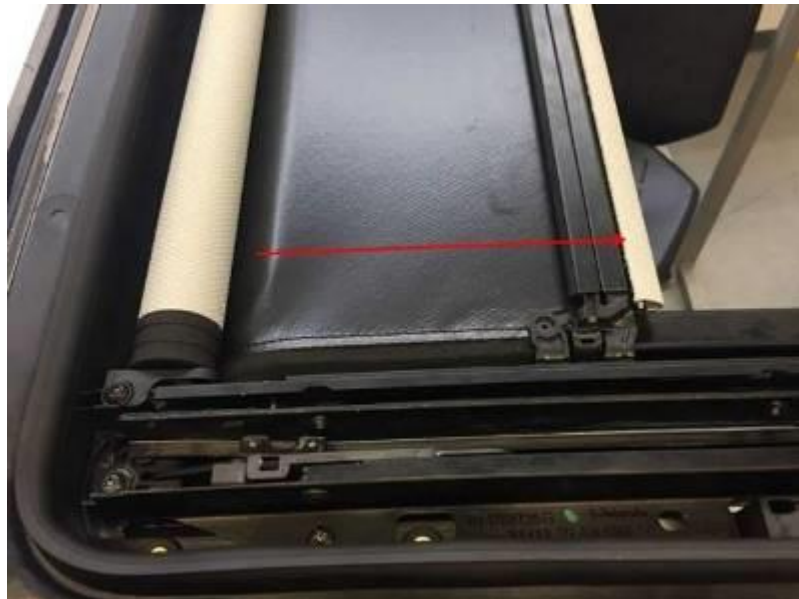
Figure 1. Closing the roller shade.

1. Remove the glass sunroof panel using the repair manual instructions.
2. Close the roller shade by about 20cm (Figure 1).

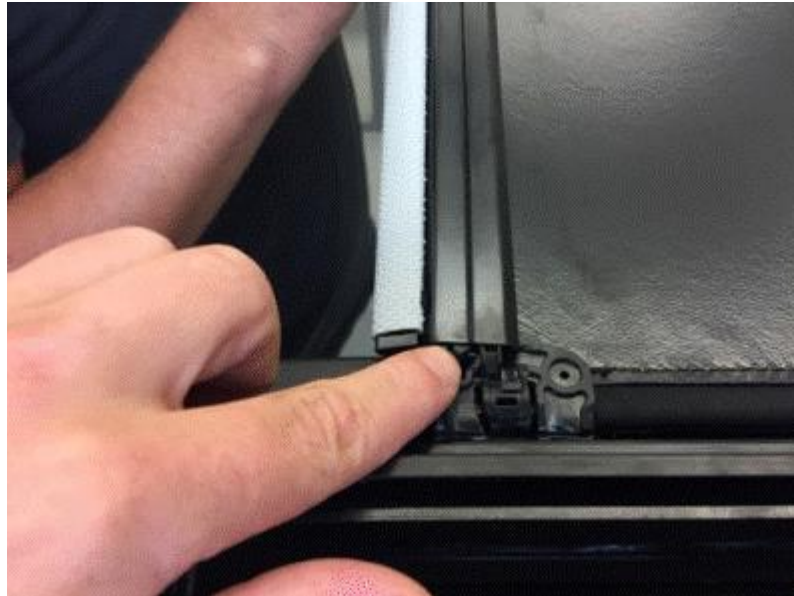
Figure 2. Move the beam off of the drive laterally.

3. Loosen the roller shade from the drive cable and push the material back until the bolts are exposed, then remove the bolts completely (Figures 2 -5).

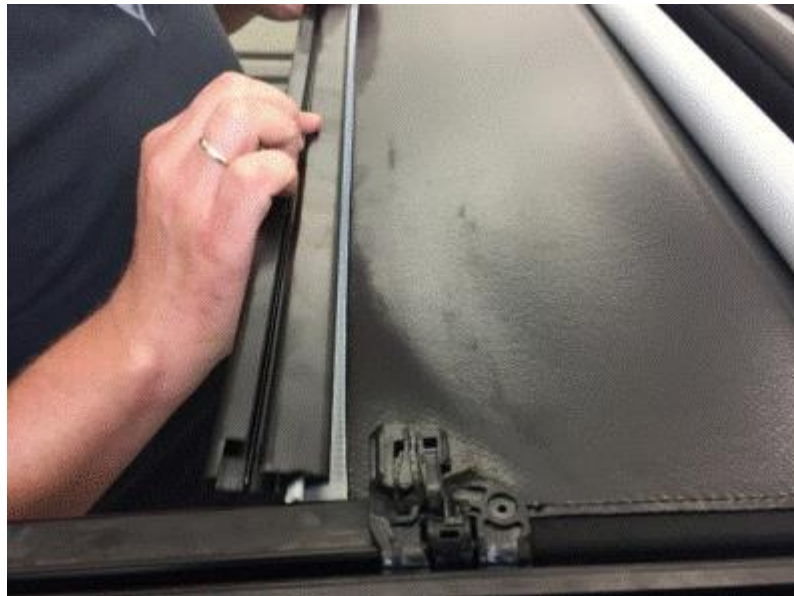
Figure 3. Beam removed from the drive.

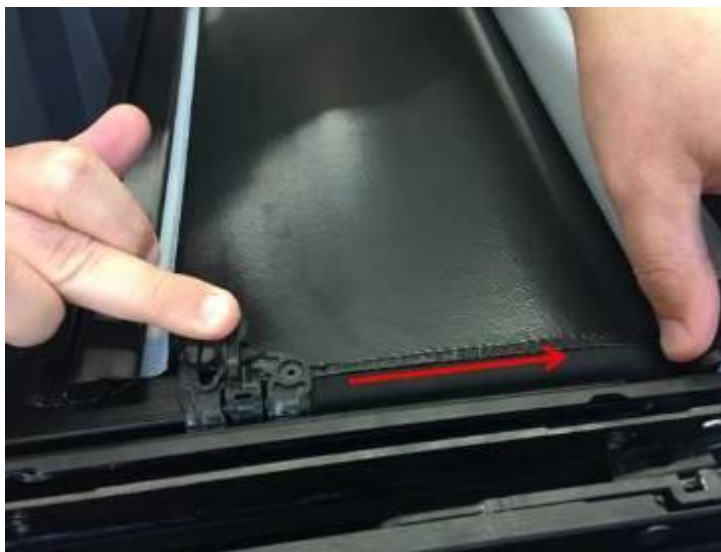
Figure 4. Push the material back to expose the bolts.

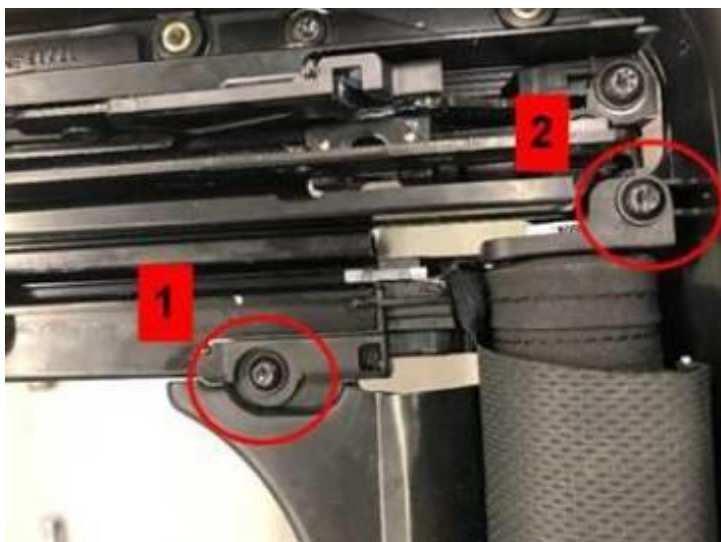
Figure 5. Remove the bolts.

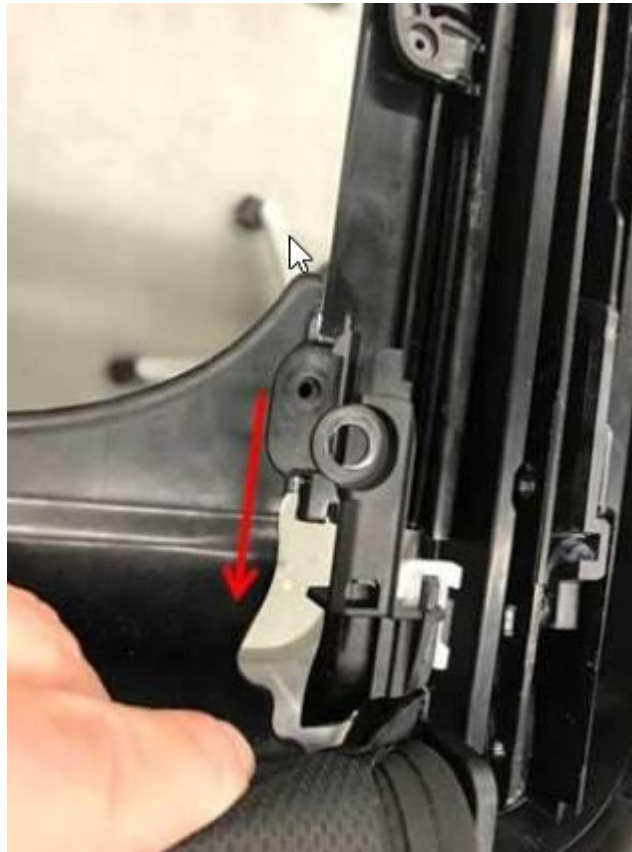
Figure 6. Slide roller shade backward.

4. Remove the roller shade by sliding it backward and clean the mounting points as shown in Figure 6 and 7. Use the cleaning solution D 009 401 04 or equivalent surface preparation solvent (e.g. isopropyl alcohol or adhesion promoter) to prepare the surfaces for adhesive backed felt strip material.

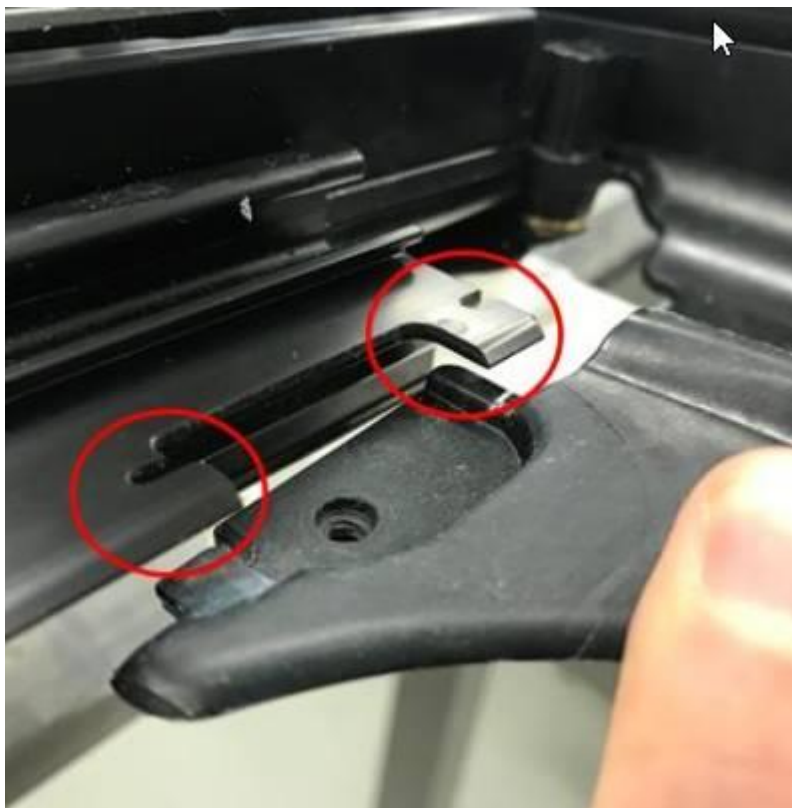
Figure 7. Areas to clean using cleaning solution D 009 401 04.

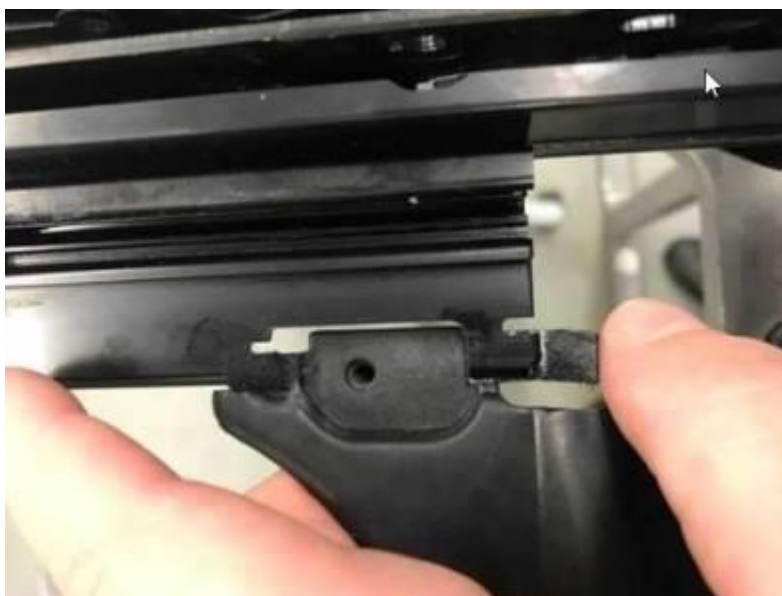
Figure 8. Applying felt tape.

5. Push down on the roller shade pan and starting from the bottom of the guide rail, wrap the areas shown in figure 8 with sections of felt tape 000 979 950 and fold them forward and over to the top of the guide rail such that both the top and bottom of the tabs are isolated (Figure 8 and 9).

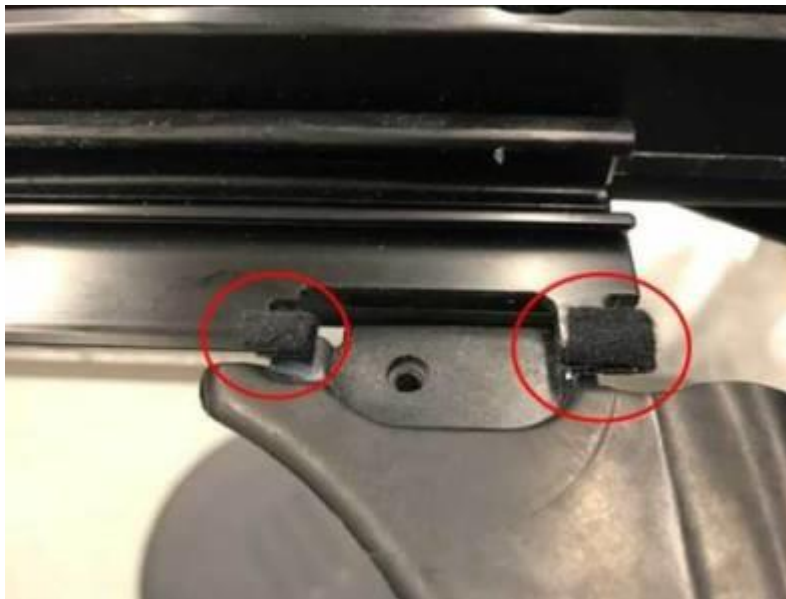
Figure 9. Apply felt tape on points shown. The tops and bottoms of the tabs must be isolated.

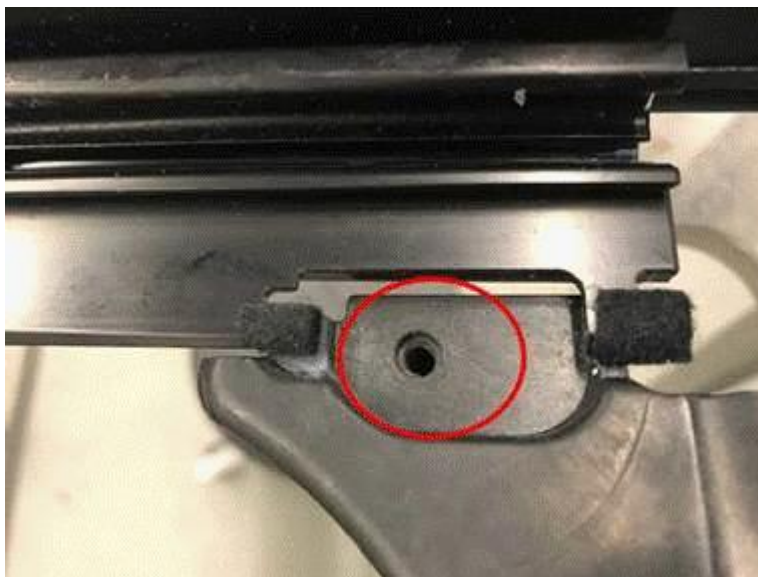
Figure 10. Apply thread locker in this area.

6. Apply thread locker to the screw hole shown in figure 10. Reinstall the bolts to the roller shade and torque to 3Nm.

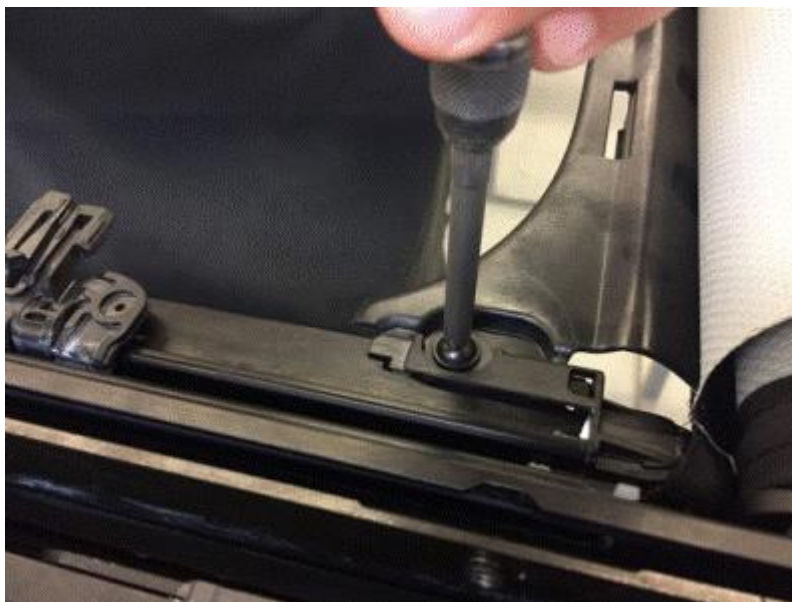
Figure 11. Torque screws to 3Nm.

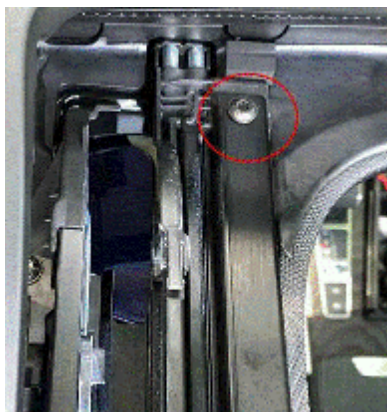
Figure 12. Loosen the bolt a few turns but do not remove the screw completely.

7. On the front of the sunroof guide rail, loosen that bolt a few turns but do not remove the screw completely.

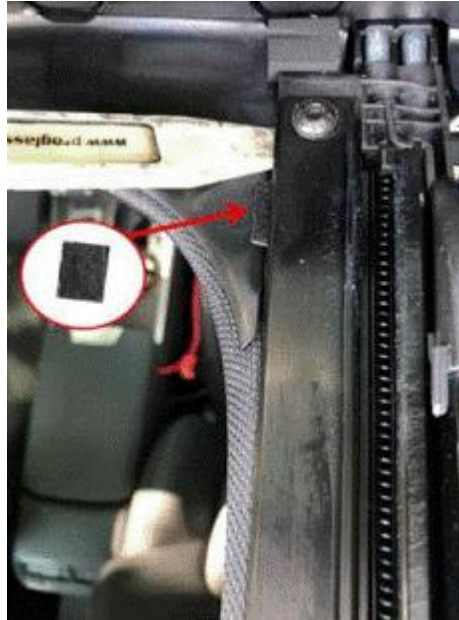
Figure 13. Isolation of guide rail and frame by the installation of a section of felt strip material.

- Lift the guide rail slightly using a plastic wedge. Place a 20mm x 20mm section of felt strip material 533 867 910 A between the guide rail and the frame as shown in figure 13. The backing for the adhesive side must be removed and the felt tape section adhered before the screw is tightened. Reinstall the screw and tighten to 5Nm. (Figure 8).

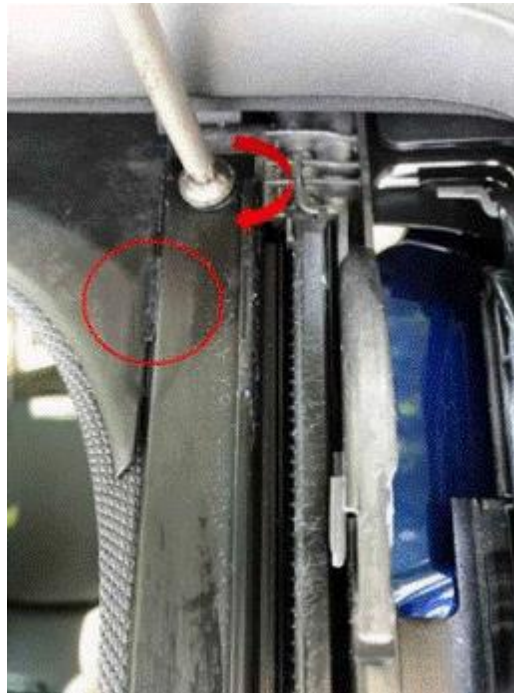
Figure 14. Tightening of the screw with the felt strip material isolating the guide rail and the frame.

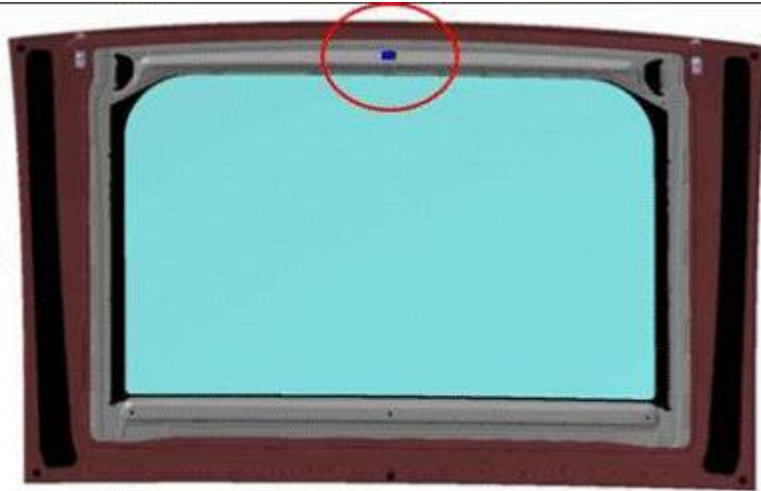
Figure 15. Area of sunroof glass panel structure to be prepared.

9. Measure and mark the center of the glass sunroof panel structure shown in figure 15. Clean this area with cleaning solution D 009 401 04 or equivalent surface preparation solvent (e.g. isopropyl alcohol or adhesion promoter) to prepare the surfaces for adhesive backed felt strip material. Apply a 20mm x 20mm section of adhesive felt strip material 533 863 288 A to this central area of the glass sunroof panel structure as shown in figure 16 and 17.

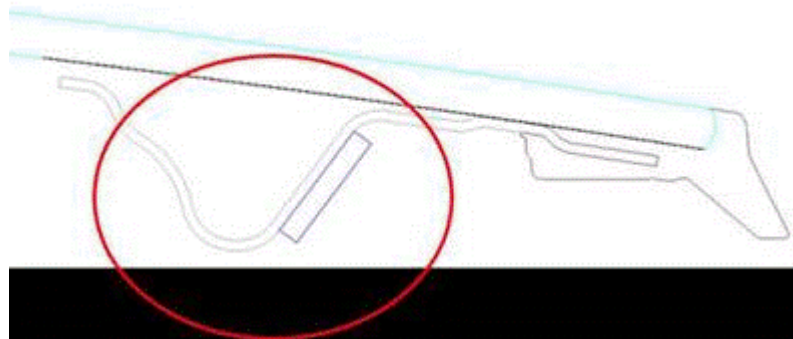
Figure 16. Affix adhesive felt strip material to the area shown.

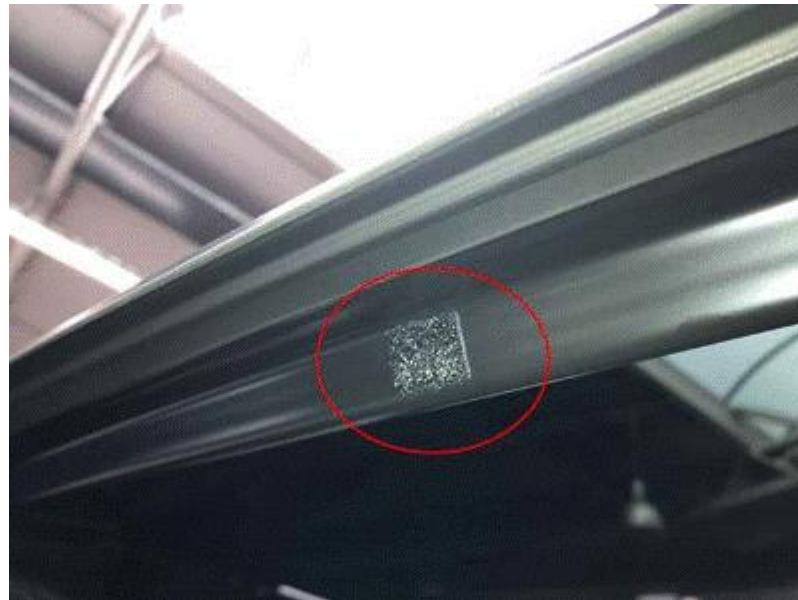
Figure 17. Adhesive felt strip material affixed to the center area of sunroof glass panel structure.
