Technical Service Bulletin

97 MMI display black and/or a parking brake malfunction, DTCs C100C01, U105400, U10B800, U10E200, and/or U10CA00

97 19 69 2057768/2 December 20, 2019. Supersedes Technical Service Bulletin Group 97 number 19-68 dated November 22, 2019 for reasons listed below.

Model(s)	Year	VIN Range	Vehicle-Specific Equipment
A6, A7	2019	All	Not Applicable

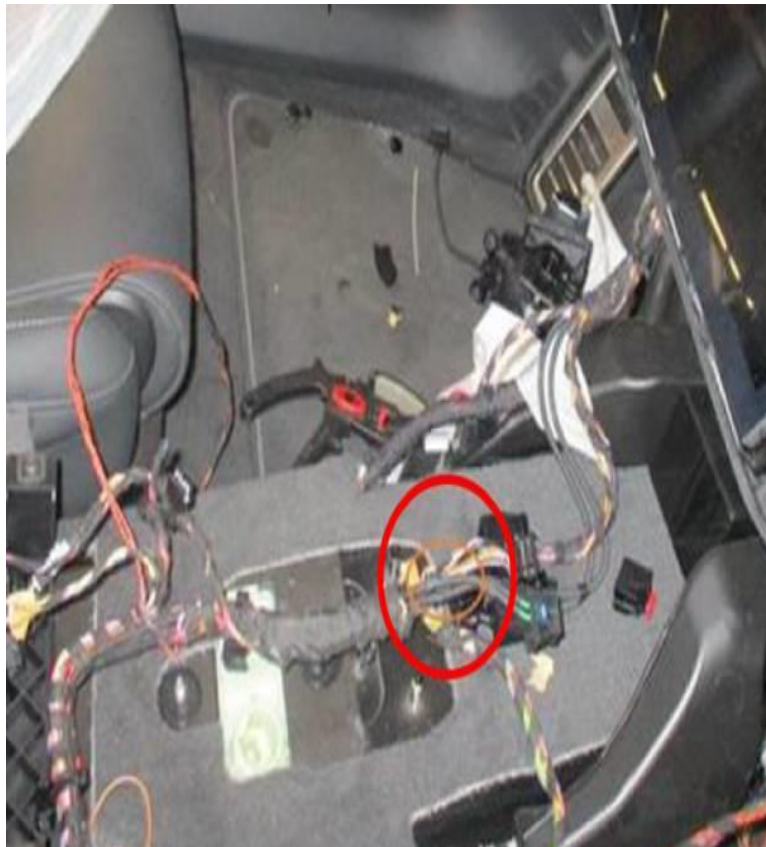
Figure 1. Location to inspect underneath center console.

2. Inspect the harness under the center console for damage as shown in Figures 1 and 2.

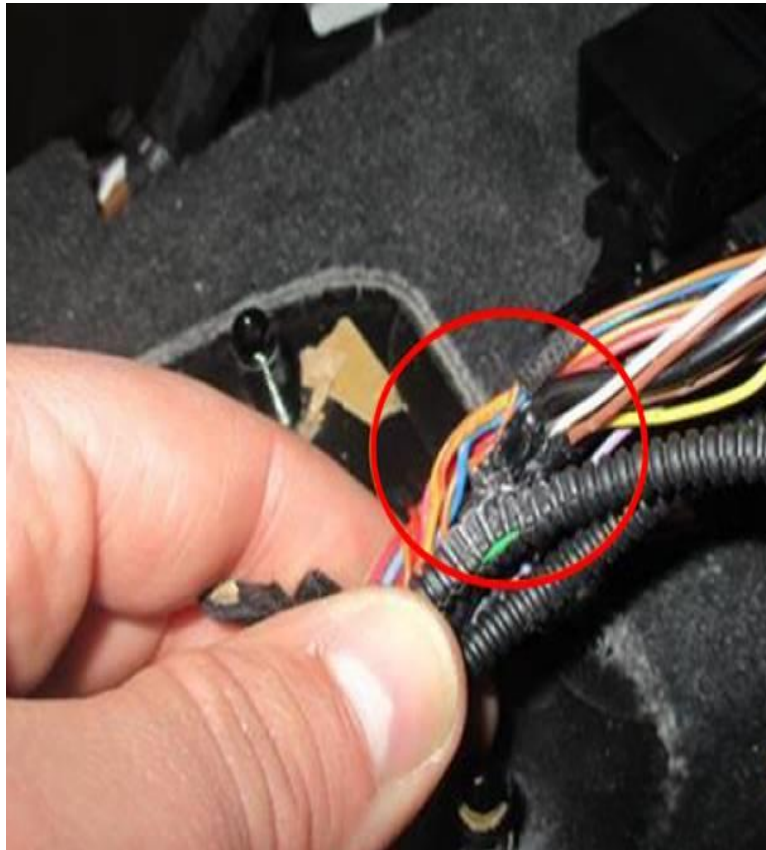
The wire harness underneath the center console may be pinched during assembly.

Figure 2. The harness is damaged during assembly.

3. If damage is found as shown in Figure 2, repair the damaged wires using VAS 1978B. Additionally, add the harness protection using the steps below.

4. Once the damaged wires have been repaired with VAS 1978B, wrap the repaired section with the textile tape N 107 290 02.
5. Install the corrugated tube part number N 107 328 01 over the wrapped cables between the red lines indicated in Figure 3.

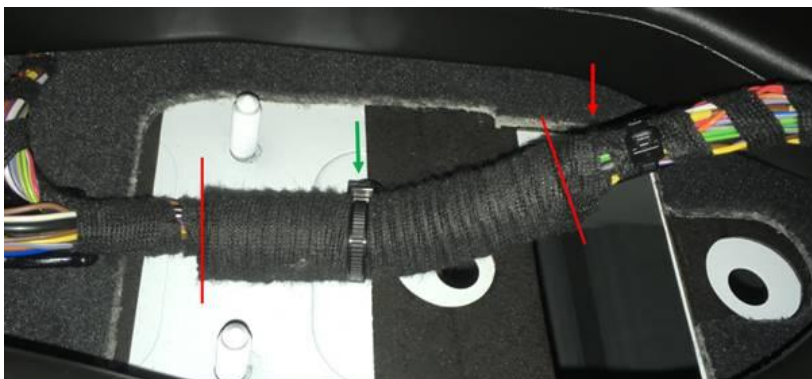
Figure 3. Completed harness protection.

6. Using textile tape N 107 290 02, completely wrap the corrugated tube over the harness so that it cannot slip out of place (red arrow on Figure 3).

7. Use a new cable tie, part number **3D0 971 838 A** and secure the harness to the body (green arrow on Figure 3).
8. Once complete, refit the center console according to the repair manual.
