MODEL
**2016-2019MY
Optima (JFa)**

NUMBER
PS638

SUBJECT: HVAC TEMPERATURE BLEND DOOR INOPERATIVE,
TICKING AND/OR MAKING A POPPING NOISE

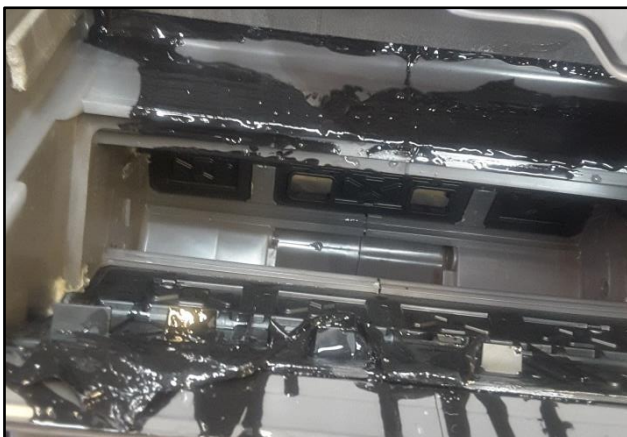
1. Black substance shown

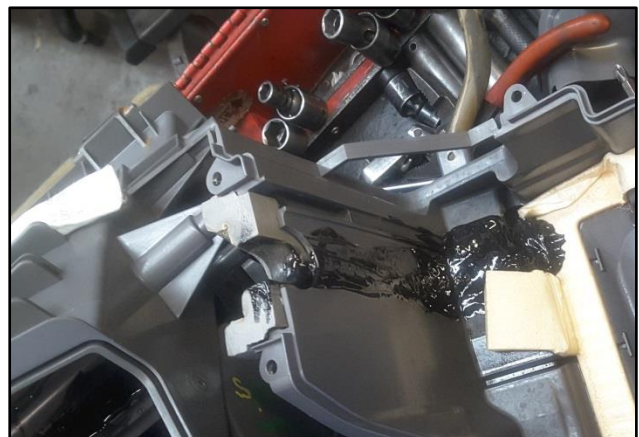
2. Black substance shown
