GROUP Body	MODEL 2020MY Telluride (ON)
	NUMBER PS641	DATE December 2019

SUBJECT: TELLURIDE SEAT SWITCH STICKING

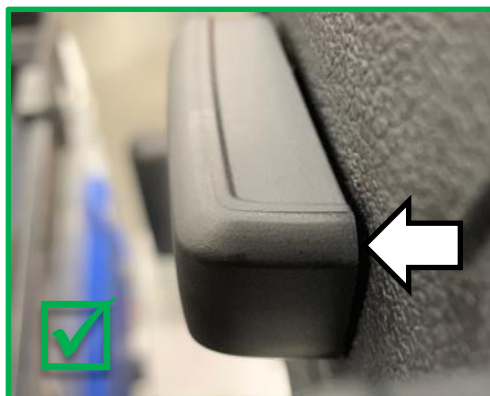
Sufficient Clearance

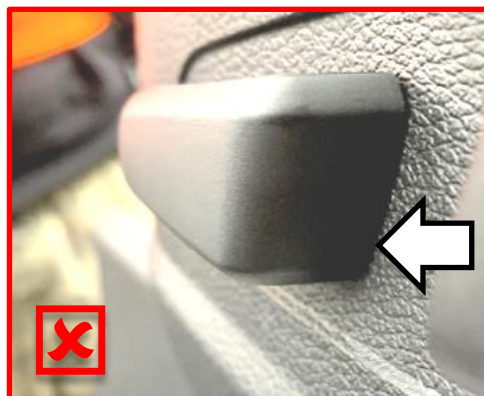
This bulletin provides information regarding the front driver and/or passenger seat adjusting switch sticking on some 2020MY Telluride (ON) vehicles. A sticking seat switch may be caused by insufficient clearance between the seat switch and side seat shield cover, and/or a broken/damaged cover. In some cases, removal and re-installation of the side seat shield cover or replacement may be required to address the concern. Refer to EPC for part and LTS for labor operation if needed.

Insufficient Clearance
