Technical Information Bulletin

A002

PACCAR 40K Forward Rear Axle Pinion Side Gear Incorrectly Heat Treated

12/19/2019

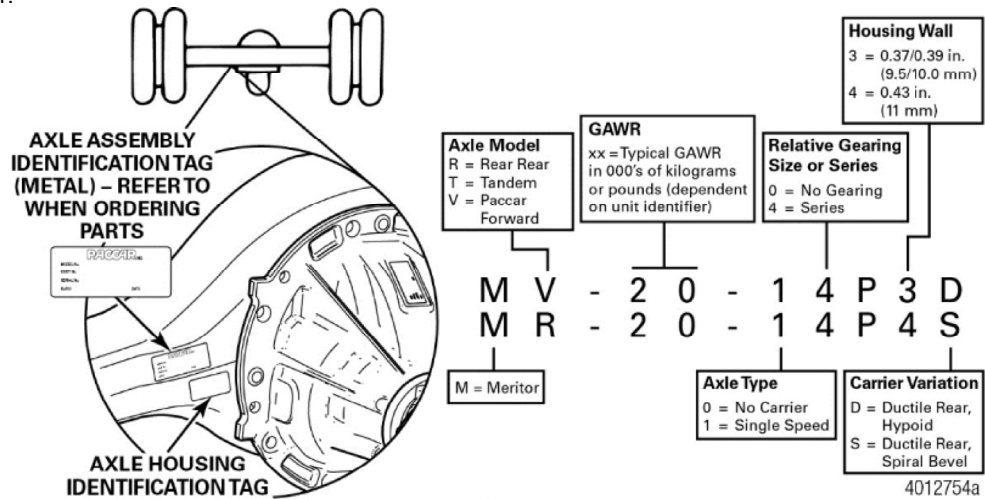
- Contact the PACCAR Parts line at 1-800-944-0251 and select option 4 when prompted, and you will be routed to a Meritor representative. Provide the Meritor representative with the VIN number, axle serial number, and mileage to confirm that the unit requires inspection. The call center will provide a case number for tracking purposes.
 - If the mileage exceeds 120,000 miles (193,121 km) and there are no complaints of vibration or a knocking noise, no further inspection is required. Report the above information to the Meritor representative and file for Quick Claim A002.
 - The axle assembly serial number can be found on a metal tag on the leg of the housing adjacent to the carrier.
