GROUP <b>BOD</b>	MODEL <b>2019-2020MY Sedona (YP)</b>
	NUMBER <b>194</b>	DATE <b>December 2019</b>
<b>TECHNICAL SERVICE BULLETIN</b>		
<b>SUBJECT: SERVICE ACTION: TAILGATE GAS LIFT INSPECTION AND/OR REPLACEMENT (SA398)</b>

## SERVICE ACTION: TAILGATE GAS LIFT INSPECTION AND/OR REPLACEMENT (SA398)

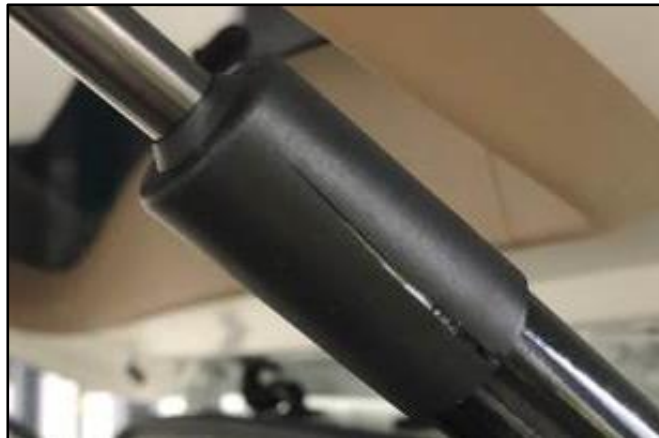
This bulletin provides the procedure to inspect the tailgate gas lift dust cover and if necessary, replace the tailgate gas lift(s) on non-power tail gate 2019-2020MY Sedona (YP) produced between March 04, 2019 through June 25, 2019, which may exhibit an inoperative tailgate gas lift due to dust cover cracks. Before conducting the procedure, verify that the vehicle is included in the list of affected VINs.

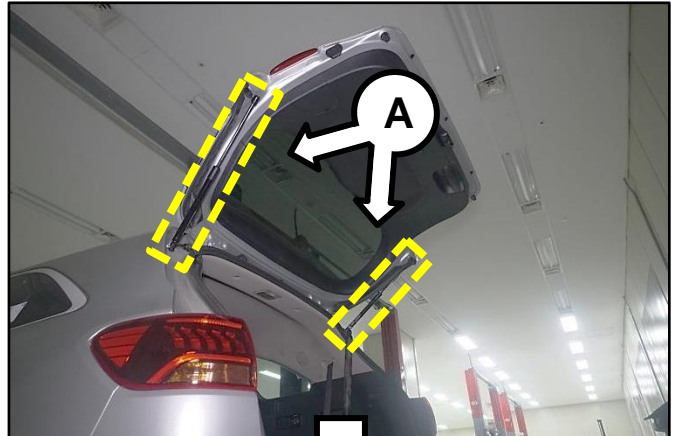
1. Open the tailgate door and locate the gas lifts (A).

2. Inspect both of the tailgate gas lift dust covers (B) for:
  - Visual cracks (image shown).
  - Fails to turn/spin.
  - Fails to disengage upward.

If the tailgate lift dust cover(s) (A) is/are faulty, proceed to step 3.
