MODEL
2019-2020MY
Sedona (YP)

NUMBER
194 (Rev 1, 12/06/2019)

TECHNICAL SERVICE BULLETIN

SUBJECT: SERVICE ACTION: TAILGATE GAS LIFT INSPECTION
AND/OR REPLACEMENT (SA398)

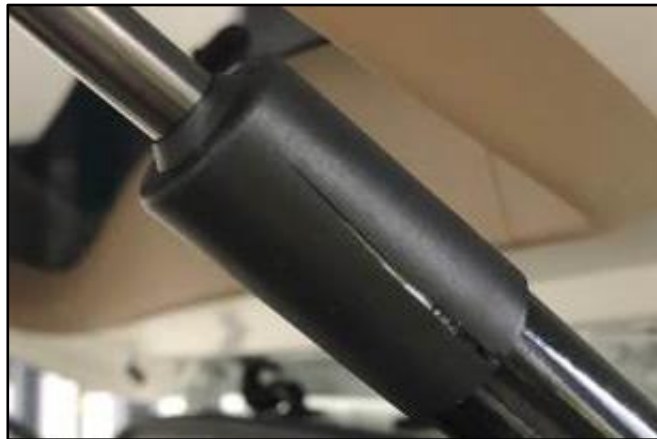
This bulletin provides the procedure to inspect the tailgate gas lift dust cover and if necessary, replace the tailgate gas lift(s) on non-power tail gate 2019-2020MY Sedona (YP) produced between March 04, 2019 through June 25, 2019, which may exhibit an inoperative tailgate gas lift due to dust cover cracks. Before conducting the procedure, verify that the vehicle is included in the list of affected VINs.

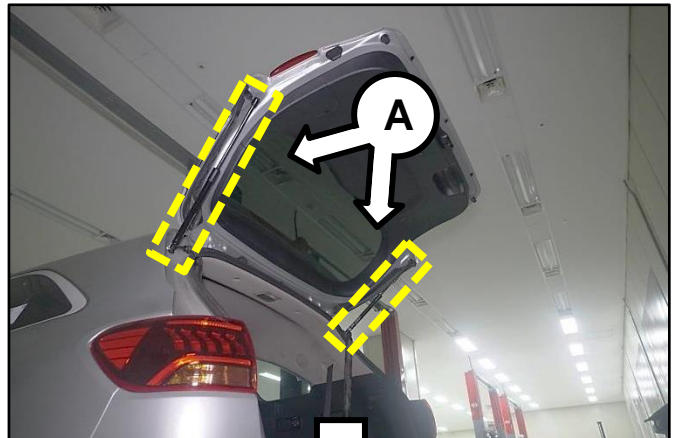
1. Open the tailgate door and locate the gas lifts (A).

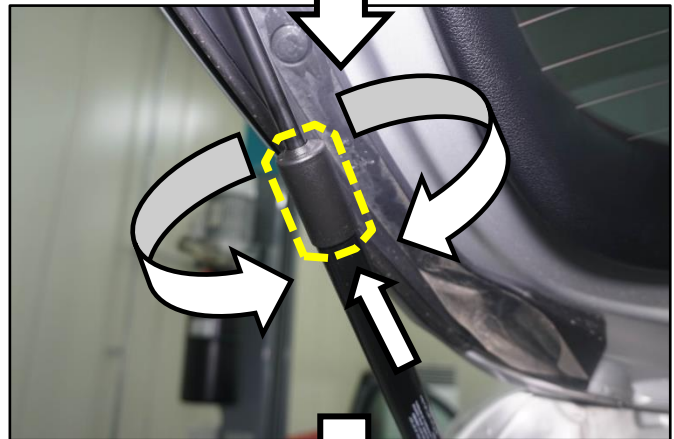
2. Inspect both of the tailgate gas lift dust covers (B) for:
 - Visual cracks (image shown).
 - Fails to turn/spin.
 - Fails to disengage upward.

If the tailgate lift dust cover(s) (A) is/are faulty, proceed to step 3.
