**Complaint - Cylinder Head Cover Near the Injector Holes Leaking: Subsequent work on cylinder head (180/18)**

Revision: **This bulletin replaces bulletin Group 1, #180/18, dated March 7, 2019.**  
This revision includes additional vehicle types.

Model Year: **As of 2017 up to 2019**

Subject: **Cylinder head cover**

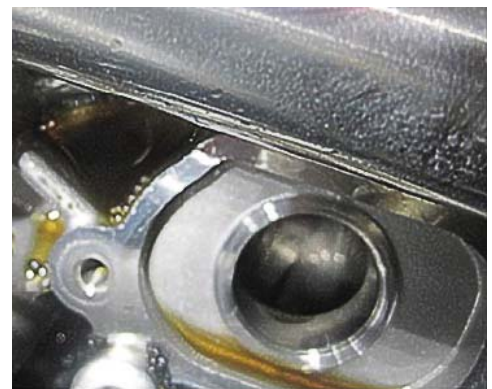
- O-ring on valve lift adjustment solenoid hydraulic valve is responsible for the leak(s).
- Clean the engine compartment and replace the affected solenoid hydraulic valve(s) with O-rings.
- If the insulation on the top of the cylinder head cover is already soaked with oil, this must be replaced too.
- Continue with ⇒ 3.

*Fault type 1: Valve lift adjustment solenoid hydraulic leaking*

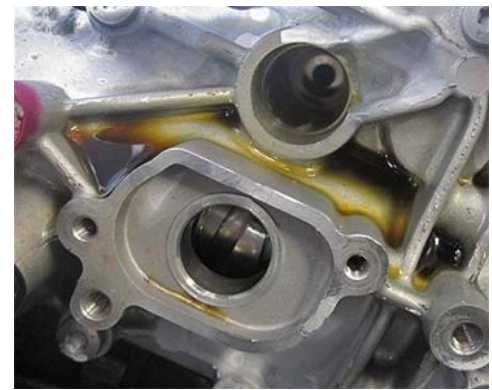
- Due to a batch error in the casting procedure there may be cast residue in the cylinder head cover sealing groove.
- This cast residue may cause the injector holes to leak.

2.3.1 Oil must have collected in the vicinity of the injector of the affected cylinder and the insulation on the bottom of the cylinder head cover should be fully soaked.

*Fault type 2: Cylinder head cover leaking*

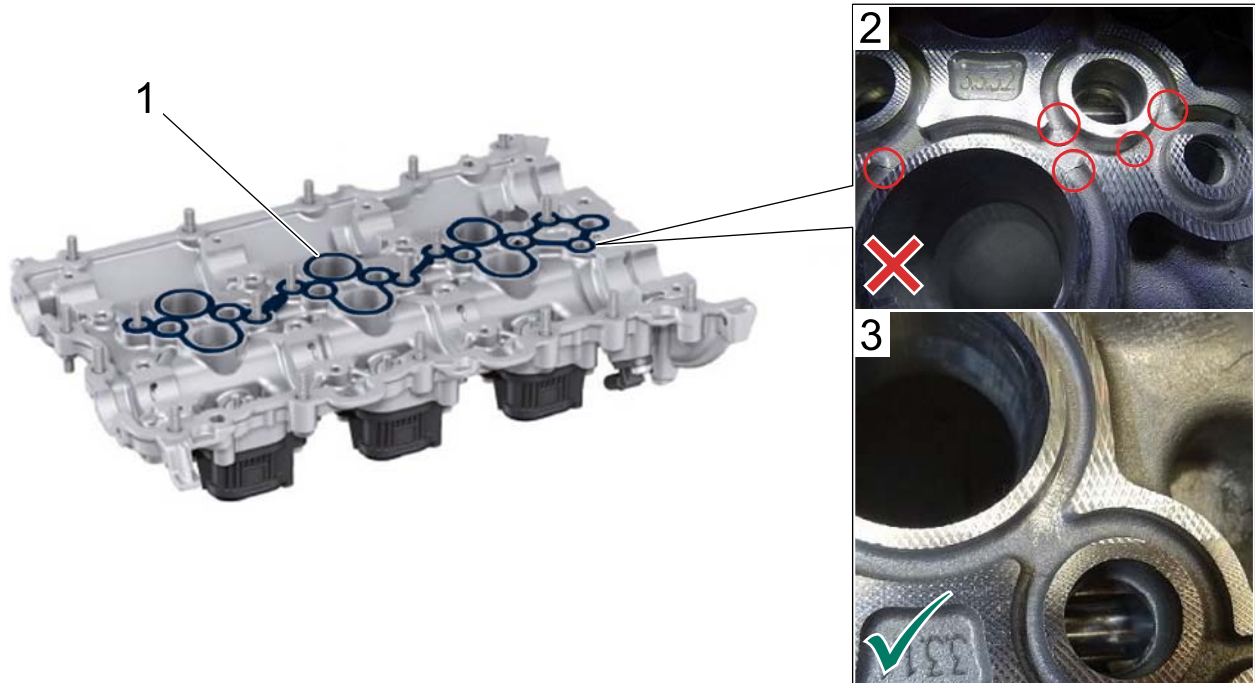
*Cylinder head cover sealing groove*

2.6 Check the sealing groove (⇒ *Cylinder head cover sealing groove -1-*) of the cylinder head cover visually. Be particularly meticulous when doing this especially in the vicinity of the affected cylinder.

2.7 Carefully remove any cast residue (⇒ *Cylinder head cover sealing groove -2-*) using a **small flat screwdriver, ensuring that the sealing groove is not damaged**. There must be no more cast residue in the sealing groove after machining (⇒ *Cylinder head cover sealing groove -3-*).
