Complaint - Cylinder Head Cover Near the Injector Holes Leaking: Subsequent work on cylinder head (180/18)

Vehicle Type: **Macan S (95B)**

Model Year: **As of 2017 up to 2019**

Subject: **Cylinder head cover**

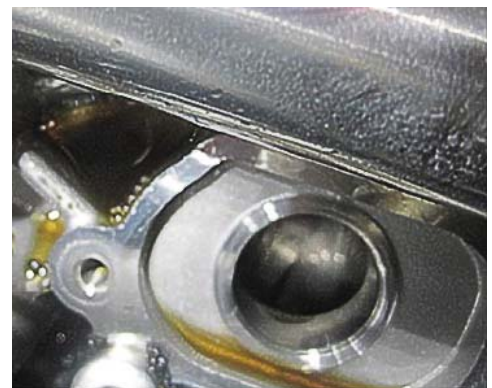
- The O-ring on the hydraulic valve for valve lift switchover is the cause of the leak(s).
- Clean the engine compartment and replace affected hydraulic valve(s) fitted with O-rings.
- If the insulation on the top of the cylinder head cover is already soaked with oil, this must be replaced too.
- Continue with ⇒ 3.

Fault type 1: Hydraulic valve for valve lift switchover leaking.

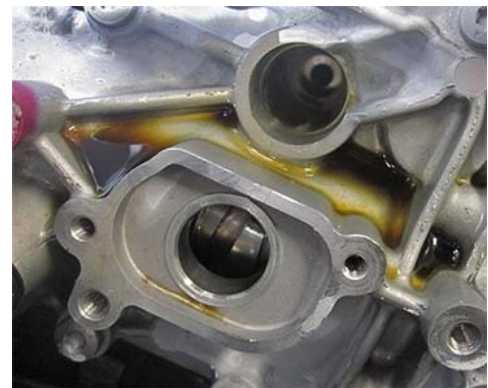
- Due to a batch error in the casting procedure there may be cast residue in the cylinder head cover sealing groove.
- This cast residue may cause the injector holes to leak.

2.3.1 Oil must have collected in the vicinity of the injector of the affected cylinder and the insulation on the bottom of the cylinder head cover should be fully soaked.

Fault type 2: Cylinder head cover leaking

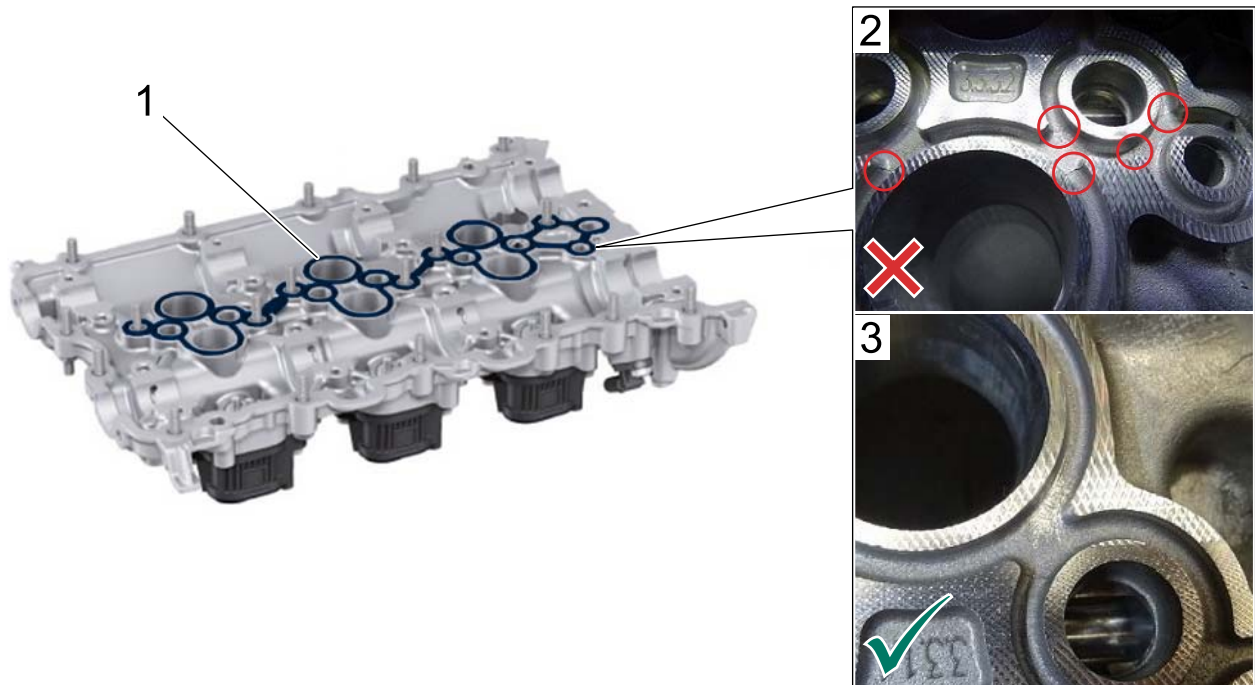
Cylinder head cover sealing groove

2.6 Check the sealing groove (⇒ *Cylinder head cover sealing groove -1-*) of the cylinder head cover visually. Be particularly meticulous when doing this especially in the vicinity of the affected cylinder.

2.7 Carefully remove any cast residue (⇒ *Cylinder head cover sealing groove -2-*) using a small flat screwdriver, ensuring that the sealing groove is not damaged. There must be no more cast residue in the sealing groove after machining (⇒ *Cylinder head cover sealing groove -3-*).
