**Noise Symptom - Noises From Around the Steering Shaft: Replacing intermediate steering shaft (SY 17/14)**

Revision: This bulletin replaces bulletin, Group 4, #17/14, dated August 23, 2017.

Model Line: **Macan**

Subject: **Intermediate steering shaft**

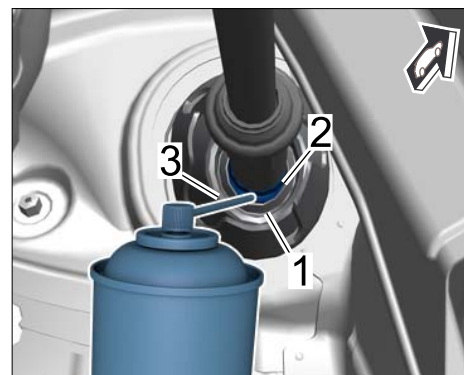
*Position of the spray nozzle at the steering shaft duct at the engine compartment side*

- 2 Carefully pull the rubber on the steering shaft duct (⇒ *Position of the spray nozzle at the steering shaft duct at the engine compartment side -item 1-*) away from the steering shaft in order to access the blue friction ring (⇒ *Position of the spray nozzle at the steering shaft duct at the engine compartment side -item 2-*).

- 3 Push the spray nozzle (⇒ *Position of the spray nozzle at the steering shaft duct at the engine compartment side -item 3-*) under the sealing lip as far as the blue friction ring (⇒ *Position of the spray nozzle at the steering shaft duct at the engine compartment side -item 2-*).

- 4 Spray the top and bottom.
- 5 For optimal distribution of the lubricant, turn the steering fully to the left and right several times immediately after spraying and also change the fore-and-aft adjustment position as far as it will go.

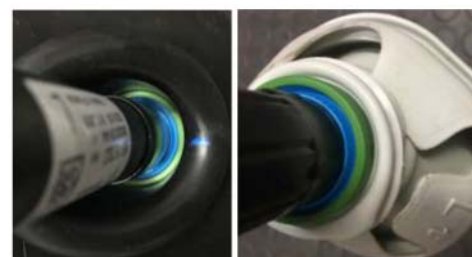
- The steering shaft has two blue rings that need to be lubricated individually (Figure 1). Lubricant can't effectively flow from one to another.
- Each ring needs to be lubricated while the shaft is held vertically.
- This means the shaft has to be removed from the vehicle.
- The top ring is lubricated, and then the shaft is turned over and the other ring is lubricated.

*Figure 1 — On the left is the passenger compartment side and on the right is the engine compartment side.*

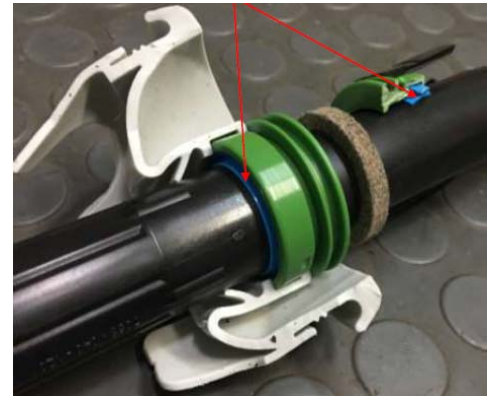
Figure 2

**Two rings** can be seen in the assembly view on Figure 2.

Both rings are identical, the passenger compartment ring is cut away for clarity. Notice the felt insulator between them.
