Technical Service Bulletin

91 MIB2 High: Navigation initialization stuck at 77%

91 19 24 2058160/1 December 20, 2019.

Model(s)	Year	VIN Range	Vehicle-Specific Equipment
A6, A7	2015 - 2016	All	MIB2 High

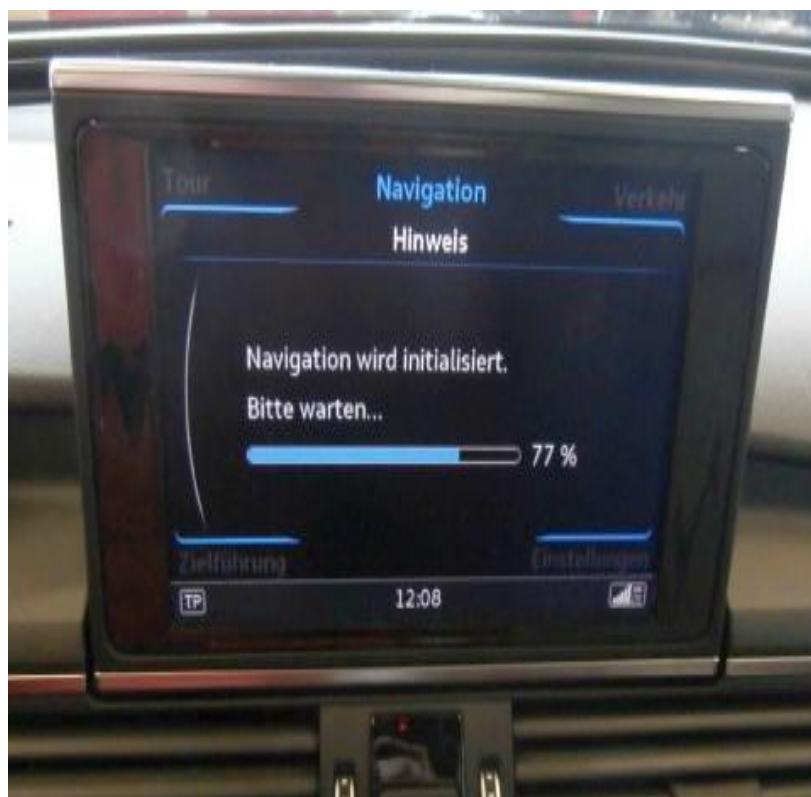
- The navigation system initializes up to 77% and freezes there (Figure 1).

Figure 1. Navigation system is frozen at 77%.

A software bug causes the initialization to freeze.

New software for the infotainment system addressed the condition.

1. Follow all instructions in TSB 2047576: *91 MIB2 High Software Update Instructions (PR Code 7UG)*.
2. Update the Infotainment System using the SVM action code as listed in the table below, if necessary:

Both updates (Steps 1 and 2 in the update table) have to be performed in sequential order. Mixing up the update order can render the main unit inoperable.
