## Federal Recall Information

**19PBG**

Dana Axle Output Shaft

12/20/2019

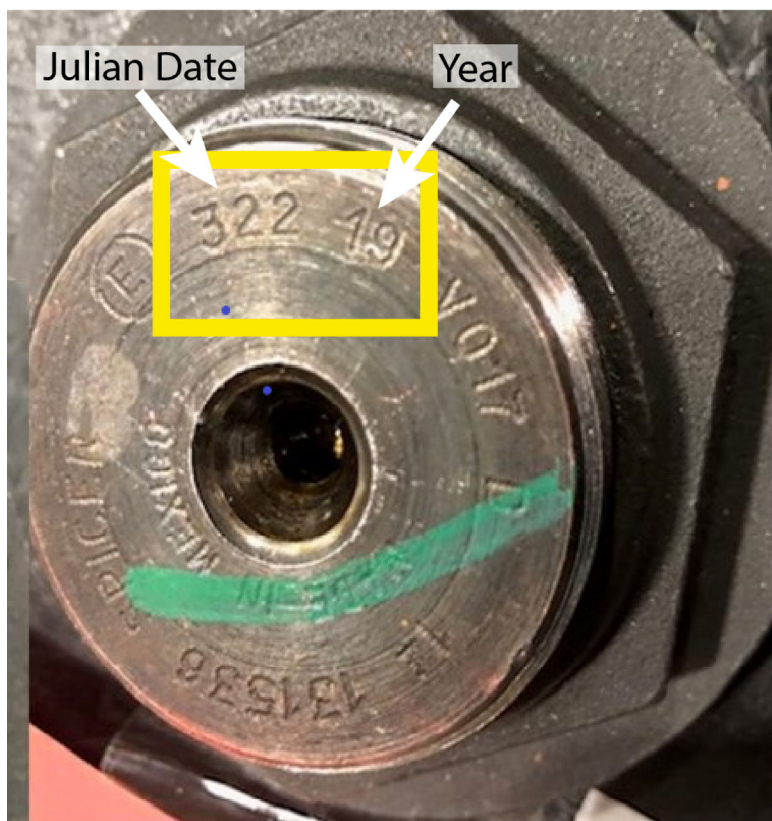
Peterbilt Motors Company has determined that a defect, which relates to motor vehicle safety, may exist in certain model 348, 367, 389, 520 or 567 vehicles manufactured between November 22, 2019 and December 5, 2019. Output shafts may not have been correctly heat-treated and could break near the pinion nut. Dealers are instructed to hold these vehicles.

1. Disconnect the interaxle driveline from the suspect output shaft.
2. Inspect the date code on the output shaft.
3. If the date code is 312 or from 318 through 328, then continue with this procedure.

4. If the date code is outside of the dates above, then no further action is required. Reinstall the driveline.
5. Replace the output shaft using procedures in manual [ASXM-0057](#) with the following exceptions:
  - the axle shafts do not need to be removed
  - the inner bearing cup DOES NOT need to be replaced
