## Technical product information

<b>Topic</b>	Clicking noises from front corner(s)
<b>Market area</b>	Bentley: worldwide (2WBE),Hongkong-Macau (5HK)
<b>Brand</b>	Bentley
<b>Transaction No.</b>	2052853/3
<b>Level</b>	EH
<b>Status</b>	Approval
<b>Release date</b>

### Bentayga

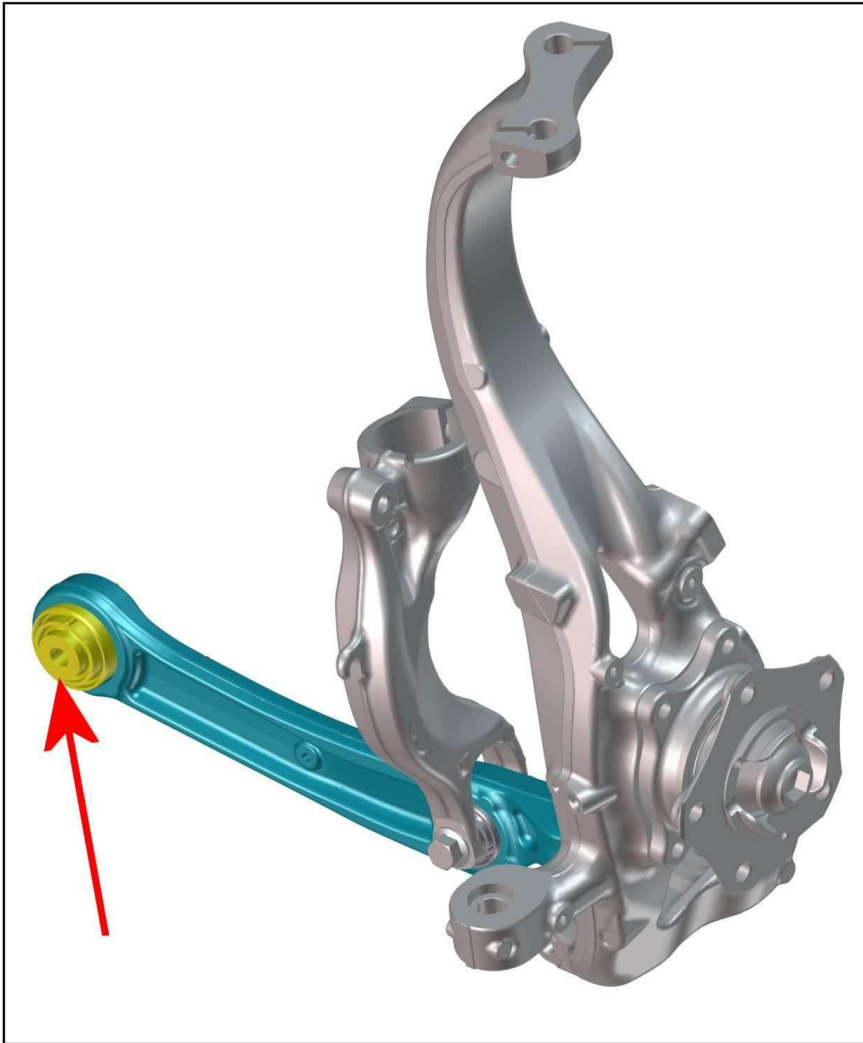
Figure 1

Symptom 1 - Single click from the front wheel corner(s) when the steering is moved from lock to lock whilst stationary

Ensure fault is as described and reference video <https://vimeo.com/298953282> If so then replace both front lower inner control arm bushes (Figure 1)

**IMPORTANT:** Please check the vehicle Repair History to confirm the inner bushes have not been previously replaced, if they have been replaced once before, You must then replace the complete arm, Do Not carry out the bush replacement procedure more than once (per lever)

Each bush should have 5ml of lubricant applied prior to fitment within the bush, the grease should remain present throughout the fitting/pressing in procedure as the grease aids the fitting process and is also crucial once fitted to eliminate any further noise issues *Please Note that x1 – 100 ml tube will be sufficient for use on 20 bushes (10 vehicles) – Do not order x1 tube of lubricant per each individual vehicle complaint*
