TECHNICAL SERVICE BULLETIN

Roof Rail Covers Loose

19-2364
09 December 2019

Ford 2016-2019 Explorer

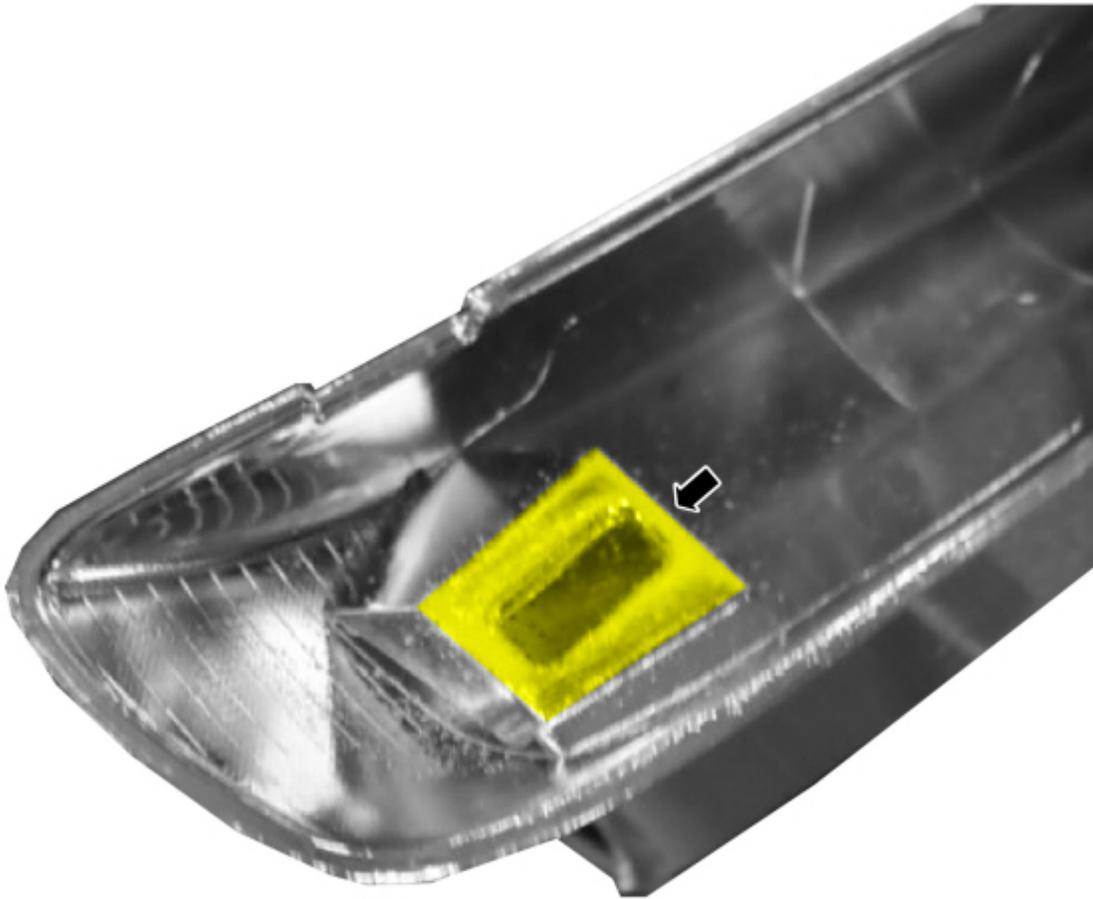
Figure 1

Issue: Some 2016-2019 Explorer vehicles may exhibit roof rail covers that become loose or partially detached. This may be caused by a lack of retention of the clips securing the roof rail covers. To correct the condition, follow the Service Procedure to apply adhesive to the roof rail covers.

1. Remove the roof rail cover. Refer to Workshop Manual (WSM), Section 501-08.
2. For chrome roof rail covers, lightly sand the clip retainer surface with 100 grit sandpaper to promote adhesion. (Figure 1)
