# Technical product information

| Topic | Garage door opener remote with a frequency of 315MHz will not program to vehicle HomeLink |
| Brand | Bentley |
| Transaction No. | 2057999/1 |

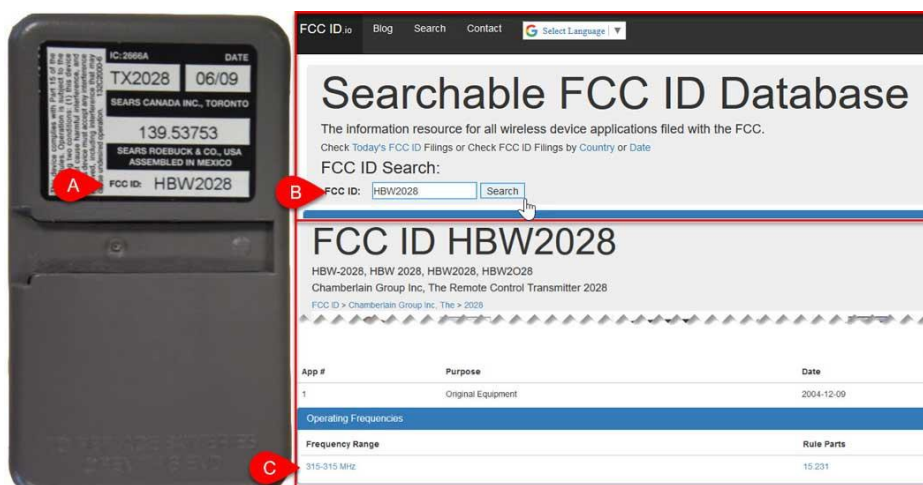
Figure 1. Checking the operating frequency.

1. Check the operating frequency of the customers remote control:
  - Locate the FCC ID number of the customers remote control (Figure 1, A).
  - Search this ID at <https://fccid.io/> (Figure 1, B).
  - Locate the Frequency Range of the remote control (Figure 1, C).

2. If the operating frequency of the customers remote control is 315MHz (+/- 10MHz), continue with this document. If not, perform diagnosis outside of this document.
3. Adapt the customer's remote control to the vehicle with the side assist modules disabled:
  - Remove Fuse -SF4- from Fuseboard SH (located in the luggage compartment) for the lane change assistance control module, J769 and lane change assistance control module 2, J770
  - Turn on the ignition
  - Make sure that an error notification for the side assist is displayed on the instrument cluster, if not, double check lane change assistance control module, J769 and lane change assistance control module 2, J770 fuse location in the wire diagram.
  - Perform programming of the customer's garage door remote, to the vehicle. Programming can occur from the MMI or the hard buttons, located in the overhead console.
