ARTICLES CONTAINED IN THIS ISSUE

07 2020MY LEGACY & OUTBACK, DTCS B2259, B2244, B282C & B2C22

11 P04AE DIAGNOSTIC ISSUES FOR 2019-2020MY ASCENT

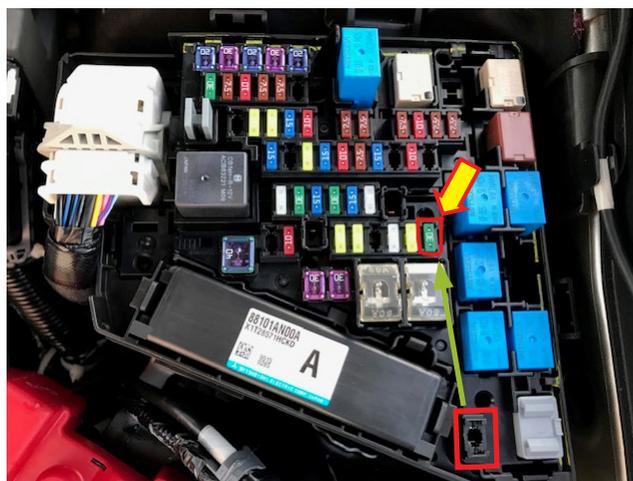
As part of retailer pre-delivery inspection (PDI) the green 30A (backup) fuse shown below is moved from "transit" position "A" to "delivery" position "B". During manufacturing and at the completion of port processing prior to shipment, the backup fuse is installed into the "A" position to eliminate battery draw during transit / storage.

NOTE: The new 2020MY Legacy and Outback will set DTCs B2259, B2244, B282C and B2C22 if for some reason, the fuse is removed from the "B" position while the ignition is "ON". This is a normal operating characteristic for these models.

For this reason, when performing a Check ALL DTC on a new 2020MY Legacy or Outback, the list of DTCs above will likely be stored in memory until the backup fuse is in position “**B**” and the memory cleared. For example: if a Technician installs an additional accessory which requires removal of the backup fuse from “**B**”, the codes above will automatically set. The memory must always be cleared after the backup fuse is reinstalled into “**B**”.

IF CURRENT: Check to see if the backup fuse is blown or not and confirm it is fully installed in the proper position. If the fuse is OK, diagnose the DTCs as per the applicable Service Manual.

IF HISTORY: Check the **Trip** count and **Freeze Frame Data** of the DTCs to determine when the DTCs were stored. If the Trip count when the DTCs were stored is *higher* than the current trip count *or*, if the FFD shows the date when the DTCs were stored is *before* the sold date, these DTCs are not related to a customer concern. The cause of the DTCs would most likely be the backup fuse was removed for some reason and the memory was not cleared after the fuse was reinstalled.

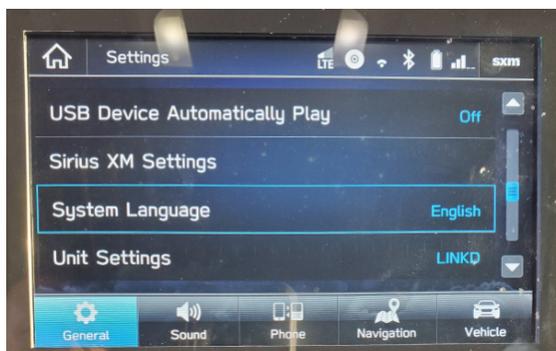
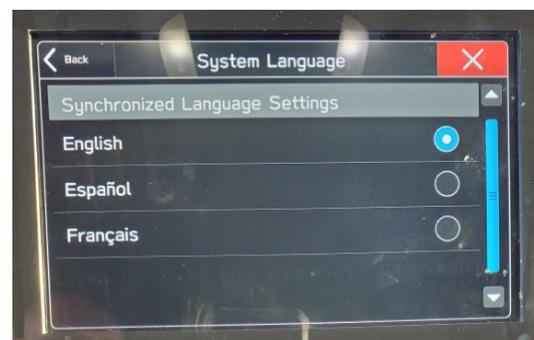
Changing SXM Channel Using Voice Recognition

There have been reports received regarding a faulty voice recognition system (VR) operation when changing the SXM channel by calling a channel name. It usually happens following a head unit factory reset. Harman has reviewed reports and found the root cause. This issue occurs occasionally when a SXM channel name file gets deleted from the cache during a factory reset. The countermeasure is already being worked on but at this point, the schedule is not available. In the meantime, Harman has recommended the following steps as the temporary work around. The issue can be resolved by changing the language from English to Spanish or French and back to English, followed by a full ignition (I/G) cycle (Full I/G cycle = Turn OFF I/G, open/close driver door, wait for 2-3 minutes, and turn I/G ON).

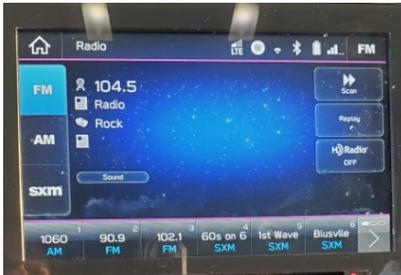
HD Radio option: OFF

Please note, the head unit displays the album art only when HD radio is on and the info is provided by the broadcaster.

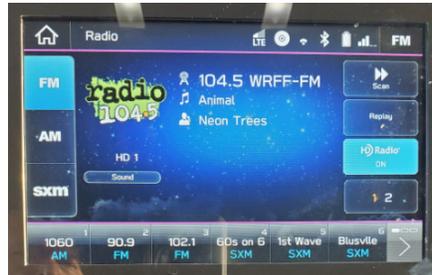
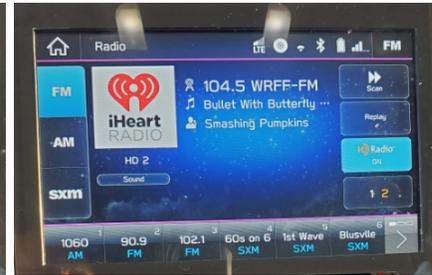
HD Radio option: ON

When the head unit has been rebooted, there will be a delay until the artwork is displayed. It is also true after the HD Radio option is first turned on.

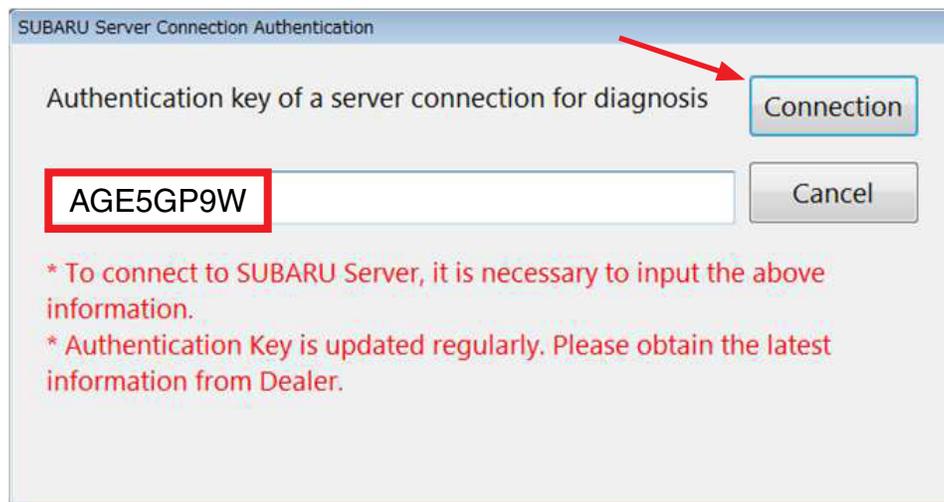
For 2020MY Legacy and Outback with a **G** or **H** -Type system, the Server Connection screen shown below will be displayed. Input the current Authentication Key and select "Connection." Currently the Authentication key is **AGE5GP9W**.
