# Technical product information

| Topic | Condensation within the cabin |
| Brand | Bentley |

## New Continental GT/GTC

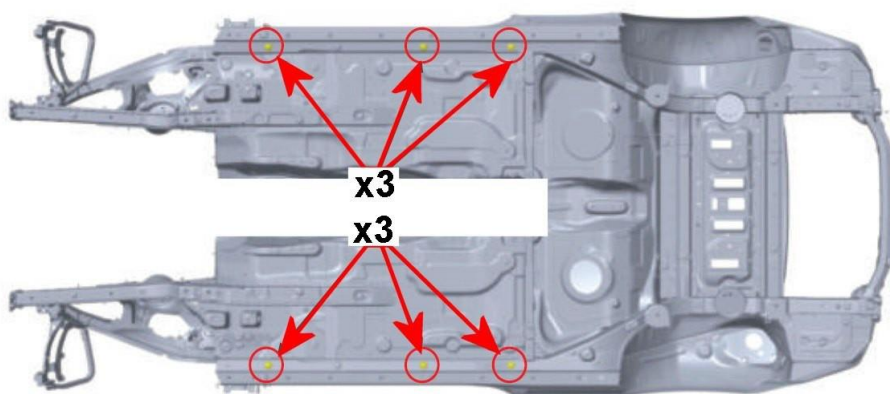
Figure 1

Condensation evident within the cabin

Should no HVAC issues be evident or the HVAC issues has been rectified and condensation is still evident please refer to the Measure section of this TPI

- Remove the x3 right hand sill grommets
- Remove the x3 left hand sill grommets

3) Replace the previously removed grommets using the parts listed in Parts information section
