SERVICE BULLETIN

APPLICABILITY: 2019-20MY Impreza
 2019-20MY Crosstrek (Including Hybrid Model)
 2019-20MY Forester
 2019MY Legacy/ Outback
 2019-20MY WRX
 2019-20MY BRZ- Navigation -equipped ONLY
 2019-20MY Ascent

NUMBER: 15-236-18R

SUBJECT: Reprogramming File Availability for Optimization of Harman Gen 3.1 Audio and Navigation Head Units

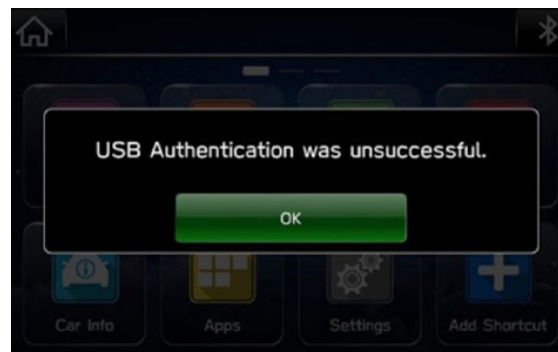
NOTE: If an attempt is made to install the wrong “grade” file into the wrong grade head unit (EXAMPLE: “Base” update file into a “Base Plus or Mid” or “High” head unit), the USB Authentication error screen below will be displayed:
