## SERVICE INFORMATION BULLETIN

**APPLICABILITY:** 2017-2018MY Impreza  
2018MY Crosstrek

**NUMBER:** 07-129-18R

**SUBJECT:** Inaccurate Tire Pressures  
Displayed in Combination Meter

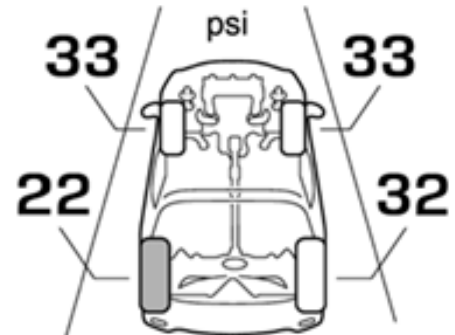
This bulletin announces availability of reprogramming files to optimize operation of the Tire Pressure Monitor System's (TPMS) real-time display function. Under certain high-altitude conditions, the tire pressure values displayed in the combination meter may not be accurate.
