SERVICE BULLETIN

APPLICABILITY: 2019MY Ascent **NUMBER:** 05-72-19
SUBJECT: Squeak / Creaking Sound from Rear Suspension **DATE:** 12/10/19

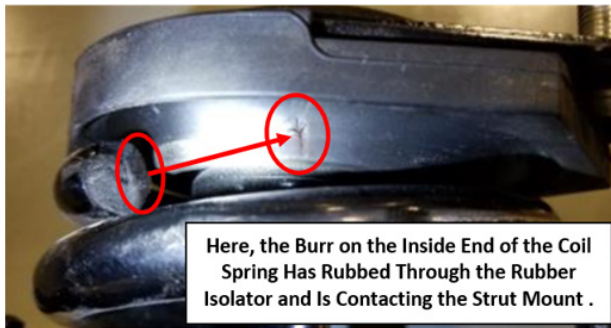
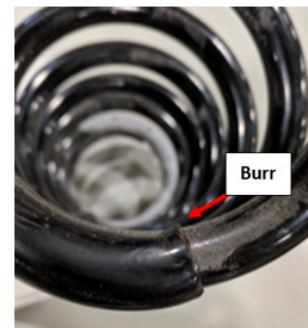
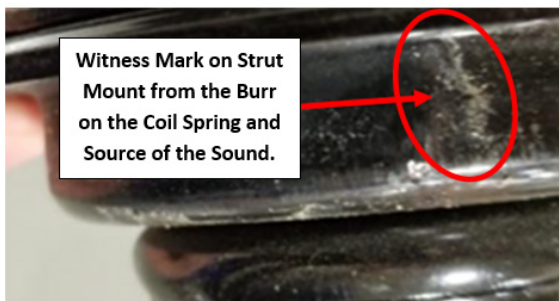
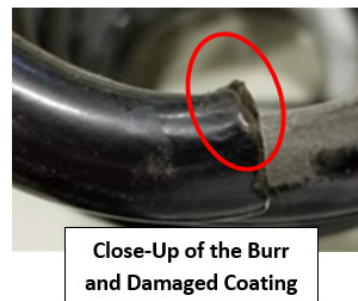
This bulletin addresses isolated concerns of a squeaking / creaking -type sound from the rear suspension. The condition is caused by a burr on the end of the coil spring winding produced with an end gap which was out of specification. This allowed the burr to make contact with the mount. Over time, the burr, which is characteristic result of the manufacturing process, can penetrate the rubber isolator and come into direct contact with the strut mount as shown in the photos below. This contact creates the sound described. Should this occur, both the mount and coil spring must be replaced. **NEVER attempt to grind or otherwise alter the burr on the new or original equipment coil spring** or repair any contact marks with paint or other coatings. Replace the affected parts with new ones.

- **The burr is a normal characteristic of the spring production process. NEVER** attempt to grind or file it away as this will reduce the corrosion resistance of the spring, even if painted or re-coated.
- If the burr has punctured through the rubber isolator and contacted the steel portion of the strut mount, the strut mount must be replaced.
