PRODUCT CAMPAIGN BULLETIN

APPLICABILITY: 2015-18MY Forester **NUMBER:** WUM-98R
SUBJECT: Occupant Detection Wiring Harness Inspection **NHTSA ID:** 19V-701
DATE: 10/14/19
REVISED: 12/13/19

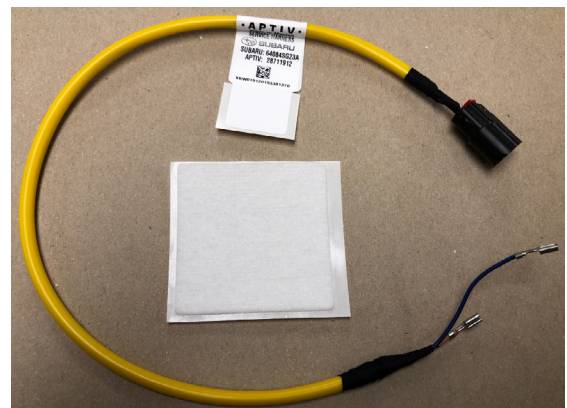
A. (PREFERRED METHOD) Replace the pictured ODS harness (p.n. 64084SG23A) following the Harness Replacement Procedure below

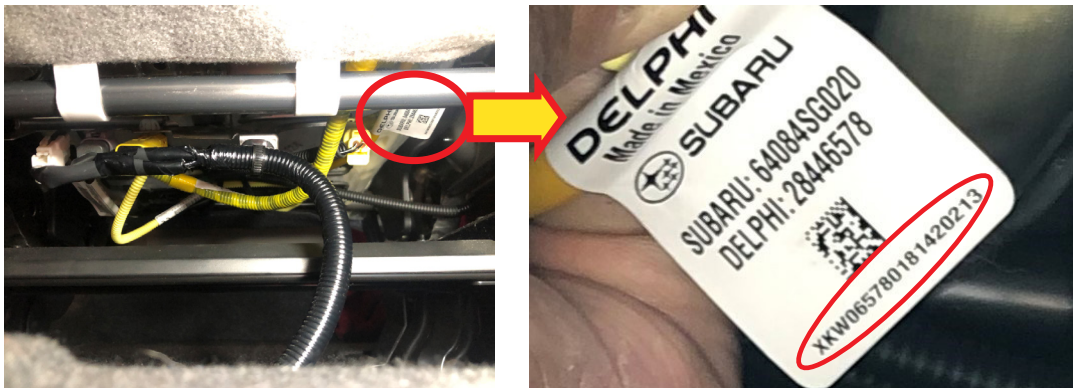
The part identification label affixed to the yellow sensor mat wiring harness is the focus of this inspection. The left photo shows an underside view of the passenger seat as seen from the front floor area and provides an approximate location of the label. On the right is a close-up of the identification label itself.

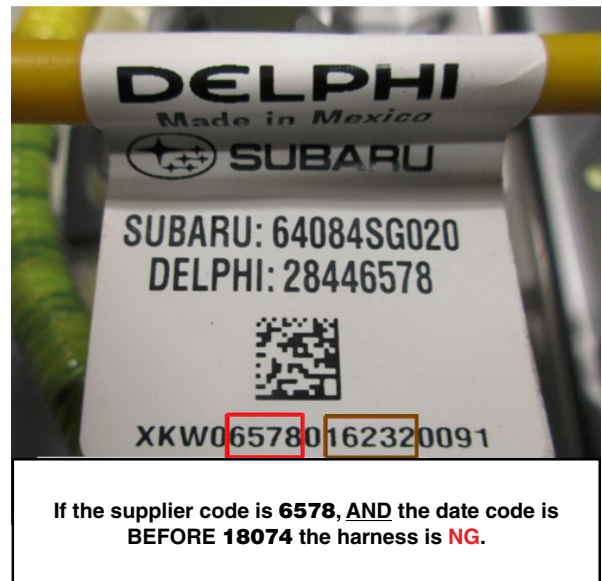
Step 1. If the date code (**BROWN** box in photo) on the label is **AFTER 18074**, the harness is **OK**. **Harness replacement is NOT necessary.** See additional ****NOTE** below.

Step 2. If the date code is **18074** or **BEFORE AND** has the supplier code **6578** (**RED** box in photo) on it, the harness is **NG** must be replaced. **Proceed to Harness Replacement Procedure as outlined below.**

- “16” is the year (2016) and “232” is the 232nd day of the year: “16232”.

IMPORTANT: The supplier code AND date code from the **INSTALLED** harness **MUST** be entered in the Miscellaneous Detail field at claim entry (e.g: **657818074**).
