PRODUCT CAMPAIGN BULLETIN

APPLICABILITY: 2019MY Legacy and Outback
SUBJECT: Front Duct Panel Spot Weld

NUMBER: WUH-93R
DATE: 06/26/19
NHTSA: 19V493
REVISED: 12/13/19

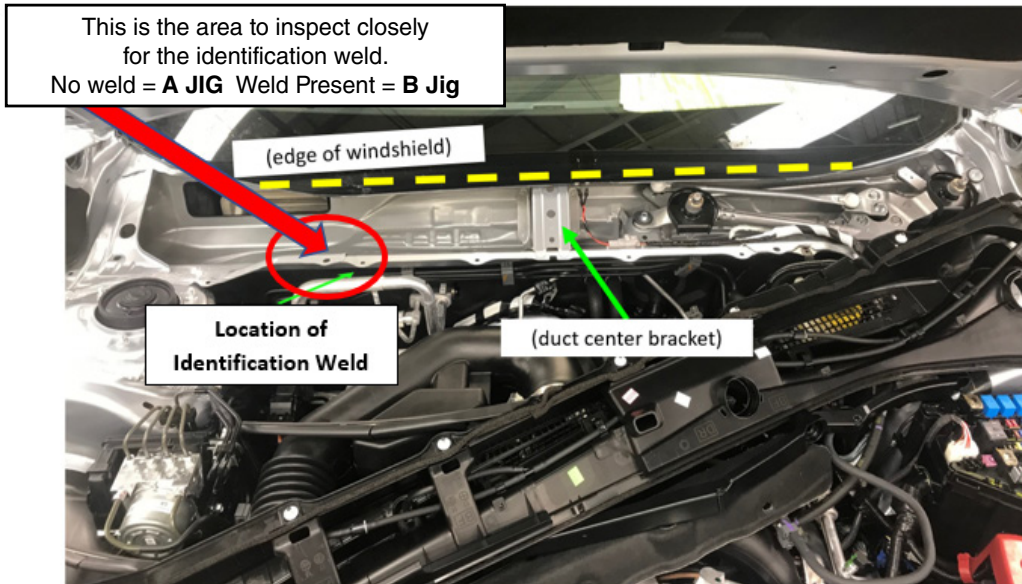
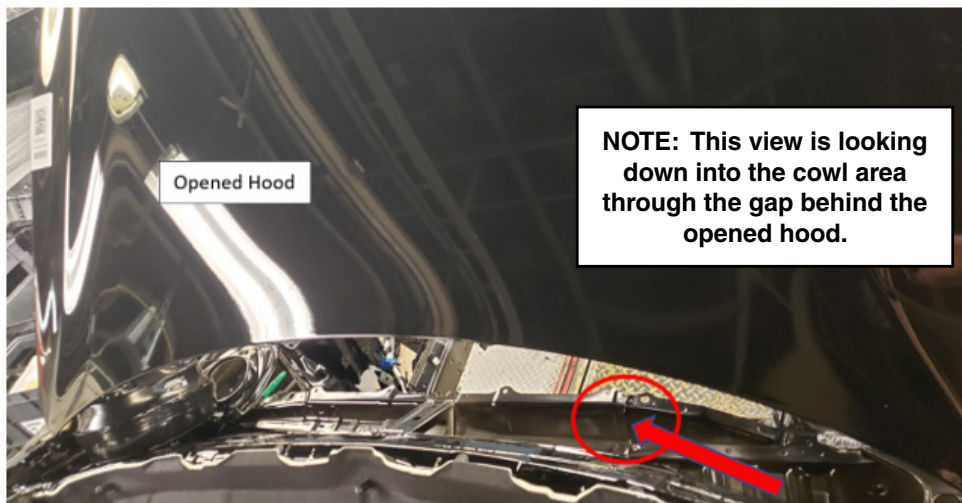
6. With the cowl trim panel removed, use the photos below to determine if the vehicle is equipped with an **A Jig** or **B Jig** part. The **B Jig** part has an identification weld to distinguish it from the **A Jig** part.

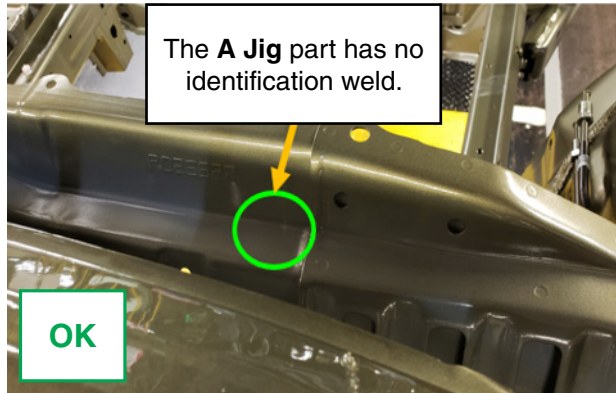
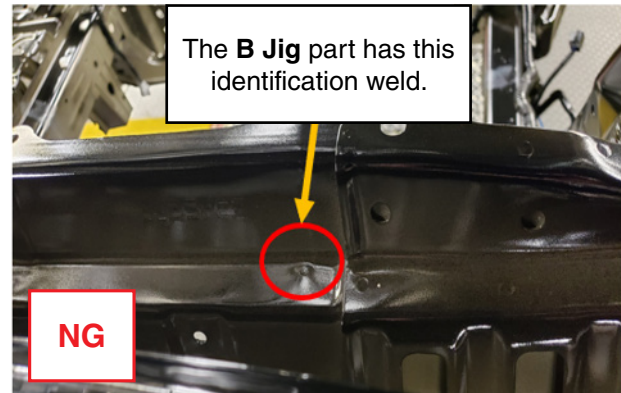
HOW TO DETERMINE IF THE INSTALLED PART IS “A JIG” OR “B JIG”

IMPORTANT NOTE: See **APPENDIX A** starting on pg. 7 for additional reference photos to use when making the **OK / NG** (pass/fail) determination for **Part A** inspections.

7. If the cowl area inspection reveals an **A JIG** part, the vehicle is **OK**. **STOP**, take a clear photo of this area and the VIN plate at the base of the “B” pillar. Reinstall all the removed parts in reverse order to prepare the vehicle for sale. Proceed to **Step 8**.

CRITICAL: If the cowl area inspection reveals a **B JIG** part, THE VEHICLE IS **NG** AND **MUST BE HELD** WHILE DETERMINING THE NEXT COURSE OF ACTION. Do not reassemble the vehicle. Proceed to **8**. below.

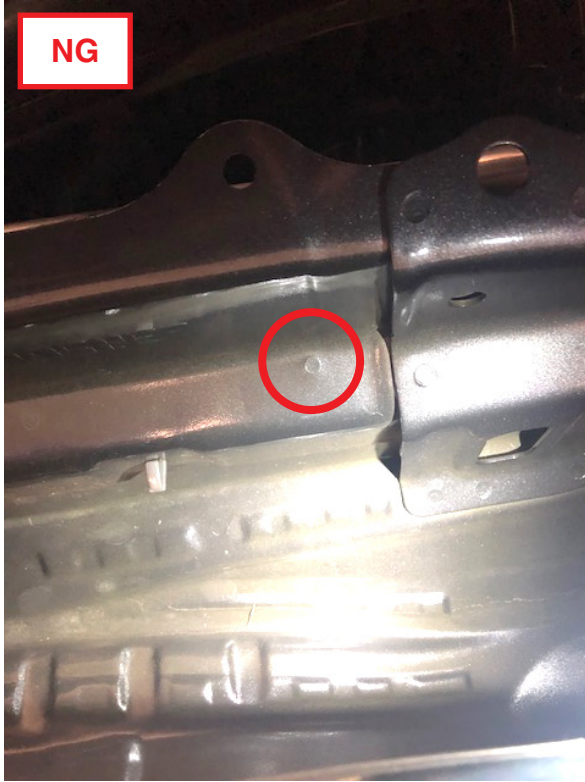
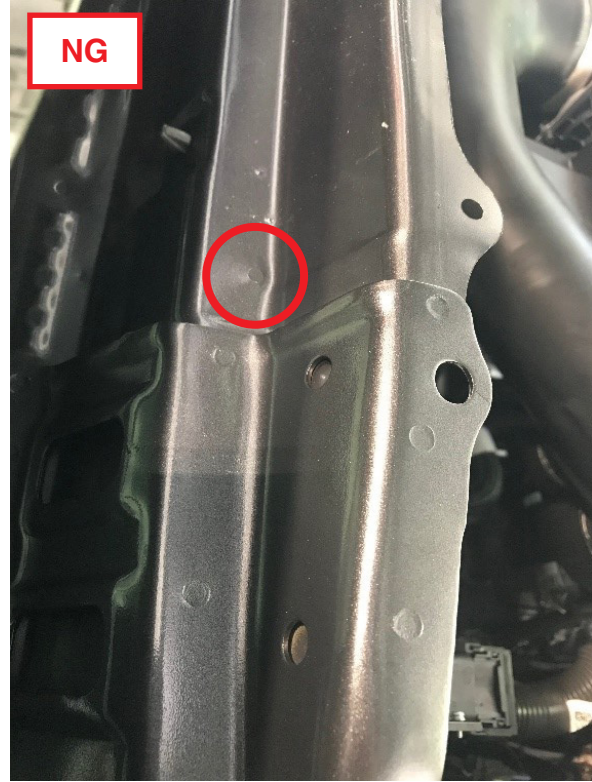
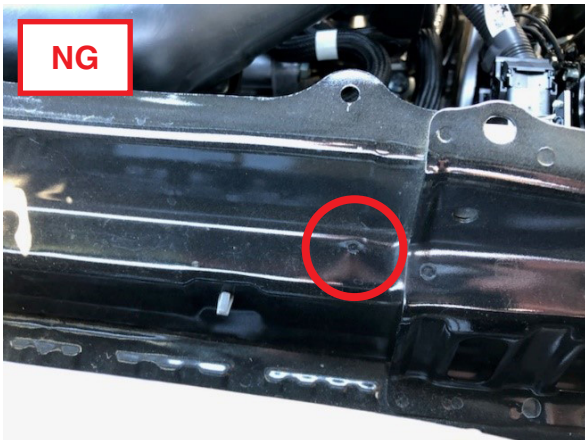
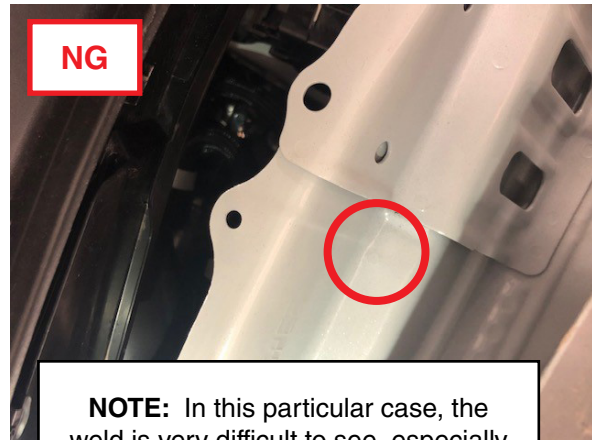
APPENDIX A: Examples of NG (“B” Jig) and OK (“A” Jig) Duct Panel Weld Inspections

NOTE: In this particular case, the weld is very difficult to see, especially in the supplied photo. Keep in mind, the vehicle's color can make the weld difficult to identify and photograph for making the OK / NG determination.
