SERVICE BULLETIN

APPLICABILITY: 2018-19MY Crosstrek
SUBJECT: A-Pillar Trim Cover- Design Change

NUMBER: 12-277-19
DATE: 12/13/19

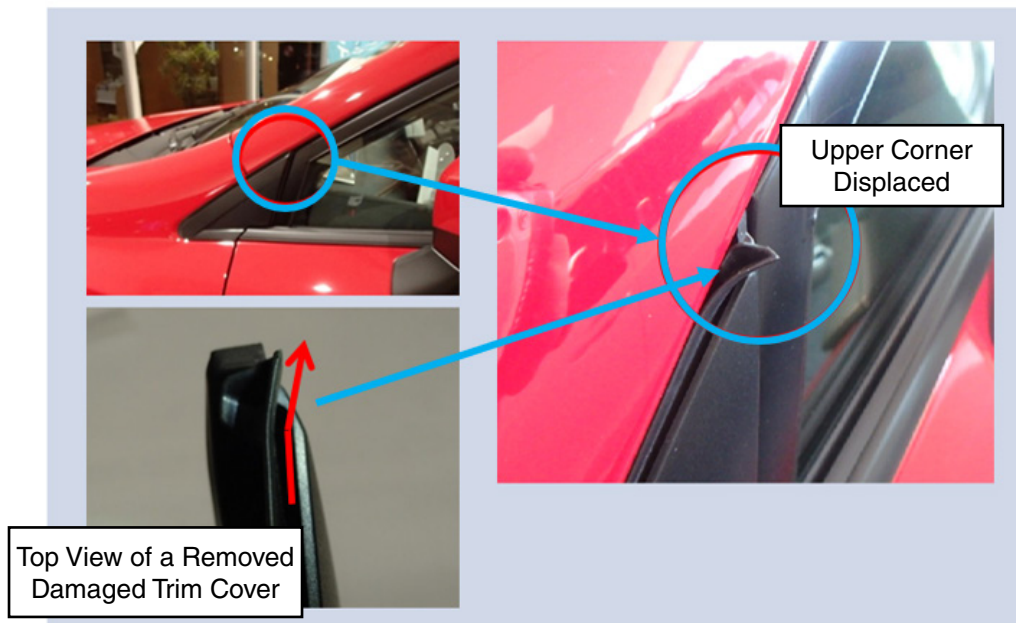
This bulletin describes a design change made to the exterior “A” pillar cover. The change involves use of materials in critical areas having added rigidity along with an extra strengthening rib. These changes will prevent the upper corner portion from being deformed should the leading edge of the front door contact it during opening and closing. The affected area and example photos of what the damaged component may look like are shown below.

The new A-Pillar covers were incorporated into production starting with VIN **KH387837**.

NOTE: When replacing these covers, they BOTH should be replaced as a set (LH and RH). New retaining clips are included with the replacement covers.
