JLRTB02007NAS2
TECHNICAL BULLETIN
 20 DEC 2019

501-03

Front Left Exterior Door Frame Finisher Damaged

MODEL:	MODEL YEAR:	VIN:	ASSEMBLY PLANT:
Range Rover Sport (LW)	2020	876107-899999	Solihull

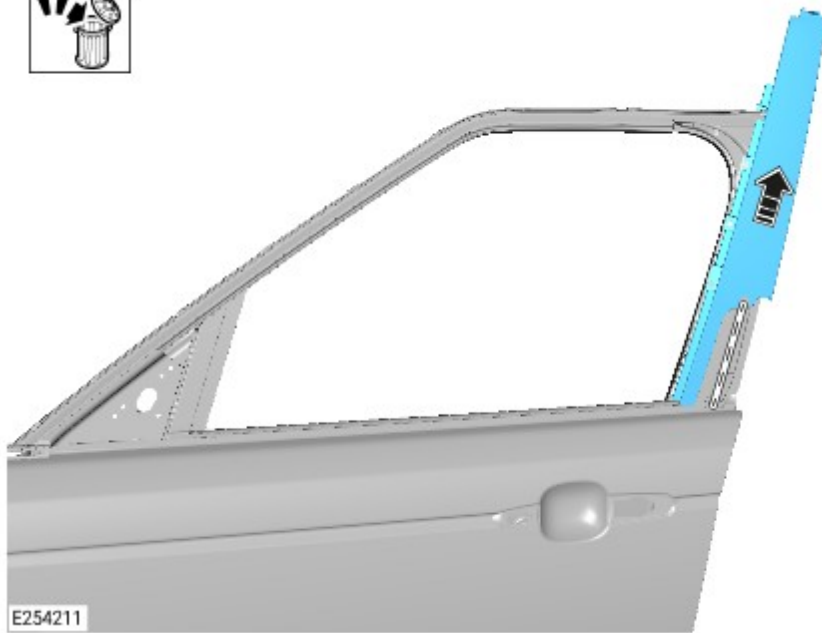
A small section of the front left exterior door frame finisher has become damaged or has detached from the vehicle.

Remove and discard the exterior door frame finisher.

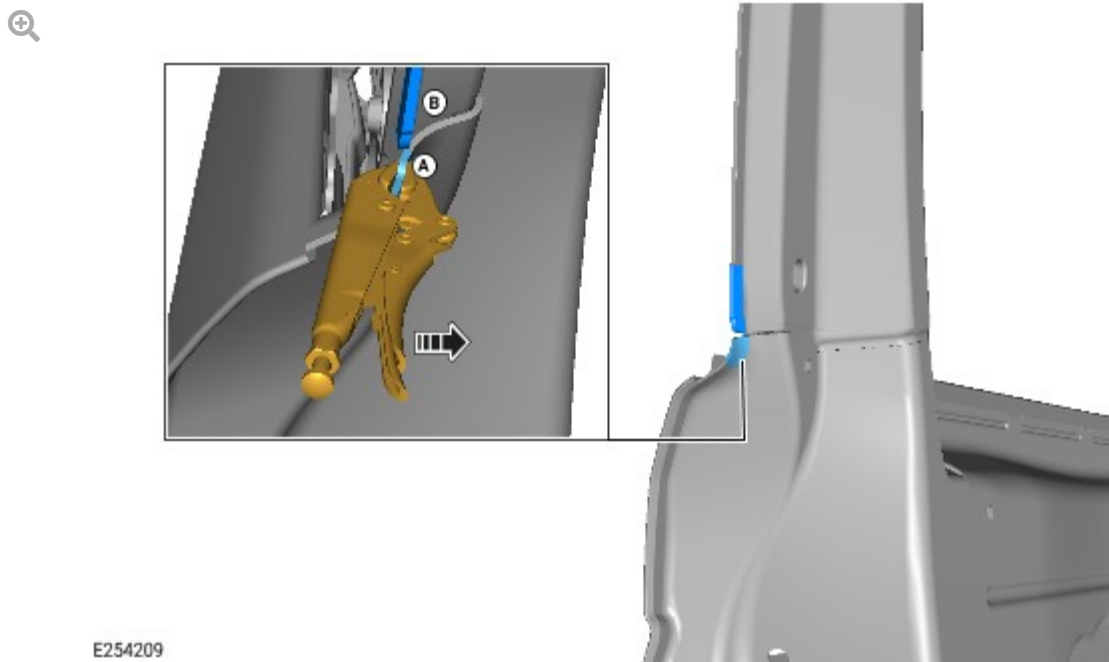
The front left door frame flange alignment tolerance is out of specification.

- Make sure no damage is caused to the vehicle.
- Make sure the surrounding area and the suitable tool are protected to avoid damaging the vehicle.
- Any body panels which have been modified/alterd must be returned to their original manufacturing condition.

Use the tool shown in the illustration to align panel A with panel B.
