JLRTB02012NAS1

TECHNICAL BULLETIN

'Gearbox Fault Detected' Displayed On The Instrument Panel Cluster (IPC)

MODEL:	MODEL YEAR:	VIN:	ASSEMBLY PLANT:
I-PACE (X590)	2019-2020	F60094-F80069	Graz (Austria)

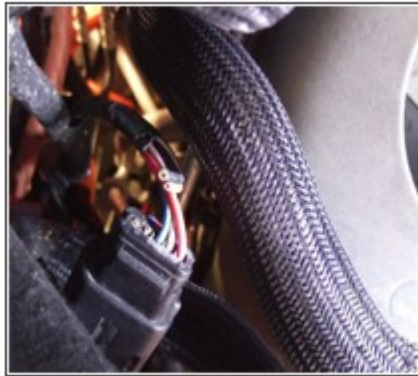
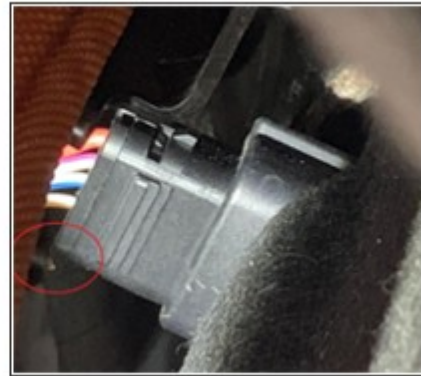
E256857

No retention to the front Electric Drive Unit (EDU) causing strain on wiring going to the park lock actuator connector (C1YE113A).

- ■ If the park lock actuator connector (C1YE113A) wiring is found to be damaged, as per the illustration, **continue to step 2.**

Renew the front compartment wiring harness (see TOPIx Workshop Manual section 418-02: Wiring Harnesses - Removal and Installation - Front Compartment Wiring Harness).
