TECHNICAL BULLETIN

03 DEC 2019

INFORMATION			
SECTION:			
501-08			
SUBJECT/CONCERN:			
Front Tow Eye Cover Adrift -	- Dynamic Bumper		
AFFECTED VEHICLE RANGE:			
MODEL:	MODEL YEAR:	VIN:	ASSEMBLY PLANT:
Range Rover Evoque (LV)	2012-2019	600000-354461	Halewood
MARKETS: NORTH AMERICA			
CONDITION SUMMARY:			
CONDITION SOLILIANT.

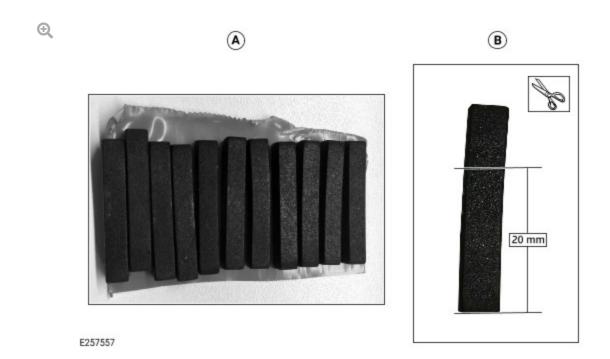
Image 'A' shows an example of how the rubber spacer kit will arrive.

A total of 8 rubber spacers are required for each repair and each rubber spacer used must be 20 mm in length, as shown in image 'B'.

- Measure 20 mm from the bottom of the rubber spacer.
- Use a suitable tool to remove the excess material.
