## Technical Service Bulletin

| <b>Topic</b> | Infotainment screen turns red sporadically |
| <b>Brand</b> | Bentley |
| <b>Transaction No.</b> | 2055846/2 |

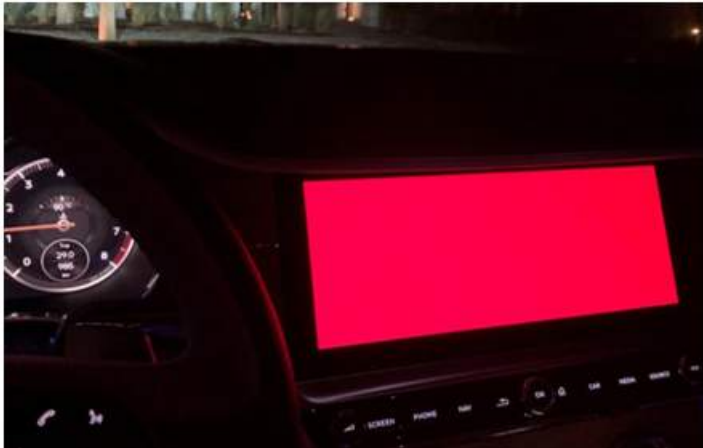
Figure 1

Infotainment screen turns red sporadically (Figure 1)

Reset the Infotainment system as follows:
