## Popping or Crackling from the Speakers? Check the MOST Bus Network

### AFFECTED VEHICLES

Year	Model	Trim
2018- 20	Odyssey	ALL except LX
2019- 20	Passport	ALL except Sport
2019- 20	Pilot	ALL except LX

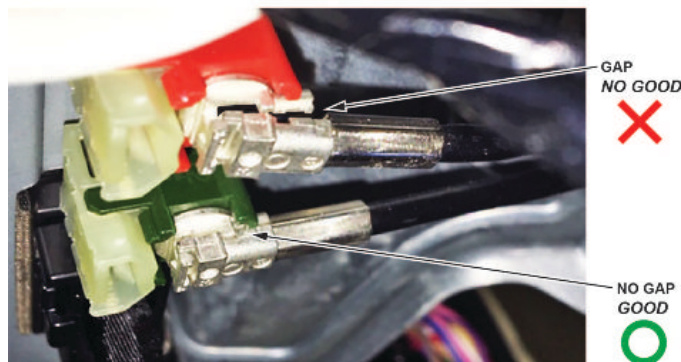
Be sure to inspect the red and green MOST connectors of all infotainment system components and any connections between the harnesses. If you find a damaged connector, like you see here, you must replace the entire harness. These connectors **are not** repairable.

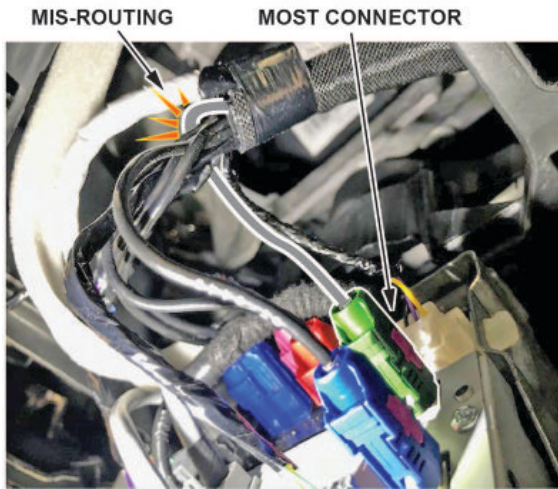
**✗ NO GOOD**

During vehicle assembly, the harness for the infotainment unit could have been misrouted, causing tension on the MOST connectors. This could cause a break in the signal during operation.

To fix this, disconnect the MOST connector and reroute the harness wire so the tension goes away.

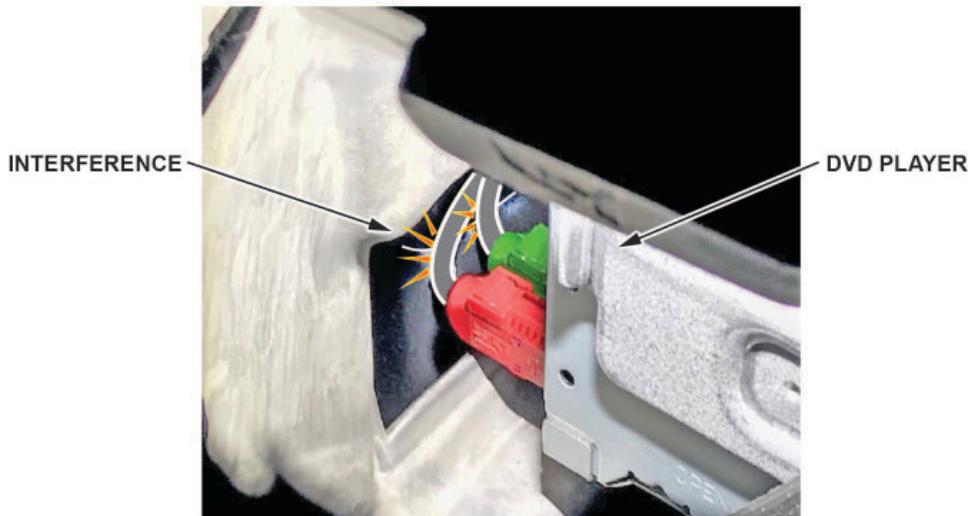
We've also found that the MOST connectors on the DVD player may get pinched between the unit and the air ducting box. We don't have a permanent fix for this, but you can try adjusting the wires to take pressure off of them.
