December 20, 2019

Version 2

MIL Comes On with DTC P0430 or DTC P0430 with P030X, P219A, P219B (With Software Update)Supersedes 19-072, dated July 5, 2019, to revise the information highlighted in **yellow**This bulletin replaces 17-036, *MIL Comes On with DTC P0430 (Front Bank Catalyst System Efficiency Below Threshold [Bank 2])*.**AFFECTED VEHICLES**

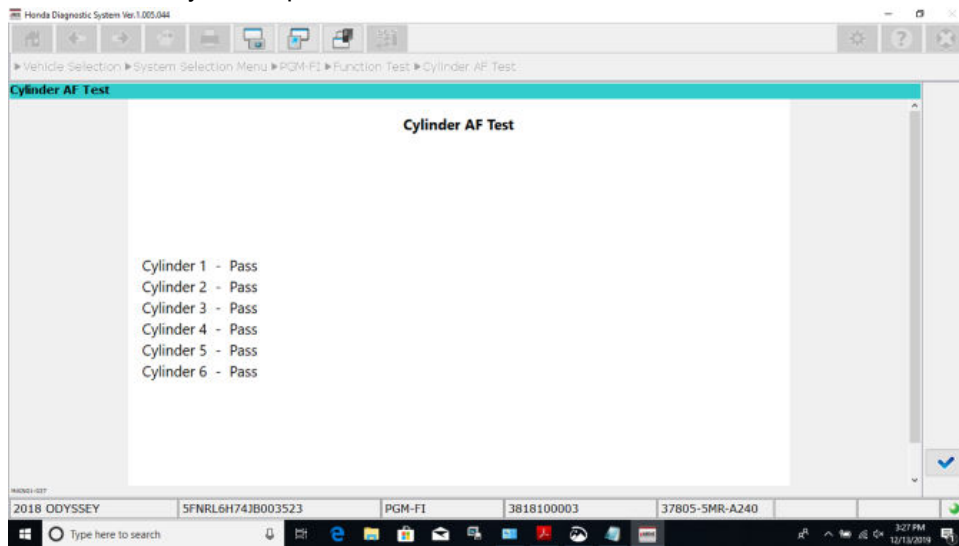
6. Make sure all cylinders pass.

No - Go to FUEL INJECTOR REPLACEMENT.

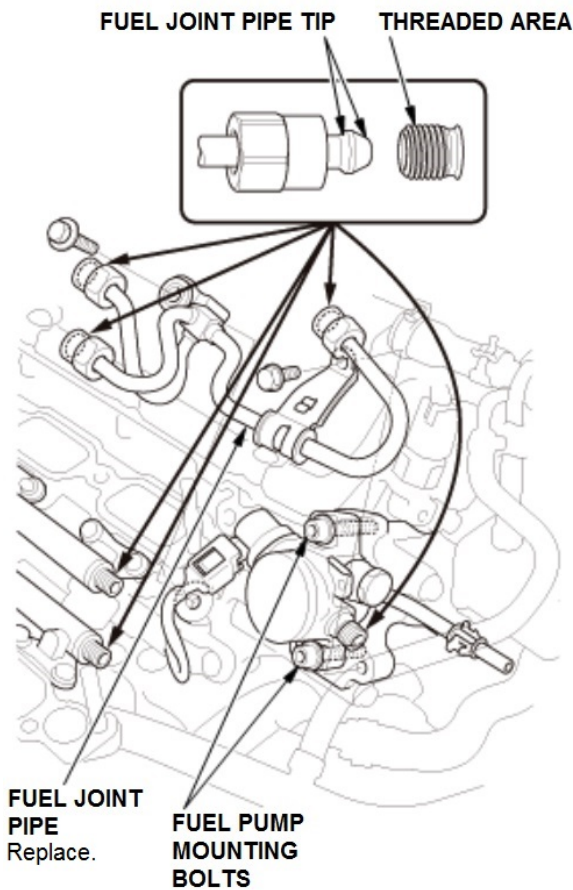
Do not reuse the fuel joint pipe. Failure to install a new fuel joint pipe will cause fuel leaks.

2. Install the parts in the reverse order of removal. Refer to the service information.
 - 2.1. Install the fuel injectors to the fuel rail.
 - 2.2. Install the fuel rail and fuel injectors to the cylinder head.
 - 2.3. Lubricate the tips of the new fuel joint pipe with polyethylene glycol (included in the fuel joint pipe kit).
 - 2.4. Also, lubricate the threaded areas of the fuel rails and high pressure fuel pump with polyethylene glycol.

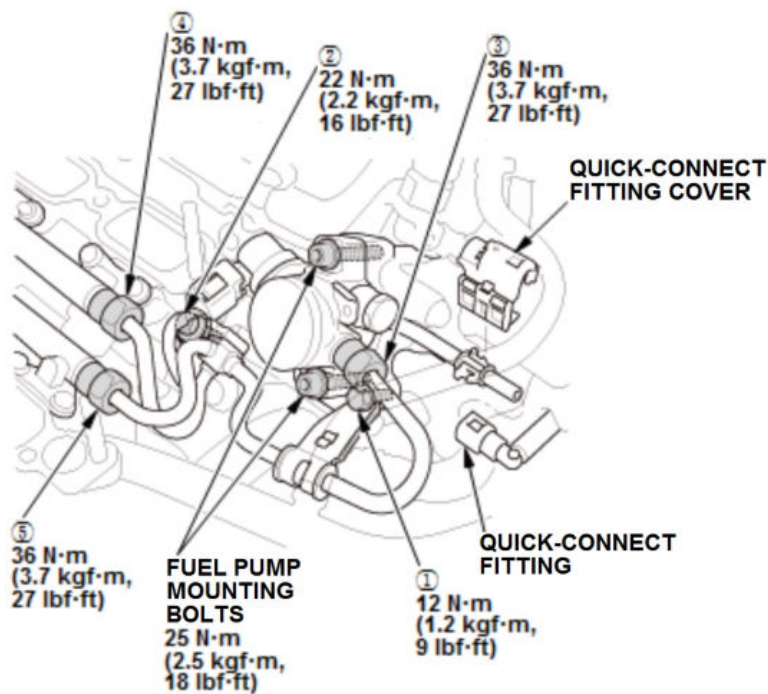
- A crowfoot-type tool increases the torque applied by the torque wrench. Refer to the procedure, Torque Specifications in the service information for details on how to recalculate the torque wrench setting.
- Failure to tighten the fuel joint pipe nuts to the proper torque will cause a fuel leak.

- 2.8. Tighten the fuel joint pipe bracket bolts to **12 N·m (9 lb-ft)** and **22 N·m (16 lb-ft)** as shown.

2.9. Tighten the fuel joint pipe nuts to **36 N·m (27 lb-ft)** as shown.
